EVALUATION OF COMPARATIVE REPAIR METHODS FOR STONE

A THESIS

Historic Preservation

2019

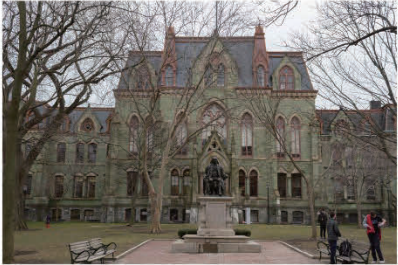
<p>Repair Type: Primarily Cast-Stone Year Installed: 1994 - 1996</p> <p>Observation:</p> <p>The principal facade of College Hall, facing north, displays a cohesive exterior. In this photograph, almost every stone on the central bay and eastward was replaced with cast-stone. The color of the cast-stone matches well with the remaining original serpentine on western portion.</p>
02

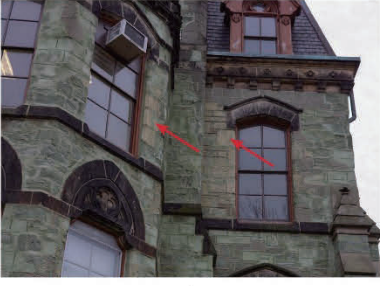
<p>Repair Type: Early Cast-Stone Replacement Year Installed: C. 1950</p> <p>Observation:</p> <p>Early cast-stone replacements used crushed serpentine as a colorant, and the serpentine has yellowed over time. The yellowing is caused by the breakdown of certain minerals into limonite.¹ Later cast-stone replacements used more stable, inorganic mineral oxide pigments that are colorfast and alkali-proof.</p> <p><small>¹ Meierding, Thomas C. Weathering of Serpentine Stone Buildings in the Philadelphia, Pennsylvania, Region: A Geographic Approach Related to Acidic Deposition. Stone Decay in the Architectural Environment / Vol. 390. Boulder, Colo. : Geological Society of America, 2005.</small></p>

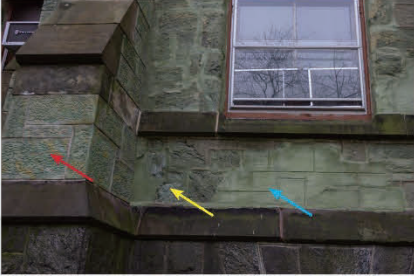
<p>Repair Type: Cast-stone, Stucco Year Installed: 1994 to post-2000</p> <p>Observation:</p> <p>This photograph shows the contrast between cast-stone replacement (red arrow), original serpentine (yellow arrow), and the temporary stucco patching (blue arrow). The cast-stone demonstrate a fairly close match to the original serpentine, while the stucco, intended as a temporary mitigation, was poorly color simulated.</p>

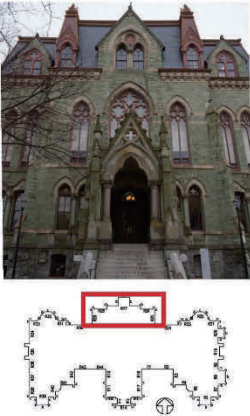
<p>Repair Type: Cast-stone Year Installed: 1994 - 1995</p> <p>Observation:</p> <p>Krier's method of using a family of different sized cast-stone successfully created ashlar pattern that is repeated but not does not appear repetitive.</p>
08

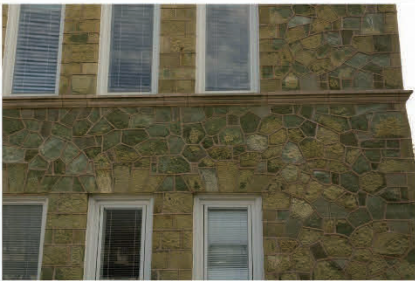
<p>Subject: Comparasion between patching and original stone</p> <p>Observation:</p> <p>This photograph was taken approximately 20 feet away. From this distance the patched stones are indistinguishable from original.</p>
03

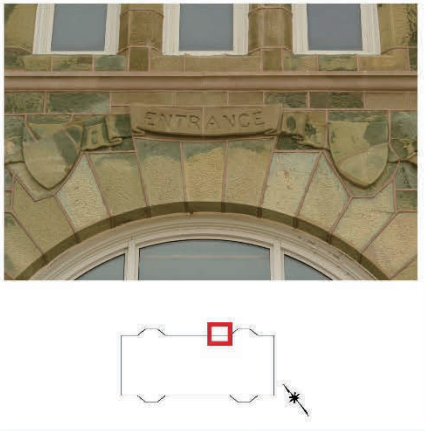
<p>Subject: Composite Repair Mortar</p> <p>Observation:</p> <p>The eroded Entrance carving was reproduced with composite repair mortar.</p>
06

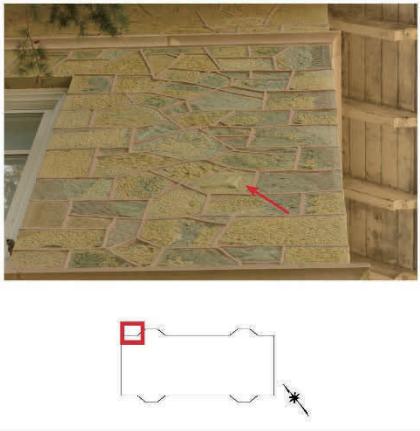
<p>Subject: Relief carving</p> <p>Observation:</p> <p>Several relief carvings, including the boot pictured here, were found during the conditions assessment. These features were carefully preserved during the construction.</p>
03
