Soft Capping of Archaeological Masonry Walls

Far View House

Mesa Verde National Park

A Thesis in Historic Preservation
Graduate School of Design
University of Pennsylvania
2009

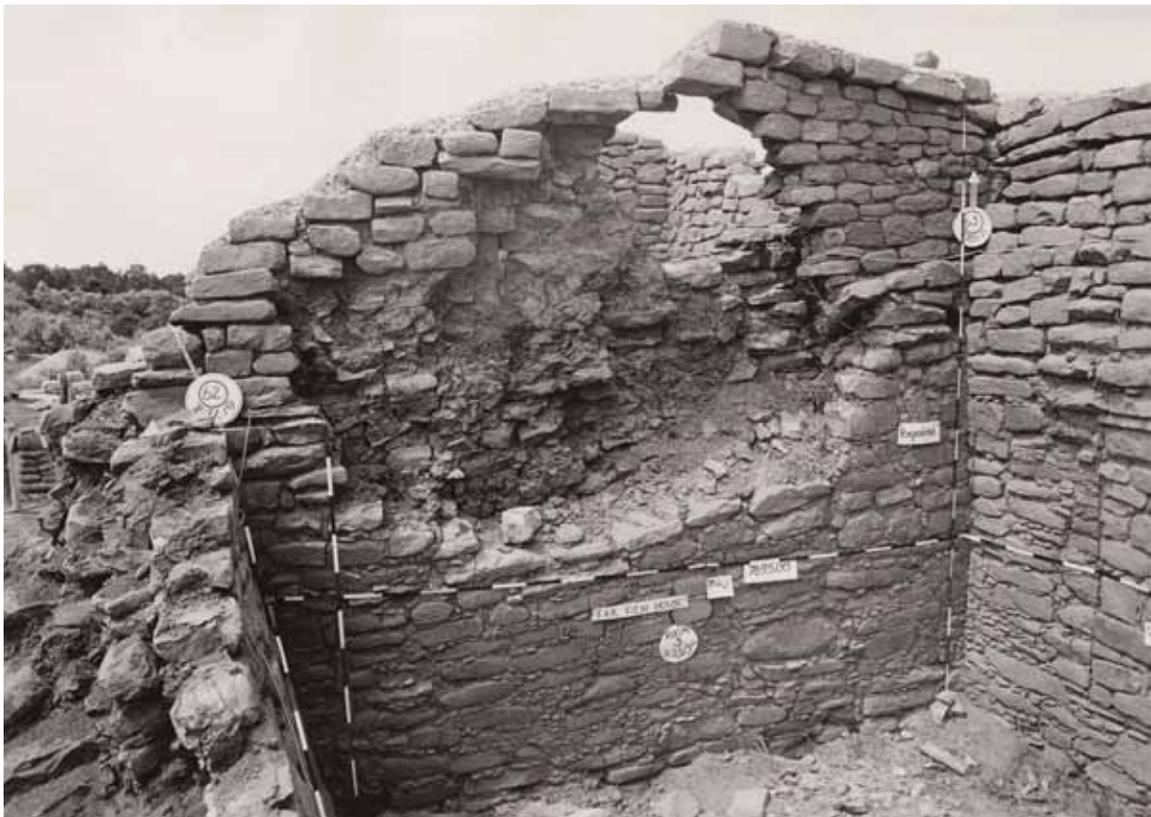
Figure 9. Room 5 North Wall in 1934 before Stabilization (Markely 1934) MVRC

original wall areas from rebuilt or repointed wall areas. Cord was placed surrounding the two smaller types of areas, isolating the third and largest type area (Figure 9).

...more than twenty weak or fallen spots were replaced or strengthened among the interior walls of the Pueblo. Some of these places were very deceptive. Where only a few loose stones showed in the face courses of the masonry, their removal revealed great cavities behind, sometimes reaching to the opposite veneer of the wall. Plugging of such holes took much more time than was anticipated... (ibid)

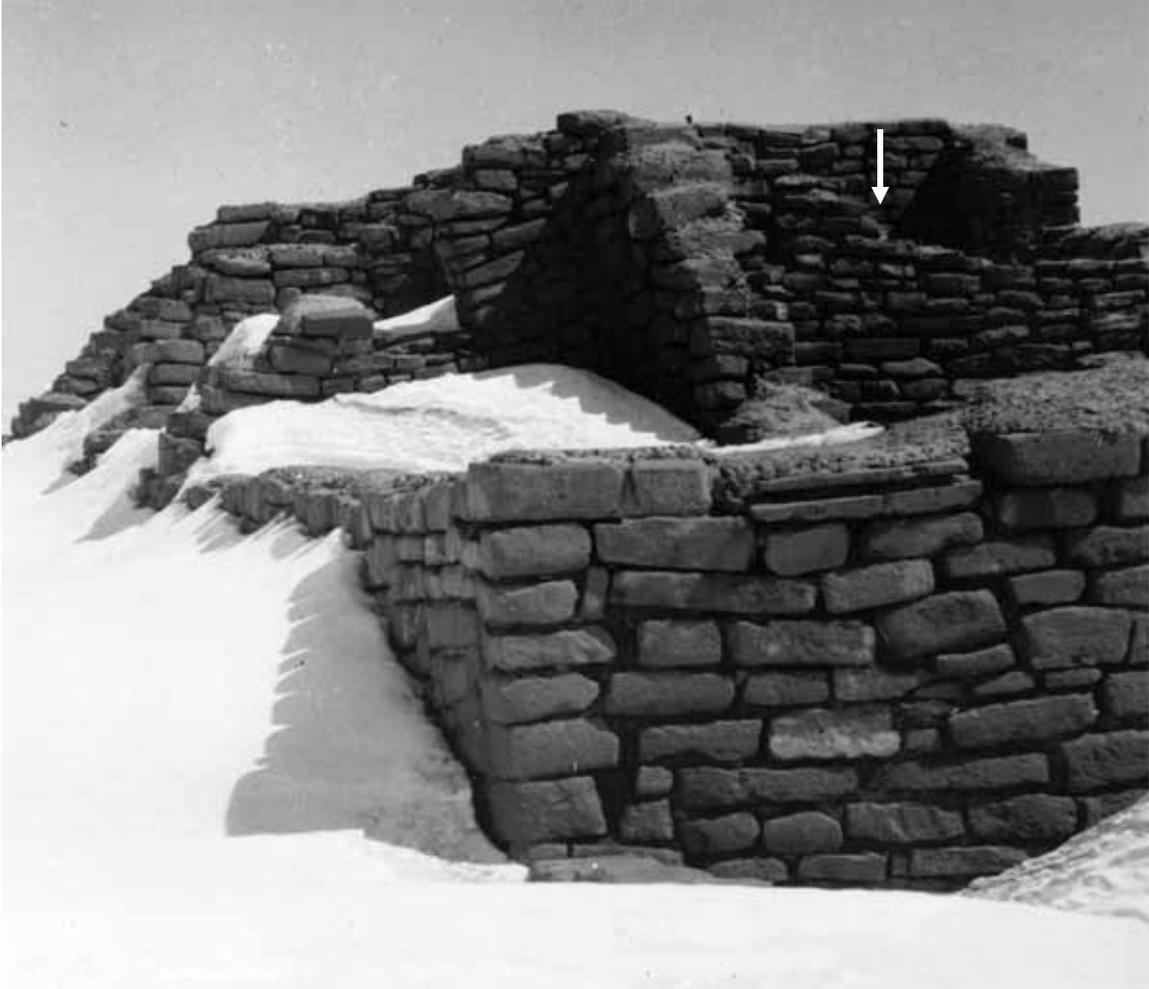
Figure 14. Photo showing Upper Part of Room 28 East Wall (Lancaster 1956) MVRC

After 1934, there exist few photos that partially document the condition of the wall. The one taken in 1956 by Lancaster, in particular, shows the wall top contour changed to a broad U-shape pattern (Figure 14). Except for the north and south ends where the test wall adjoins other walls, the stone courses show significant change compared to 1934 photos. The photo suggests that the rebuilt portion suffered from stone falling or underwent at least one more repair before the photo was taken. A photo by Decker in 1967 also shows a very similar configuration (Figure 15). The wall

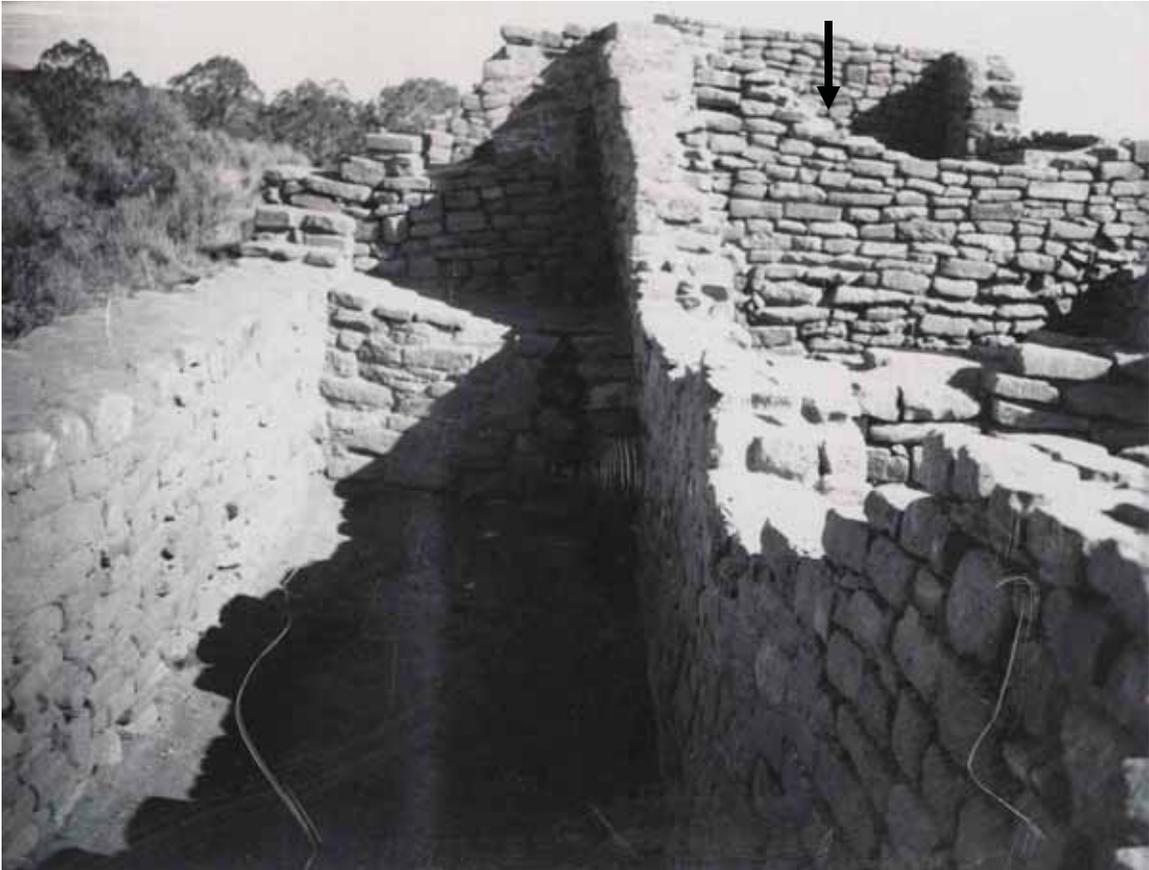
Figure 15. Photo showing Upper Part of Room 28 East Wall (Decker 1967) MVRC

pointing is maintained to a minimum, revealing recesses between sandstones. Viga sockets are no longer visible.

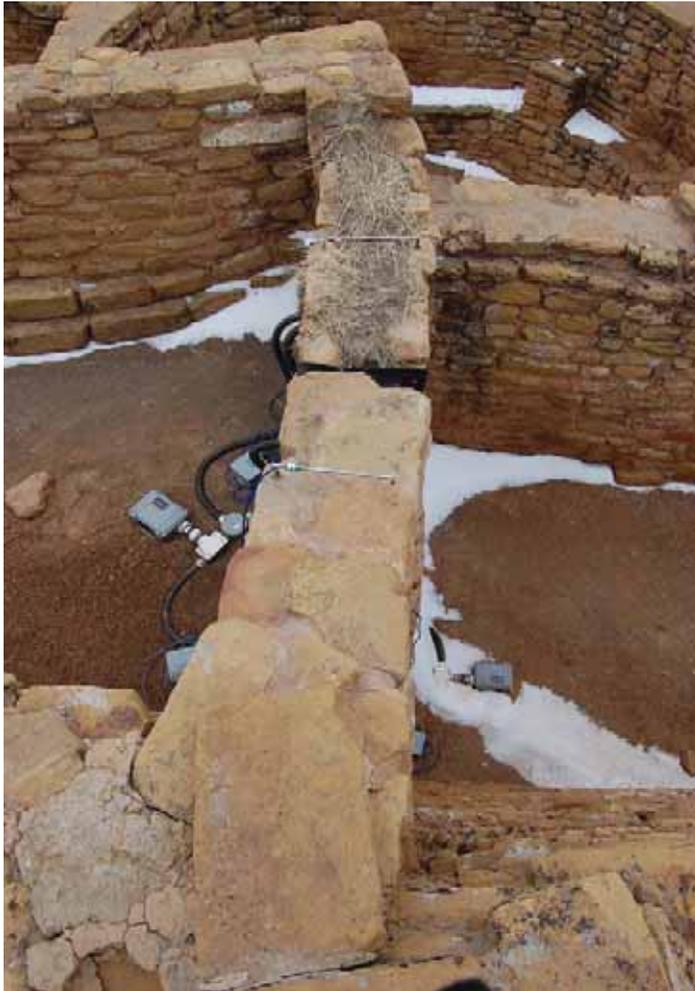
Figure 31. The test wall at the time of data retrieval (Fisher 2009)

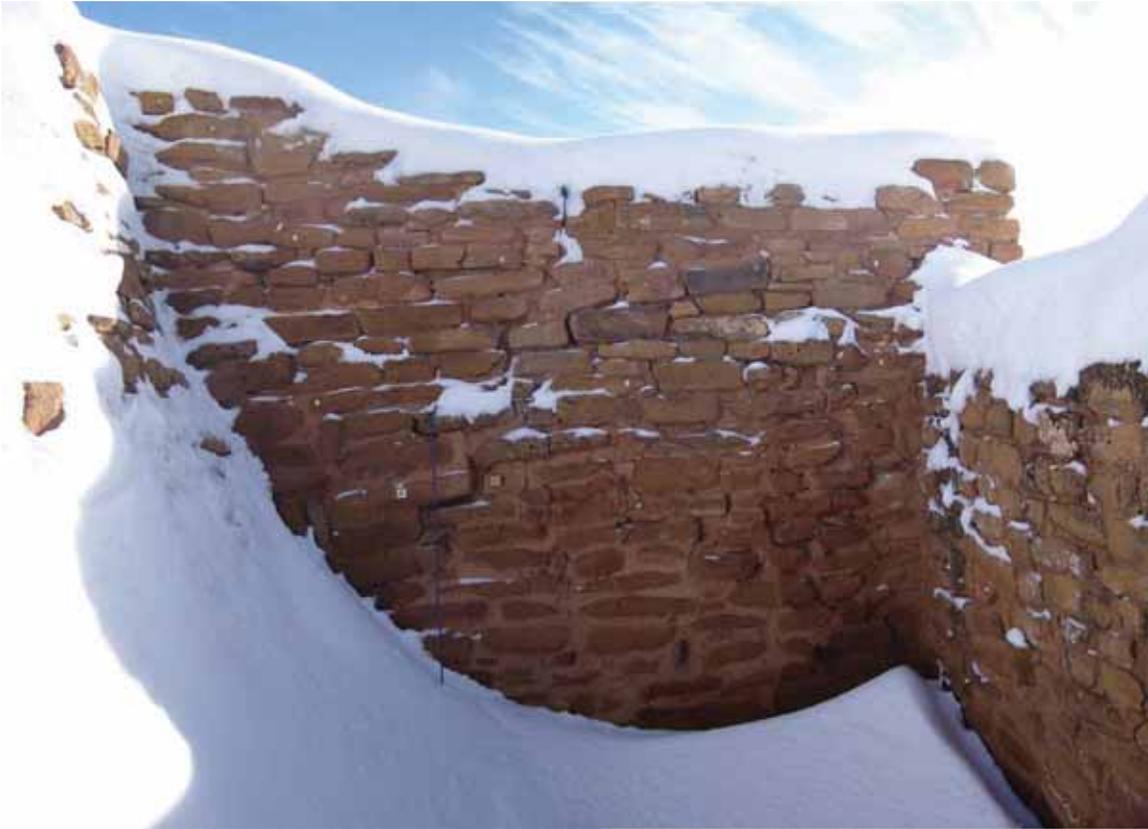
Figure 32. Room 13 Eat Wall in December 2008 (Lim 2008)

The probes were installed on October 9th, 2008 and the data was first retrieved on March 20th, 2009. These recordings were compared against the weather data from the weather station at Far View House. The lateral movement of the wall tops was also analyzed by installing two crack monitors on October 31st, 2008. The crack monitor installed on the wall face with epoxy fell due to the friability of the stone surface and was reinstalled with screws on November 6th, 2008 (Figures 32-33).
