ASSESSMENT AND ANALYSIS OF THE PLASTER EXHIBIT HALL CEILING  
AT THE WAGNER FREE INSTITUTE OF SCIENCE, PHILADELPHIA, PA

A THESIS

Historic Preservation

2008

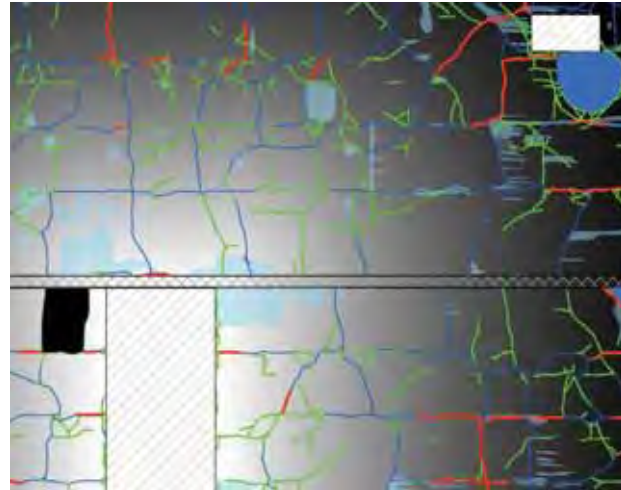
**Figure 5: Distance from skylight. Black and white raster is overlaid with vector conditions in color.**

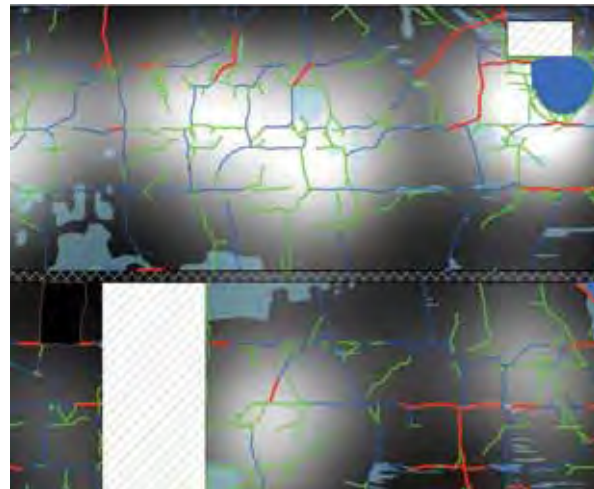
**Figure 6: Density of small cracks with vector overlay.**

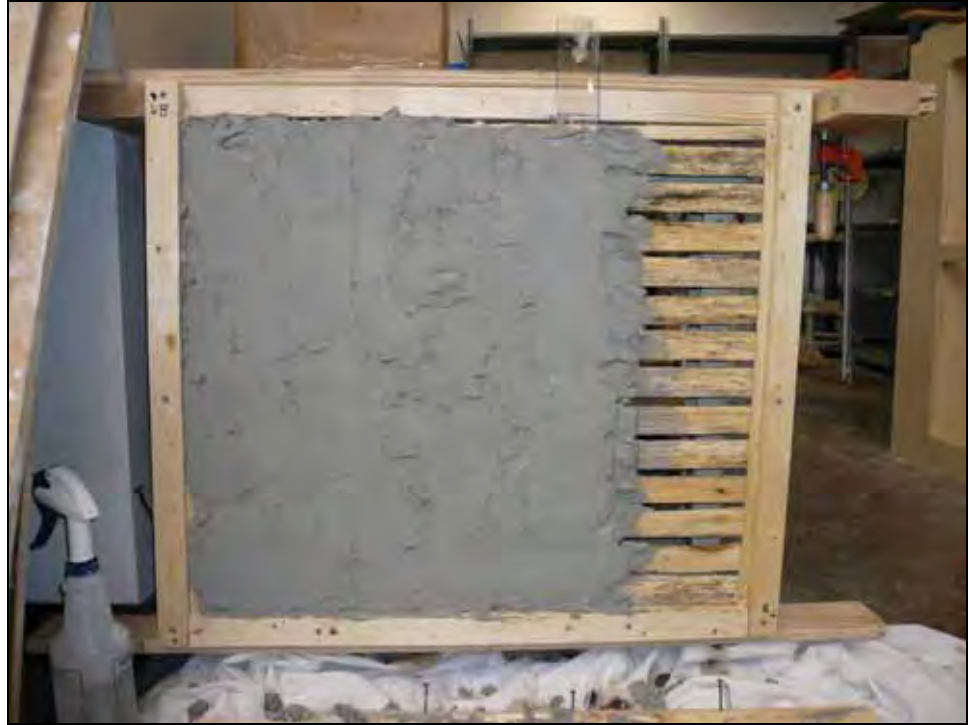
**Figure 17: Plaster mock-up “B” – simulating detachment between the lath and the scratch coat.**

To test the potential for extending this methodology to wood-frame systems, a study was undertaken in conjunction with the Applied Research Laboratory at the Pennsylvania State University in State College, Pennsylvania. In this study, three ceiling mock-ups were designed to closely reproduce the condition of most concern at the Wagner – detachment. Frames of approximately two feet square were built to hold the plaster. Wood lath of similar dimensions were attached to the frame with the same sized gaps as found at the Wagner. Since lime (the original binder of the plaster) could not be used because of its long set time, a proxy material called Structo-Lite, a pre-mixed, perlite-aggregate gypsum, was

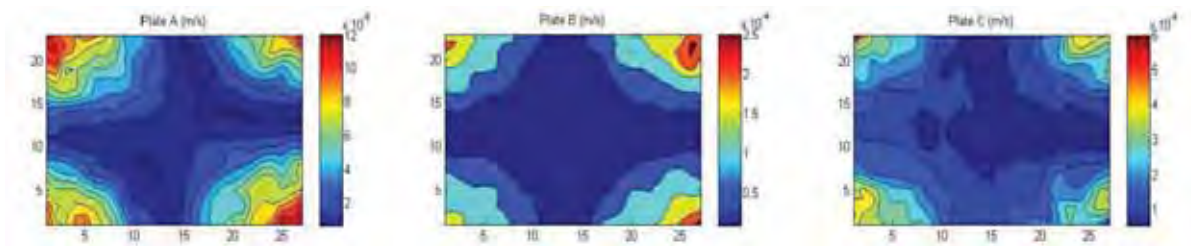
When the results for the three plaster samples are compared, it can be seen that the FRF's are very similar in frequency, and many of the beam and plate modes were observed in the FRF's (See Figures 7A-7C in Appendix A). Between the range of 48 Hz and 54 Hz, the (1, 1) mode could be seen in every sample, and was easily distinguishable. This mode was measured at 53.8 Hz for Sample A, 51.3 Hz for Sample B, and 48.8 Hz for Sample C. The velocity magnitudes for every point on each sample were plotted in MATLAB® for the corresponding modal frequency, as shown in Figure 3. Using MATLAB®, Samples B and

Figure 3: Velocity Distributions at Analyzed Mode: Sample A – 51.3 Hz, Sample B – 51.8 Hz, Sample C – 48.8 Hz (Speaker Excitation 20-500Hz)

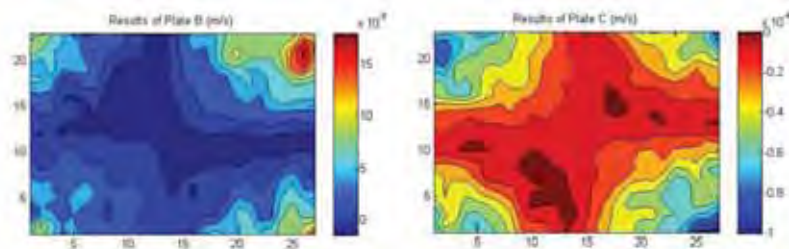
C were then compared to Sample A. A MATLAB® code was used to subtract the velocity magnitudes for Sample A from Samples B and C. The results for Sample B-A and Sample C-A were plotted and are shown in Figure 4. As observed in Figure 4, there is no indication

Figure 4: Comparisons of Sample B & C to Sample A (Speaker Excitation 20-500Hz)

of any types of horizontal faults in either Sample B or Sample C. The data is inconclusive as to the presence of the faults and where the faults are located. Due to the fact that the data is inconclusive, the experiment was performed again over a broader range of frequencies using an F3 piezoelectric shaker driven by band-limited white noise from 20 Hz – 5 KHz. When the results for the three plaster samples are compared from the shaker test, it is once again evident that the FRF's are very similar in frequency. Many of the beam and plate modes can again be seen in the FRF's (See Figures 8A-8C in Appendix A). Between the

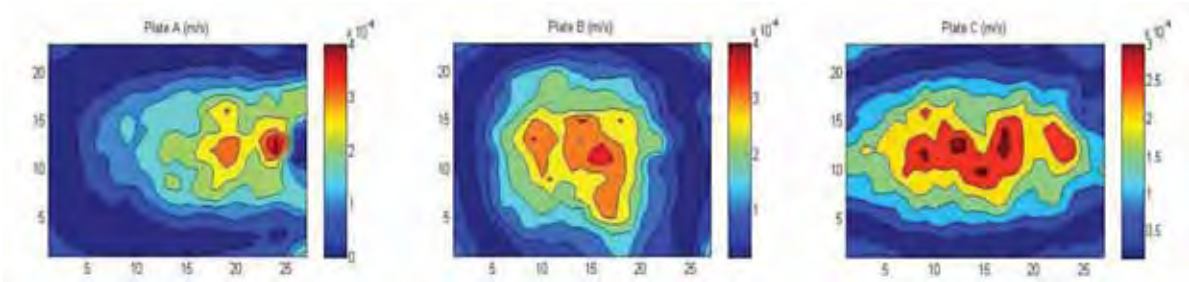
range of 128 Hz and 134 Hz, the same mode was observed in every sample, and was easily distinguishable from any other mode. This mode was measured at 131.3 Hz for Sample A, 133.6 Hz for Sample B, and 128.1 Hz for Sample C. The velocity magnitudes for every point on each sample were then plotted for the corresponding modal frequency, as shown in Figure 5.

Figure 5: Velocity Distributions at Analyzed Mode: Sample A – 131.3 Hz, Sample B – 133.6 Hz, Sample C – 128.1 Hz (Shaker Excitation 20 Hz – 5 KHz)

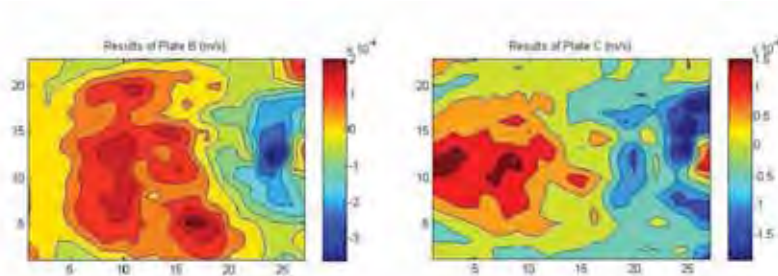
Figure 6: Comparisons of Sample B & C to Sample A (Shaker Excitation 20 Hz – 5 KHz)

The results from Figure 6 again show that there is no indication of any types of horizontal faults in either Sample B or Sample C. Thus, the data is again inconclusive as to what types of faults are present and where the faults are located.
