ADAPTIVE REUSE: RECENT HOTEL CONVERSIONS
IN DOWNTOWN PHILADELPHIA

A THESIS

Historic Preservation

2005

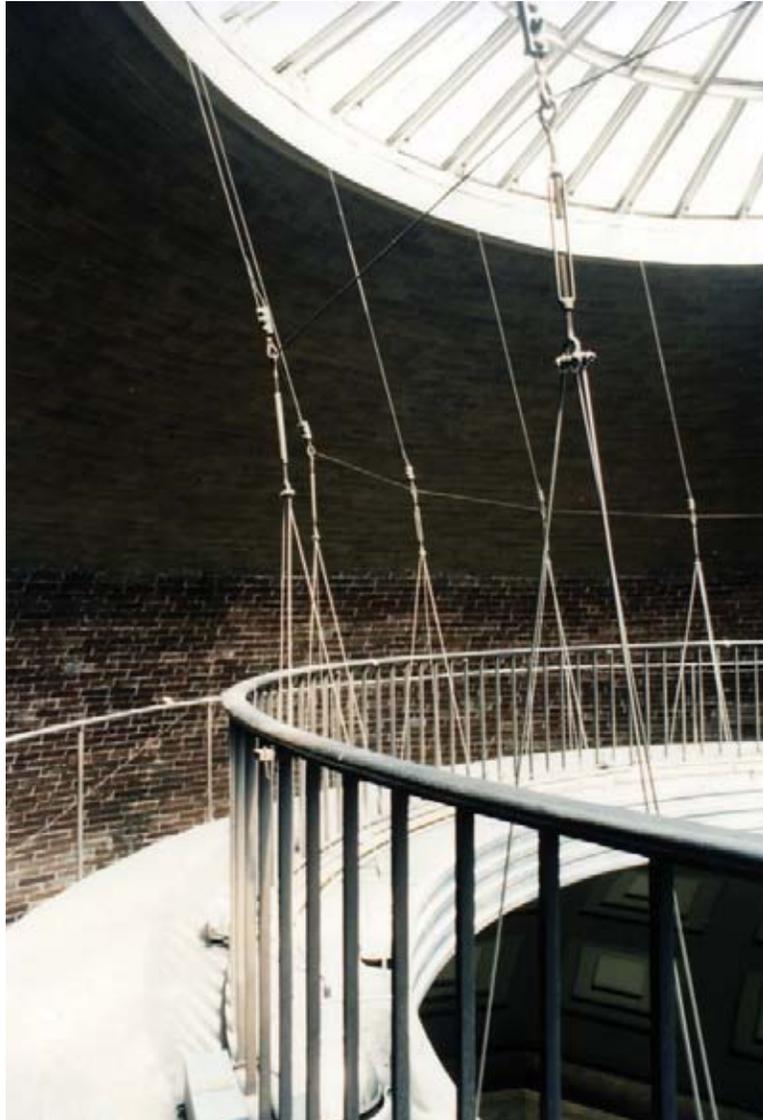
Figure 6: Girard Trust Company Dome Building, 1908 plan.

Figure 5: Girard Trust Company Dome Building, the space in between the inner and outer Guastavino tile domes, 1998.

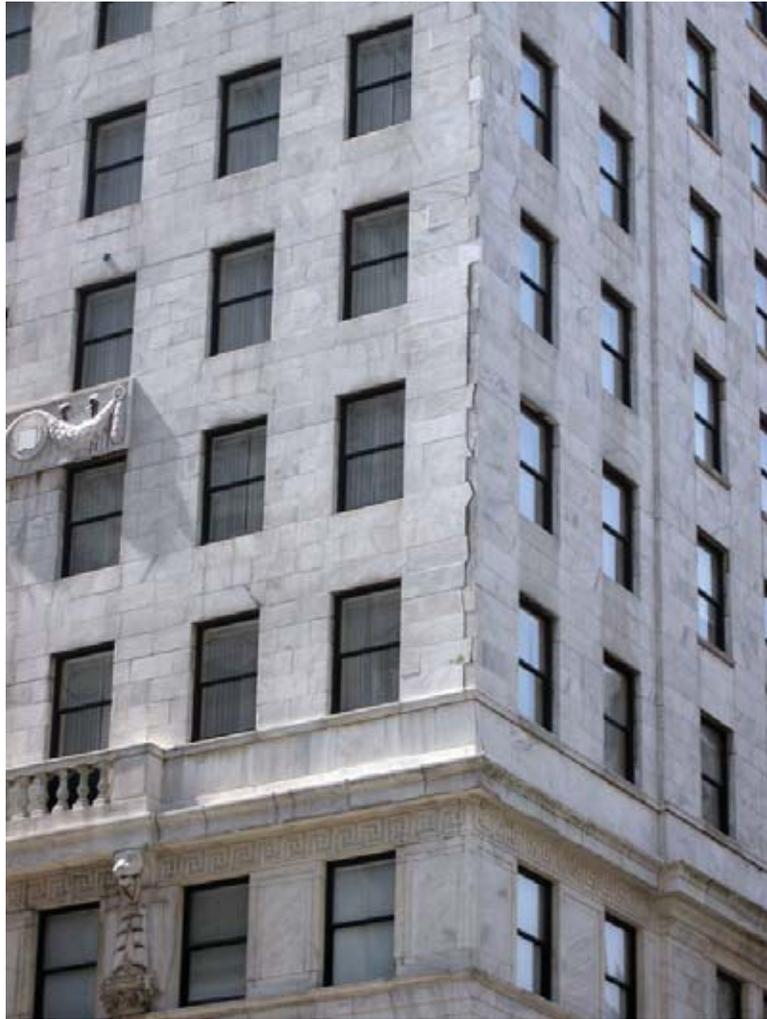
Figure 11: Girard Trust Company Tower Building, partial view of Chestnut Street and South Penn Square facade showing double hung one over one windows, January 2005.

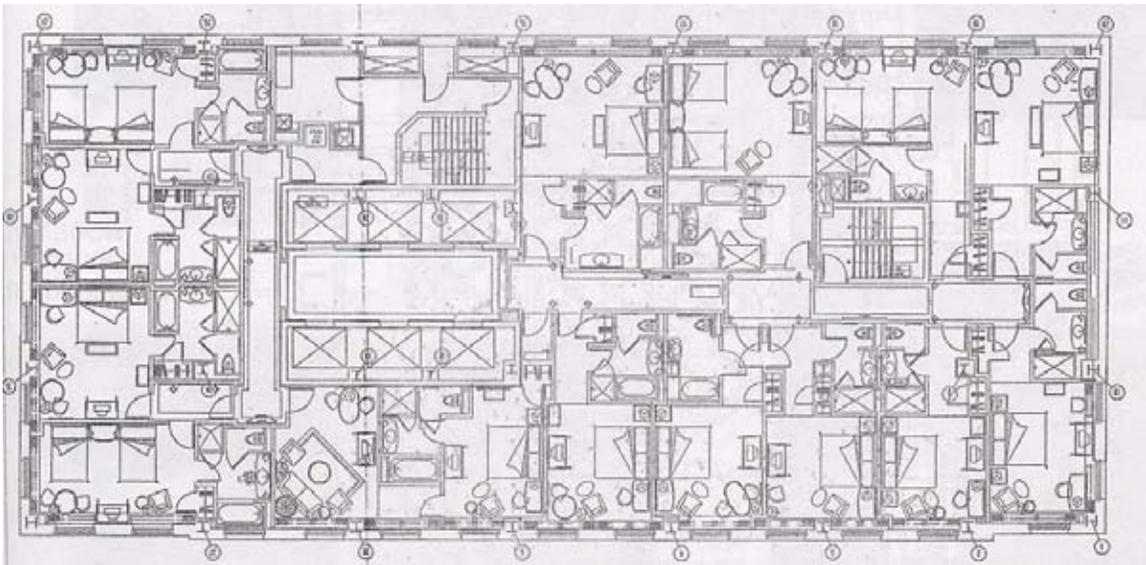
Figure 18: Girard Trust Company Tower Building, plan of typical guest room floor.

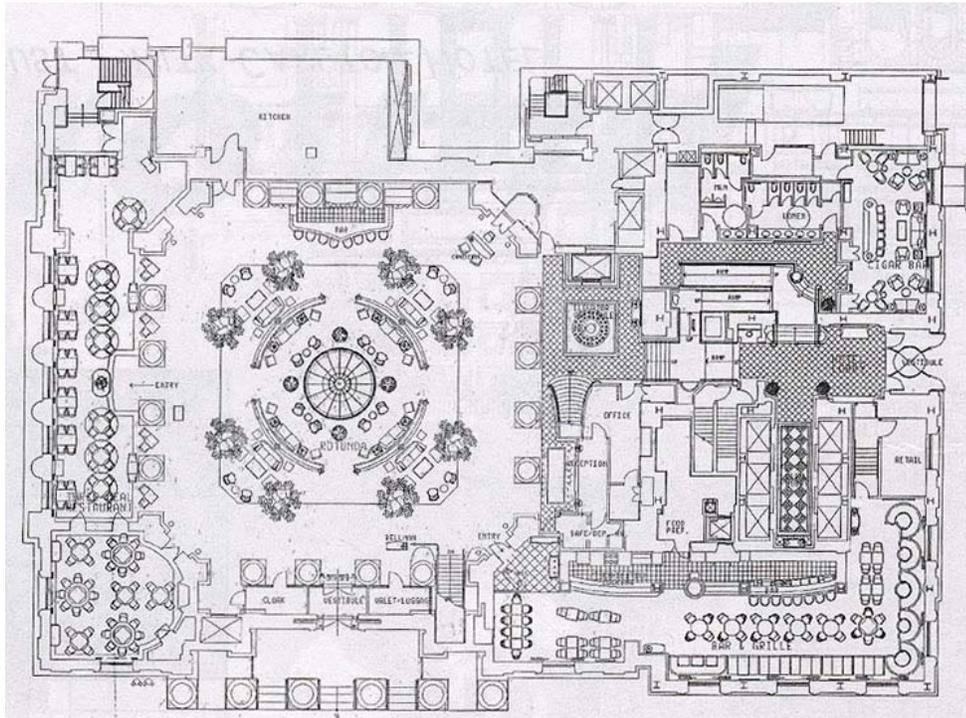
Figure 20: Girard Trust Company Dome and Tower Buildings, plan of first floor illustrating new connection between the two buildings and ADA accessible ramp.

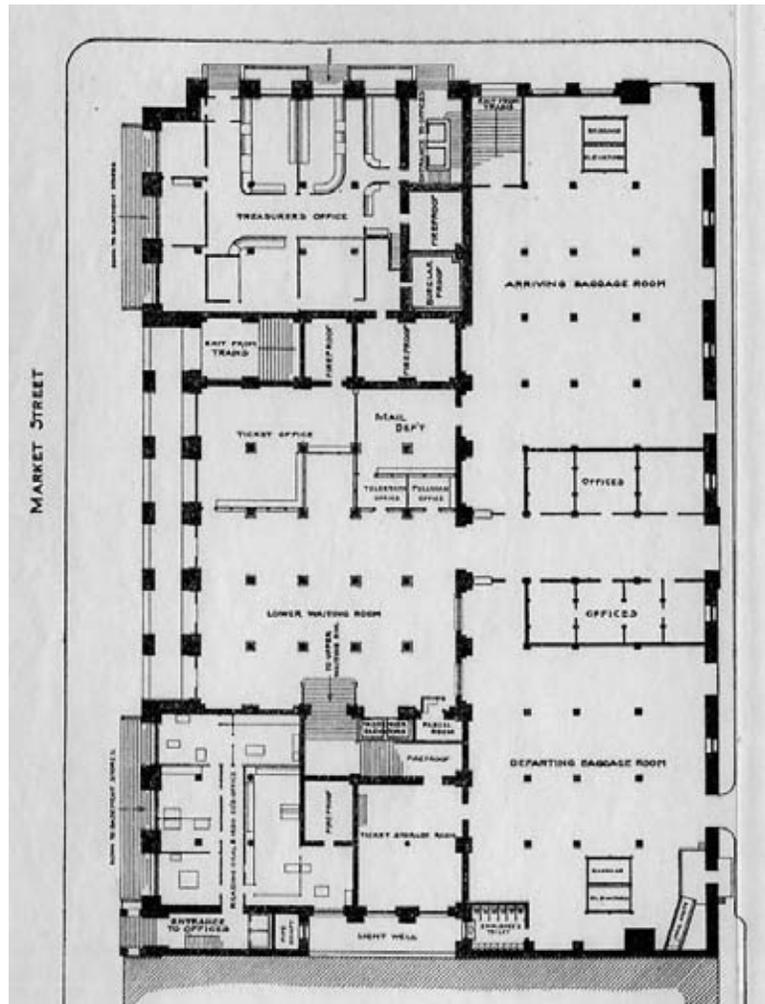
Figure 25: Reading Terminal Headhouse, ground floor plan, 1893.

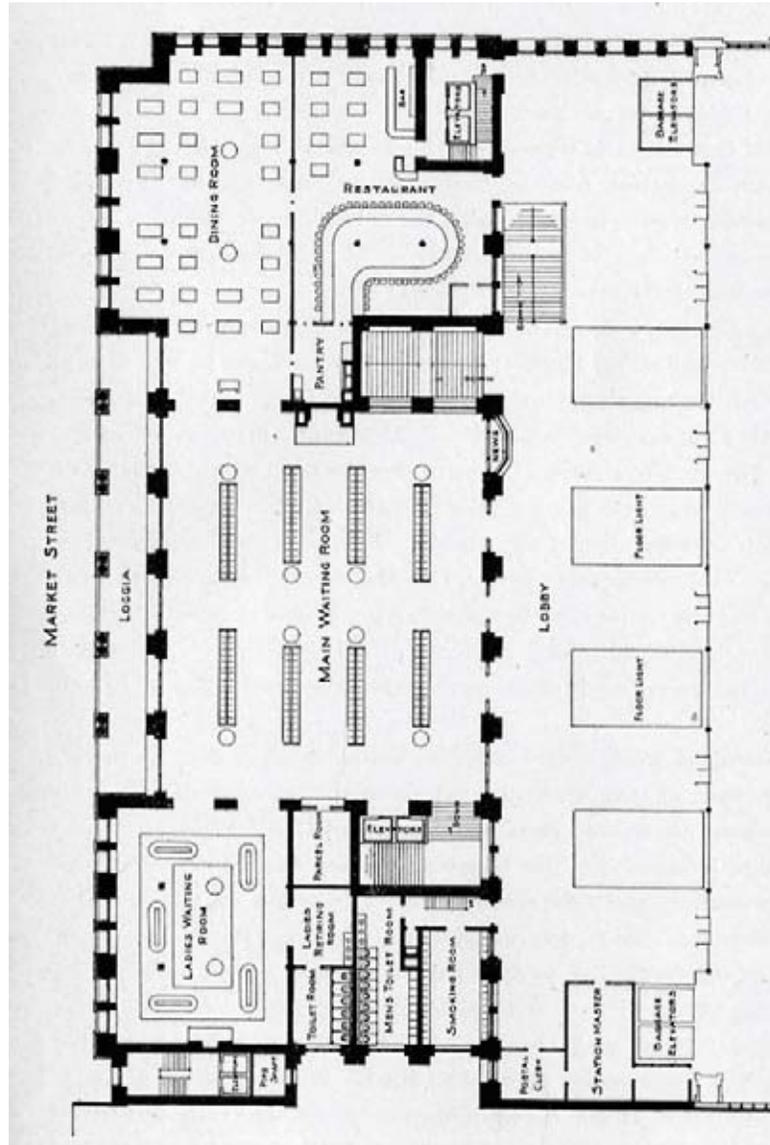
Figure 26: Reading Terminal Headhouse, second floor plan, 1893.

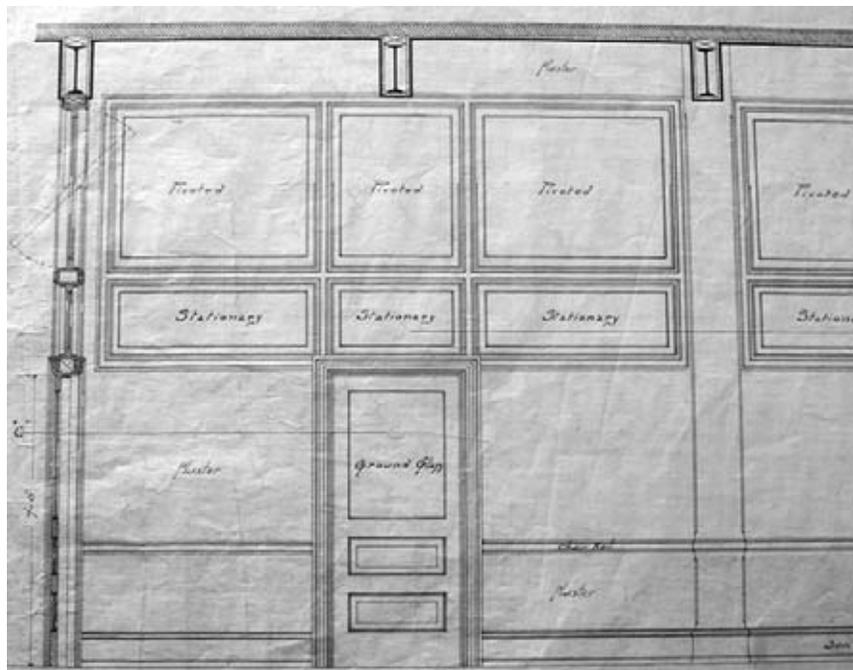
Figure 27: Reading Terminal Headhouse, original drawings of glass partitions for the 2 ½ story. Note baseboard, chair rail, and moldings around windows and doors, 1893.

designed to permit light into the corridor, punctuated by the doors with inset ground glass panels (*Fig. 27*). A baseboard, chair rail, and moldings around the windows and doors demarcate the walls.

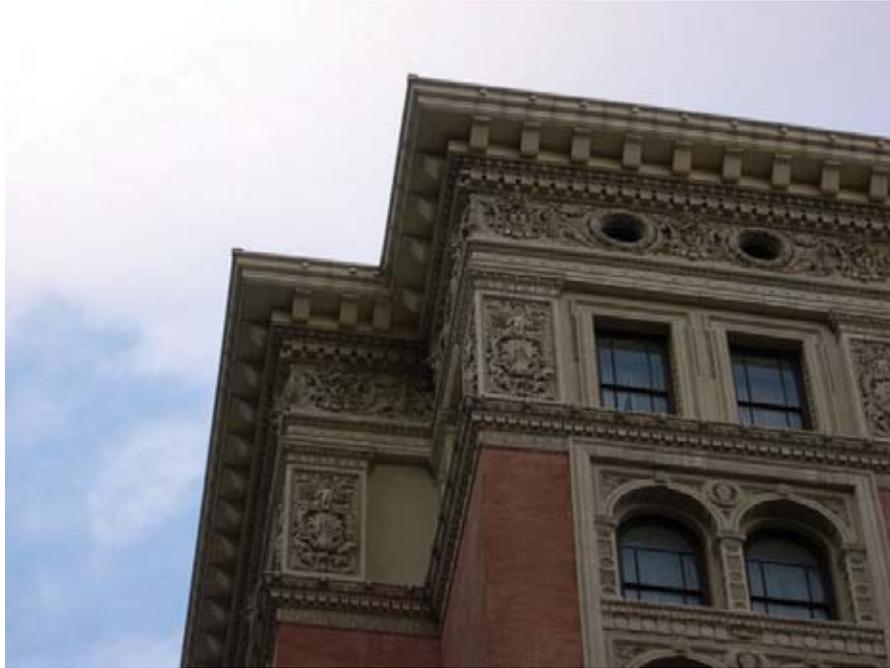
Figure 29: Reading Terminal Headhouse, the new sheet metal cornice lacks much of the original's detail, March 2005.

parapet, but without the same level of detail (*Fig. 29*).¹⁷⁵ This approach had been utilized in the effort to reconstruct the original two-story, six-bay, granite, brick, and terra cotta arcade, beginning in 1983 under the “Public Entrance” project.¹⁷⁶ The original elements were recreated but without their original intricate surface detail. This approach was taken both as a measure of cost savings and because the lack of detail would serve to differentiate between old and new material,¹⁷⁷ in accord with Standard 9. Completed work included new granite piers and segmental arches at the first floor topped by a new cast stone cornice. Installed at the second floor was a new cast stone balustrade between brick piers supporting paired Ionic columns supporting the arches articulated with voussoirs. The original terra cotta elements, such as columns, balusters, voussoirs, and keystones were reproduced in cast stone and glazed to create a finish similar to the original terra cotta.¹⁷⁸ The cast stone elements evoke the general profiles but do not attempt to incorporate the original details.

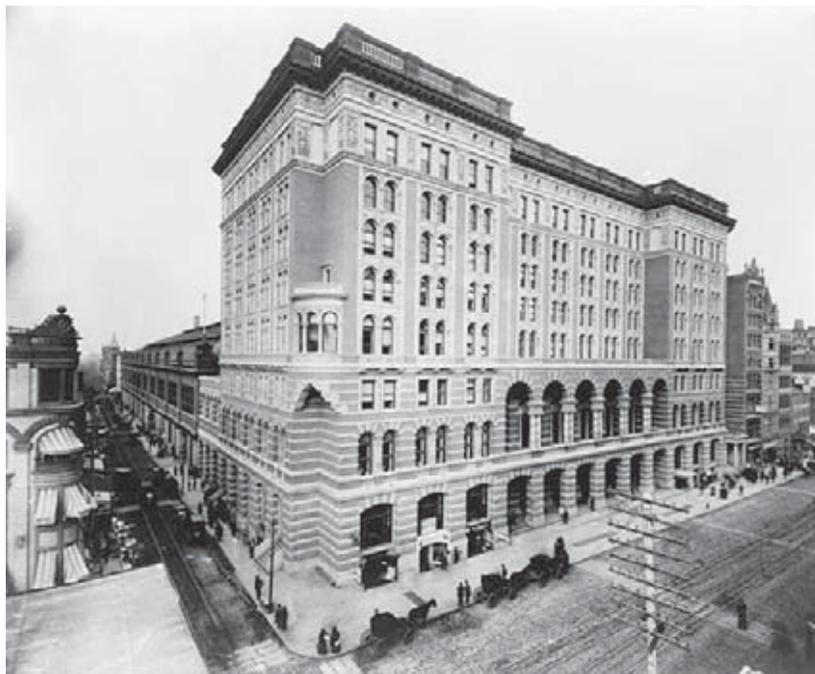
Figure 30: Reading Terminal Headhouse, historical photograph showing terra cotta colonettes on either side of the doors/windows under the second floor arcade, 1893.

that had been found stored within the building.”¹⁷⁹ The terra cotta belt courses, the voussoirs and keystones at the door/window openings, pilaster capitals, and radius brick at the corner of the pilasters were all going to be recreated with cast stone.¹⁸⁰ In addition, it was hoped that the newly discovered terra cotta colonettes and the elaborately detailed spandrels that they supported in between the door/window openings could be reconstructed (*Fig. 30*). However, the scheme was soon discovered to be far too costly and abandoned.¹⁸¹

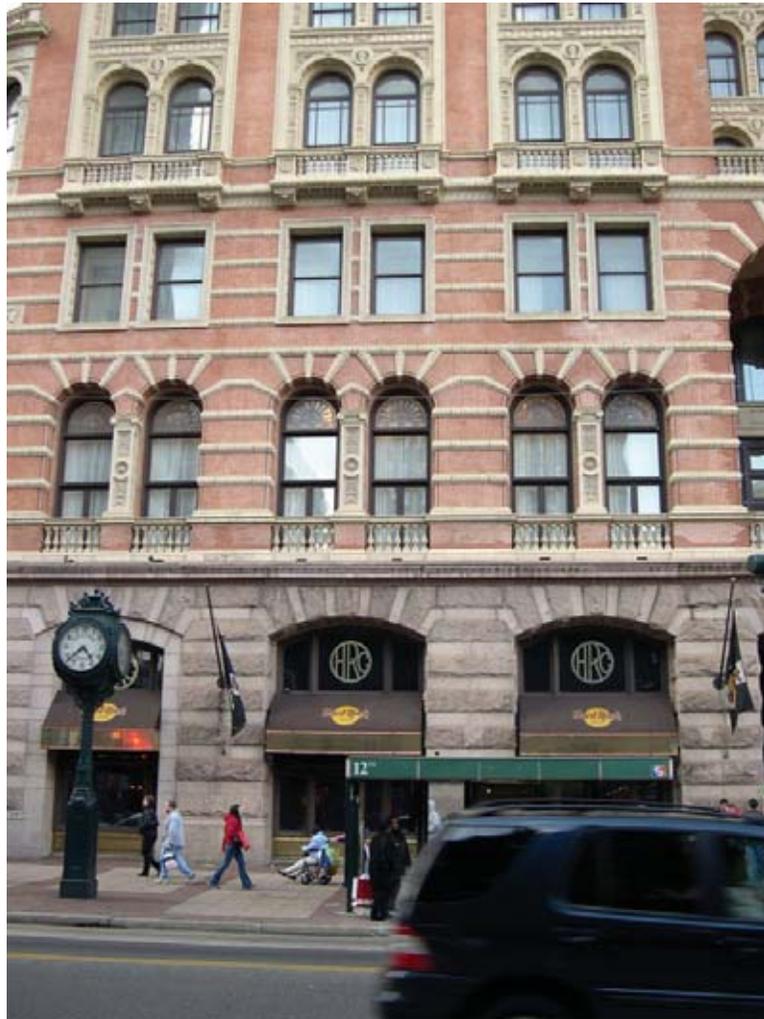
Figure 31: Reading Terminal Headhouse, replacement windows included bronze windows in the Hard Rock Cafe storefronts, wood windows on the second floor of the Market Street elevation, and aluminum windows above, April 2005.

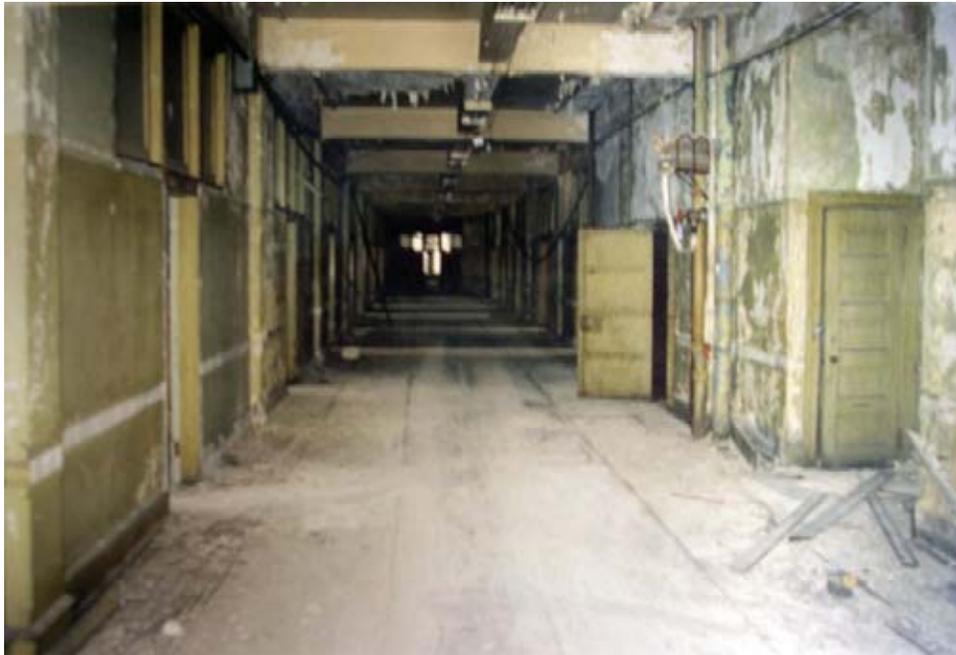
Figure 32: Reading Terminal Headhouse, 6th floor corridor, looking east. Hallways were 16-foot wide, July 2, 1997

on the interior.²⁰⁰ The width of the corridors, along with partitions featuring pivoting sash, glass panels, and various moldings proved problematic (*Figs. 32, 33, & 34*). It was this issue that had caused denial of the first tax credit project and the same problems in the second. It again caused considerable debate in the third. The architects wished to reduce the width of the corridors on the guest room floors because they accounted for about 20% of each floor, precluding a feasible number of guest rooms per floor.²⁰¹ Further, the existing layout did not fit that necessary for hotel guest rooms. The architects initially sought to reduce the width of the corridors on the guest room floors from 16 to 8 feet for code, sound, and privacy.²⁰² Negotiation and discussion began with the requirement that the corridor be retained as is on one floor. Nearly four months later it was determined that the project with Marriott could not proceed with the retention of one floor because it would cause the loss of a number of rooms, making the project no longer feasible. At this juncture, in a meeting between the RDA, JMA, and the SHPO, it was agreed upon that if the corridors were not preserved then the new corridors were to feature replications of the existing moldings, the outside corners were to be chamfered and on the ninth floor the entrance to the concierge lounge would feature the sidelight and transom elements found on the lower floors. An exhibit would also be installed in the public areas.²⁰³

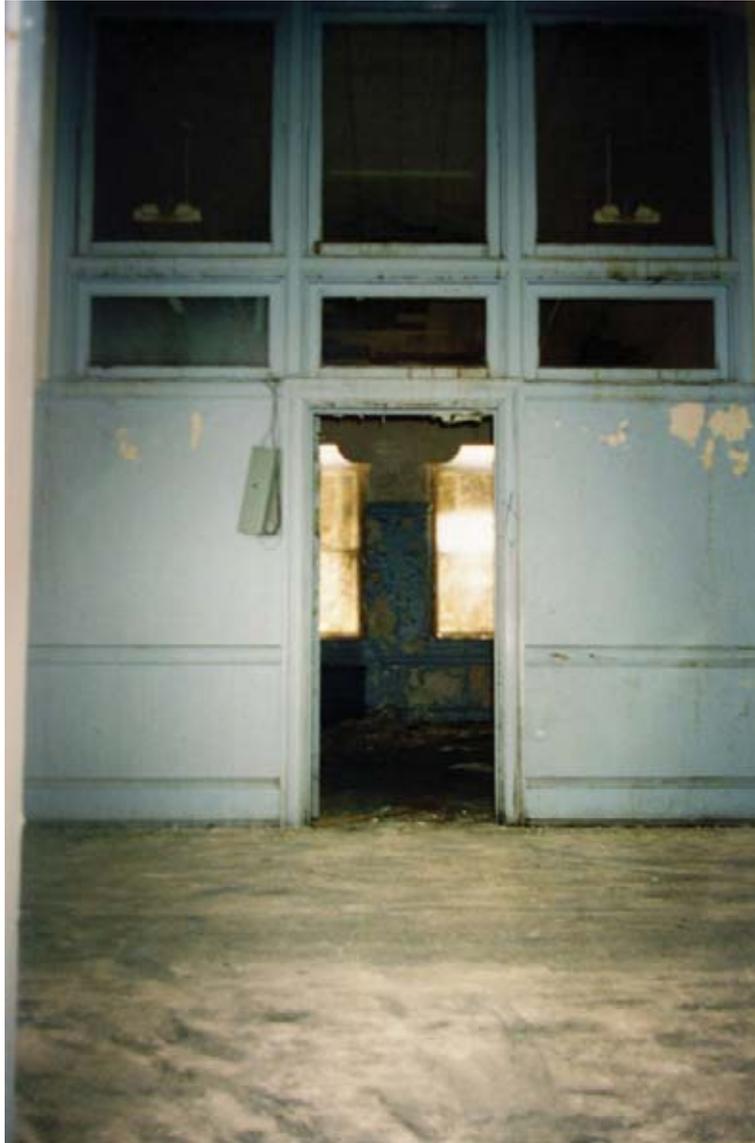
Figure 33: Reading Terminal Headhouse, 4th floor original partition. Note baseboard, chair rail, and moldings around window and door, July 2, 1997

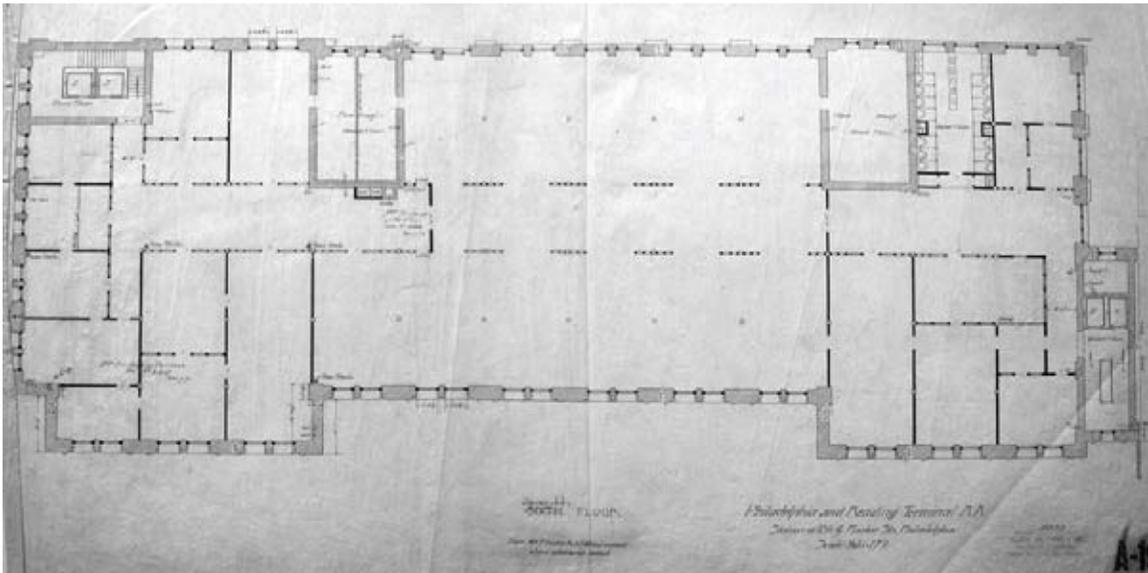
Figure 34: Reading Terminal Headhouse, original 1897 plan of seventh floor, illustrative of typical office floor layout.

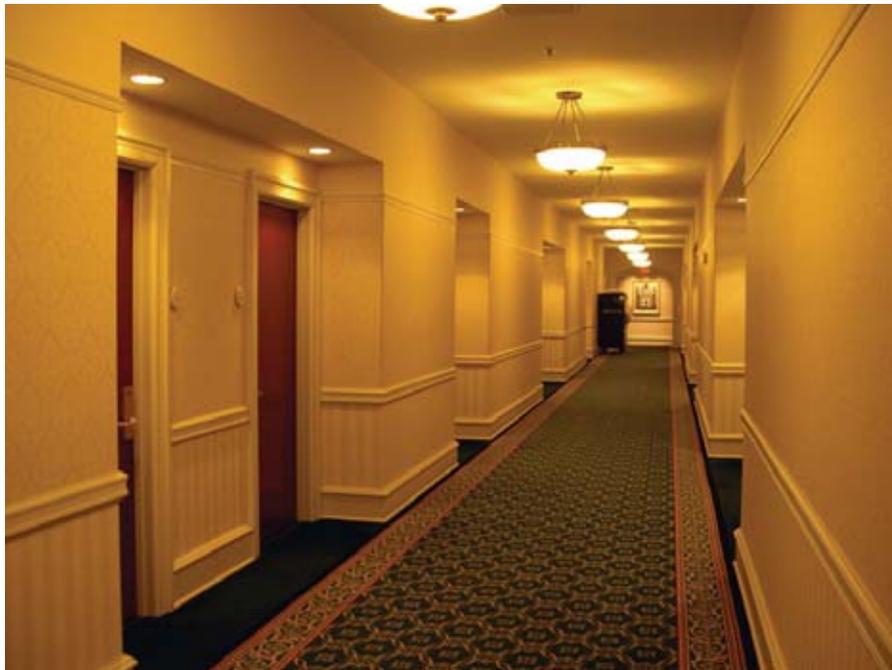
Figure 35: Reading Terminal Headhouse, 6th floor corridor, looking east. Hallways have been reduced to 8 feet, April 2005.

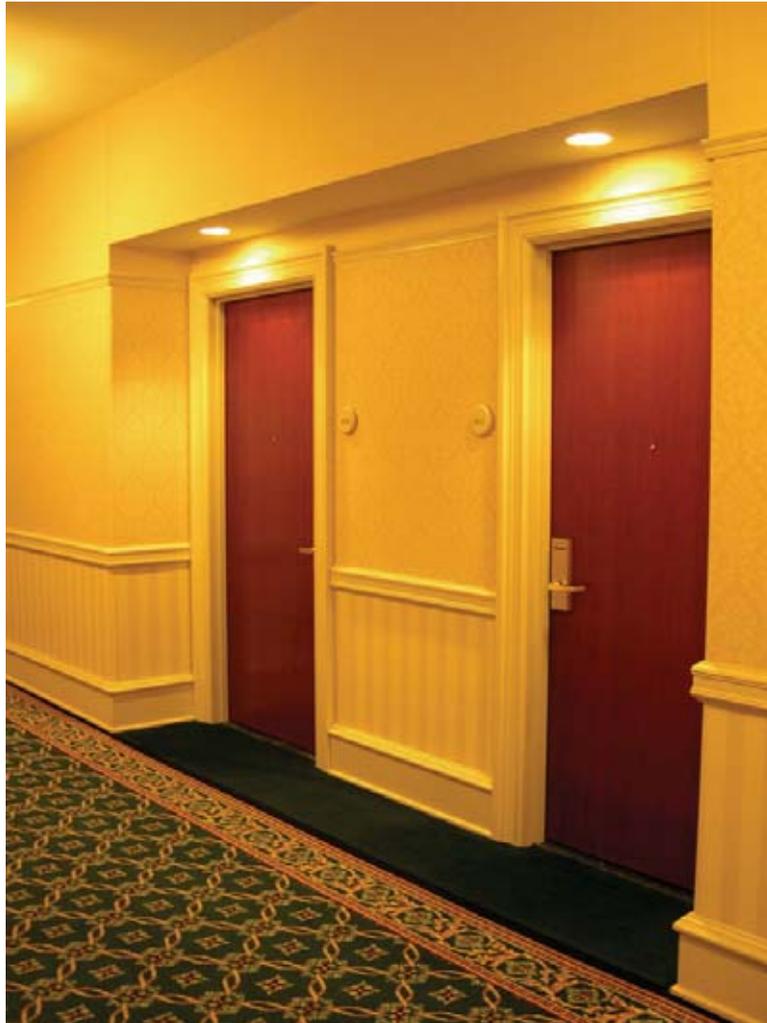
Figure 36: Reading Terminal Headhouse, view of 4th floor hallway representative of typical guest room floors. Note replication of baseboard, chair rail, and moldings around doors, April 2005.

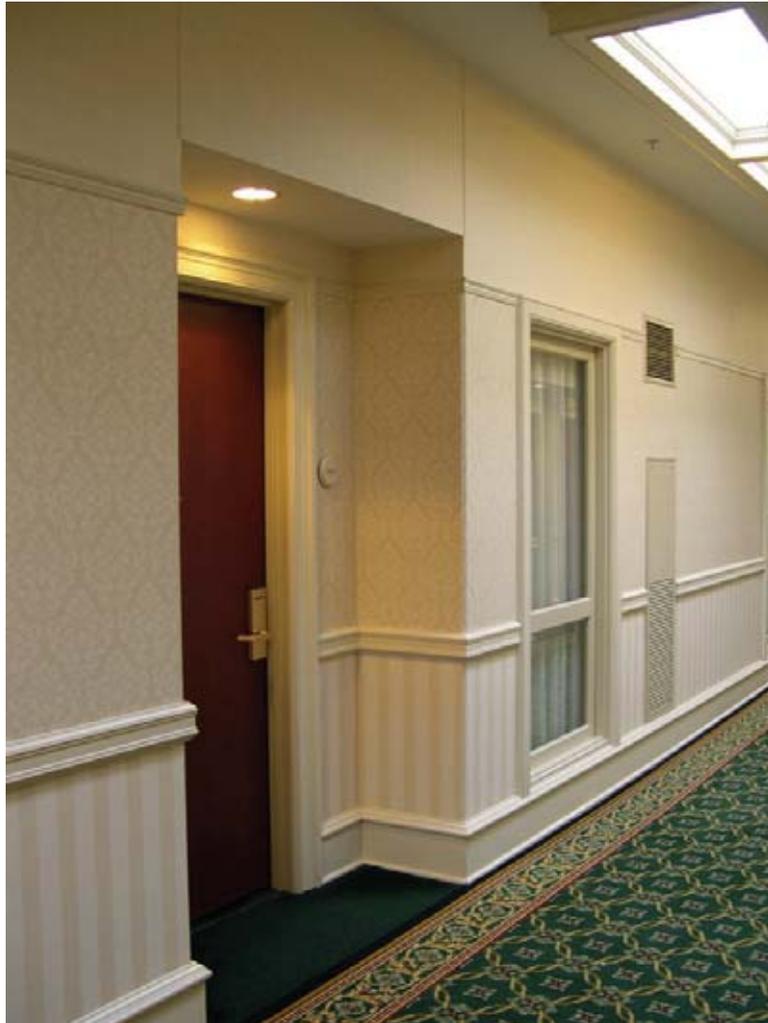
Figure 37: Reading Terminal Headhouse, view of partition on 9th floor, with window into the guest room and skylight above. Note replication of baseboard, chair rail, and moldings around door and window, March 2005.

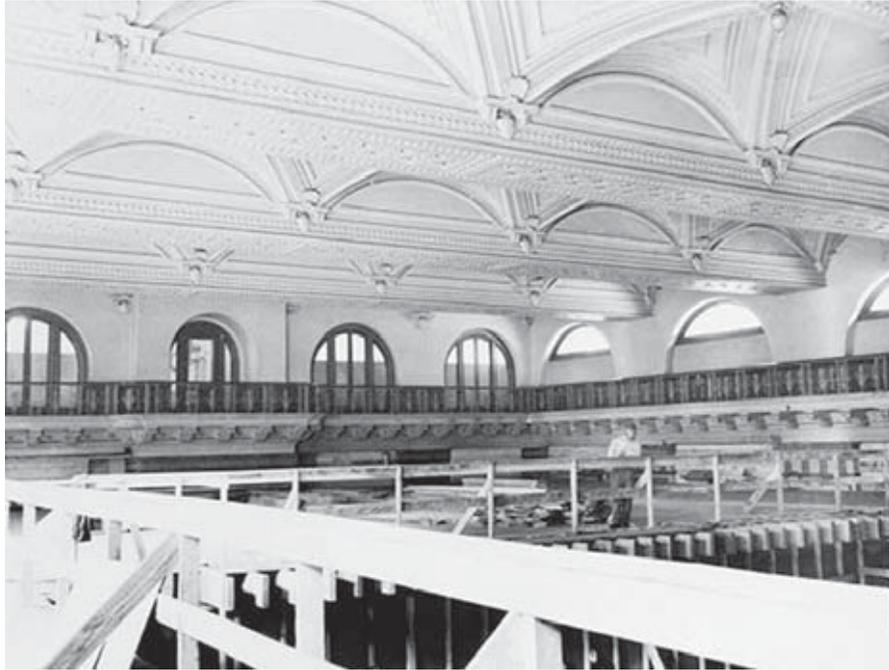
Figure 38: Reading Terminal Headhouse, second floor waiting room, during alterations in the 1950s when the space was subdivided. Note the balconies running along the edge of the room, c. 1948.

The original double-height, second floor waiting room had been very ornate, with balconies on four sides and high arched windows looking out onto the loggia and onto Market Street (*Fig. 38*). A bracketed cast iron cornice supported the balconies. The piers

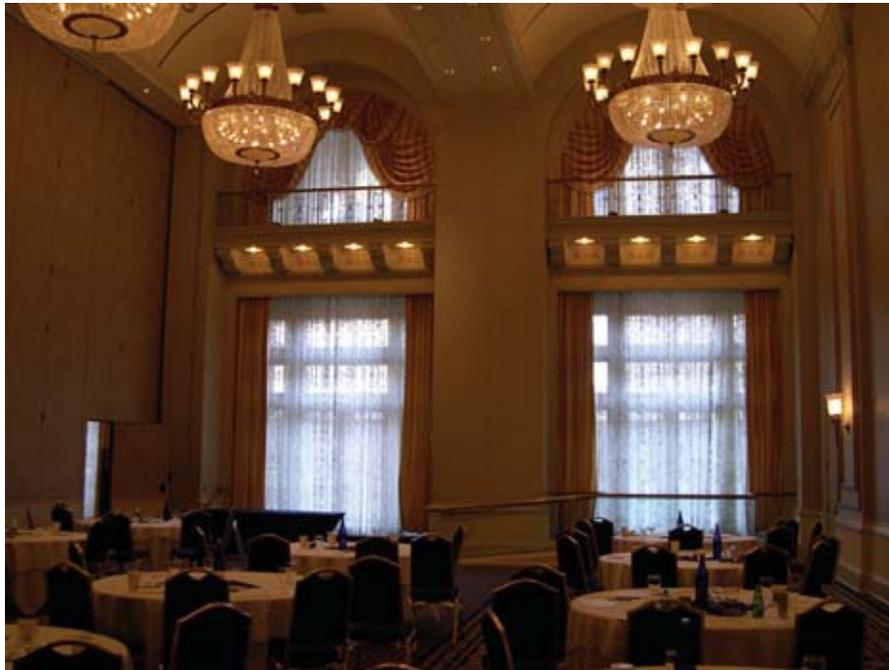
Figure 39: Reading Terminal Headhouse, Liberty Ballroom in former second floor waiting room, after rehabilitation. Note the partially reconstructed balconies in between the arched openings, April 2005.

below were faced with ornamental majolica tile on a 10” blue marble base. However, the space had been completely stripped of its details and subdivided by an inserted floor in the 1950s. For the rehabilitation, the original double-height volume was recreated for use as a hotel ballroom (*Fig. 39*). Two story tall windows separate the room from the loggia, now used as an exterior auxiliary space. The balcony on the south wall has been partially reconstructed within the arched openings. The western end of the floor holds meeting rooms and a new exit stair and elevator.

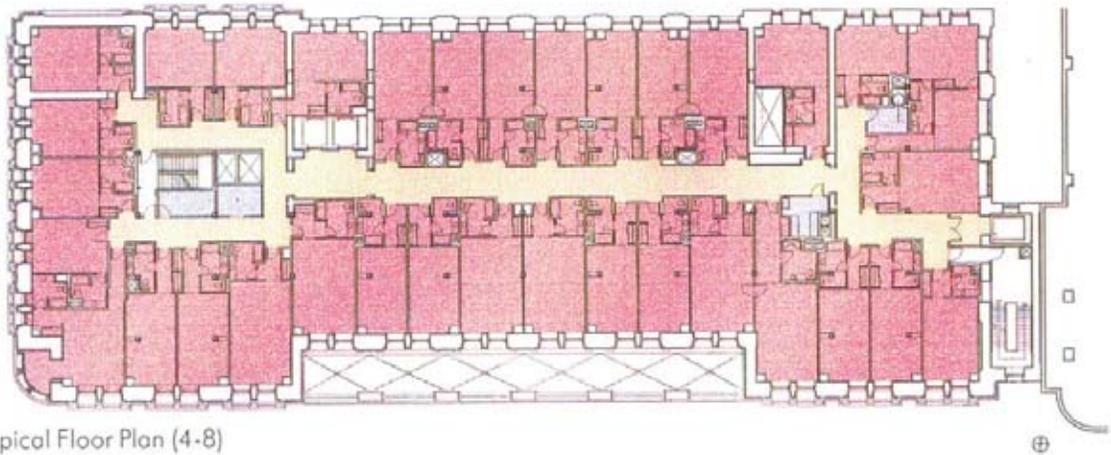
Typical Floor Plan (4-8)

Figure 40: Reading Terminal Headhouse, plan of typical guest room floor on floors 4-8.

The guest room layout can prove complicated and architects fight to incorporate as many rooms as possible into the design. The building’s 80-foot depth, rather than the more usual 60-foot added to the challenge. Mr. Jones of Bower Lewis Thrower, whose job it was to optimize the number and quality of rooms, stated that he produced a dozen different alternatives.²⁰⁸ For him, working with Marriott to determine the right number of rooms was a cooperative process. Mr. Jones had to work around the existing 20-foot column module and window placement and create a rhythm for the 27-foot module needed for two 13-foot guest rooms plus their partitions.²⁰⁹ As a result some columns are located in the rooms. Many of the guest rooms are bigger and deeper than might be ideal because of the building’s wider depth; but Marriott was willing to accept this situation and priced these “concierge rooms” at a higher level than those in its main hotel (*Fig. 40*).²¹⁰ The layout resulted in a few “quirky rooms,” with more character than the standard Marriott room. In fact, these rooms have been popular and appeal to the 10% of Marriott’s customer base that want something a

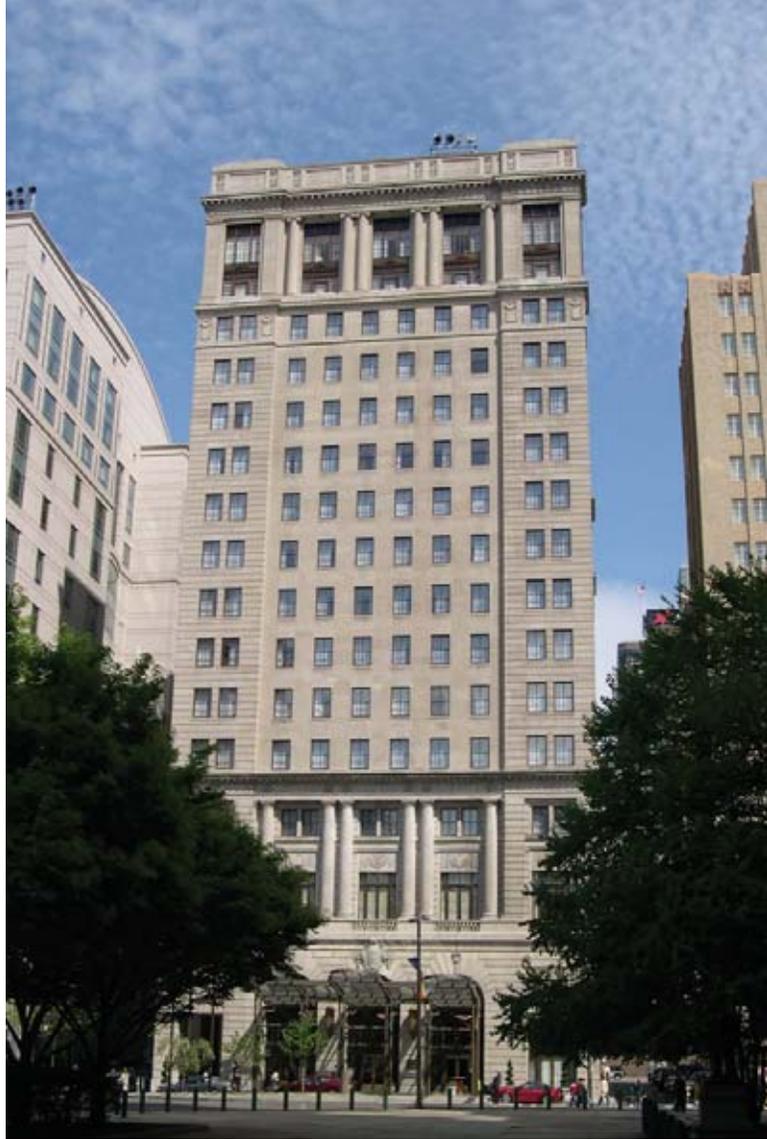
Figure 41: City Hall Annex, Juniper Street facade, April 2005.

City Hall Annex (hereafter the Annex), a Classical Revival, fifteen-story building is located on Penn Square at the southeast corner of Filbert and Juniper Streets. On its western and eastern façades, the Indiana limestone building is divided by five bays and on its northern façade by twelve bays (*Fig. 41*). Separated into five parts by cornices, the Annex's four façades each differ slightly. The building has a rectangular shape on the lower floors and is U-shaped above the second floor. On the primary, Juniper Street façade, the smooth-faced rusticated two-part base features three monumental arches in between two rectangular openings. The arches contain detailed bronze windows and doors; two six-foot sconce light fixtures mark the piers in between, and a cartouche of the city's emblem is located above the doorway in the center arch. A balustrade and cornice separate the entrance from the upper section of the base, which contains a row of large rectangular windows topped by a row of smaller ones and divided vertically by two pairs and two single engaged Doric columns. The shaft of the building is divided by a modillioned cornice from the base and by a plainer cornice from the cap. The outer bays contain pairs of two over two, aluminum windows while the three middle bays, each with two windows, are recessed slightly. The lower story of the cap contains another two paired and two single engaged Ionic columns with the outer bays demarcated by pilasters. In between are large bronze windows. A paneled parapet tops the building.

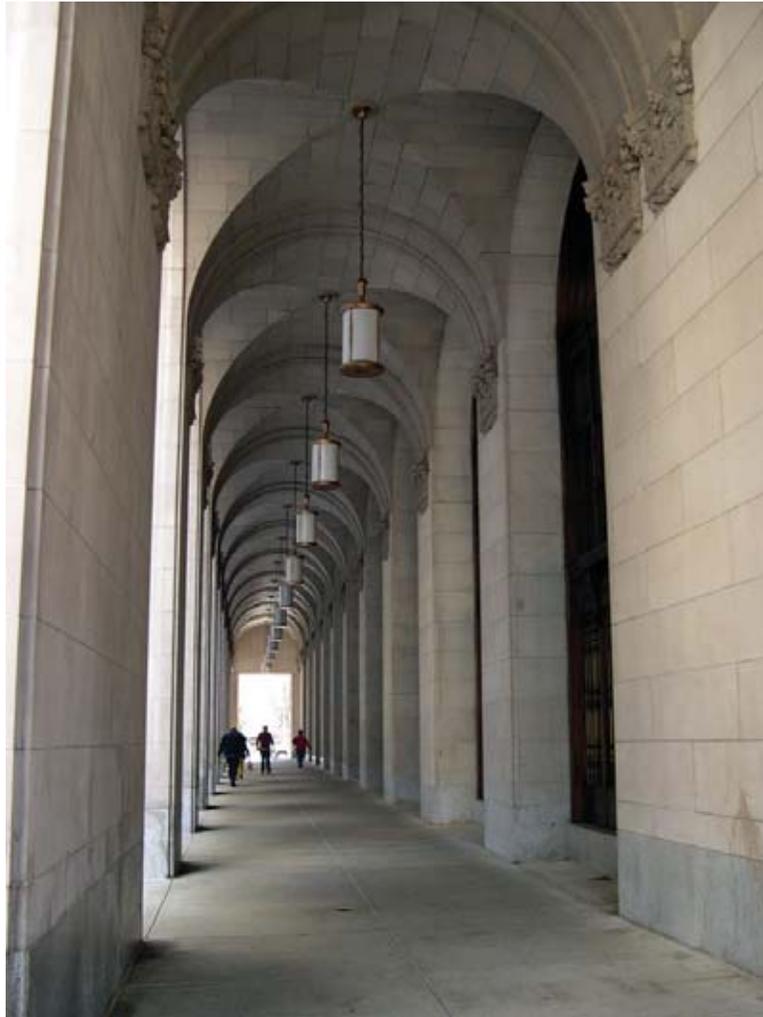
Figure 42: City Hall Annex, public arcade, author, April 2005.

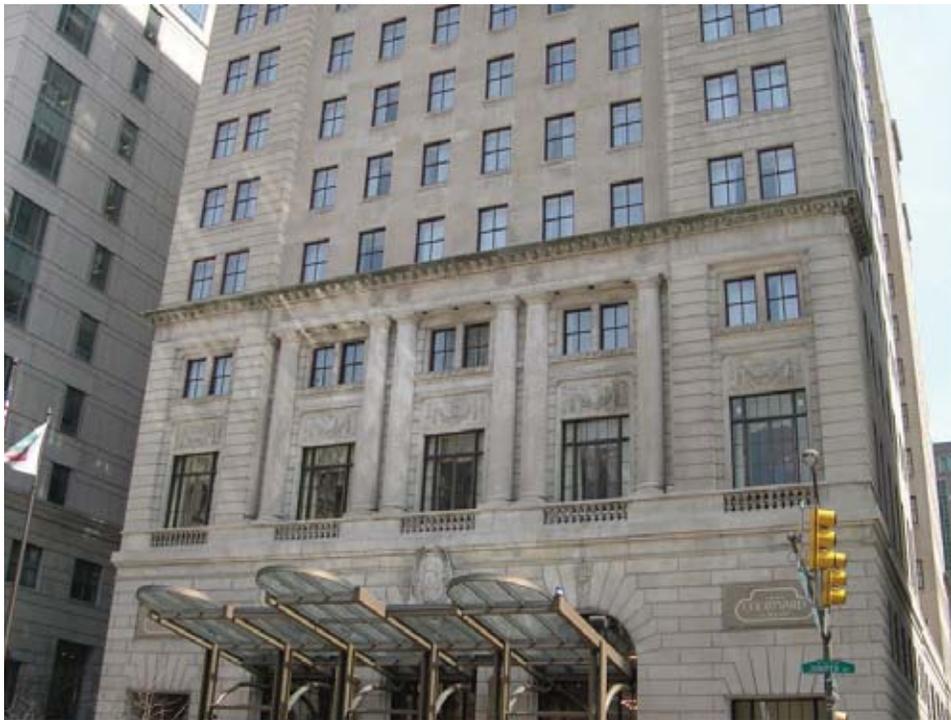
Figure 43: City Hall Annex, restored bronze windows on second floor and double hung two over two aluminum replacement windows above the second floor, April 2005.

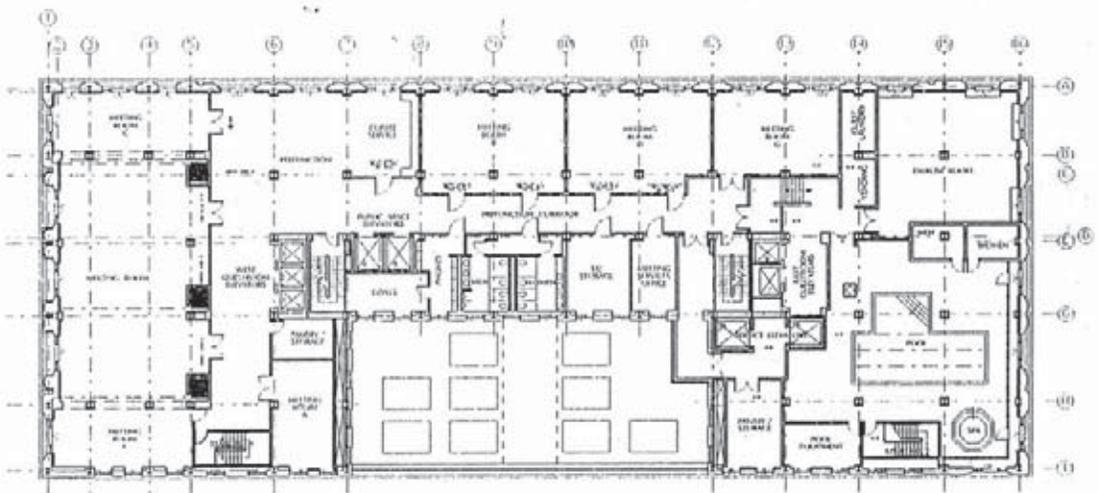
Figure 52: City Hall Annex, plan of first floor, Burt Hill Kosar Rittlemann Associate Architects, September 9, 1997.

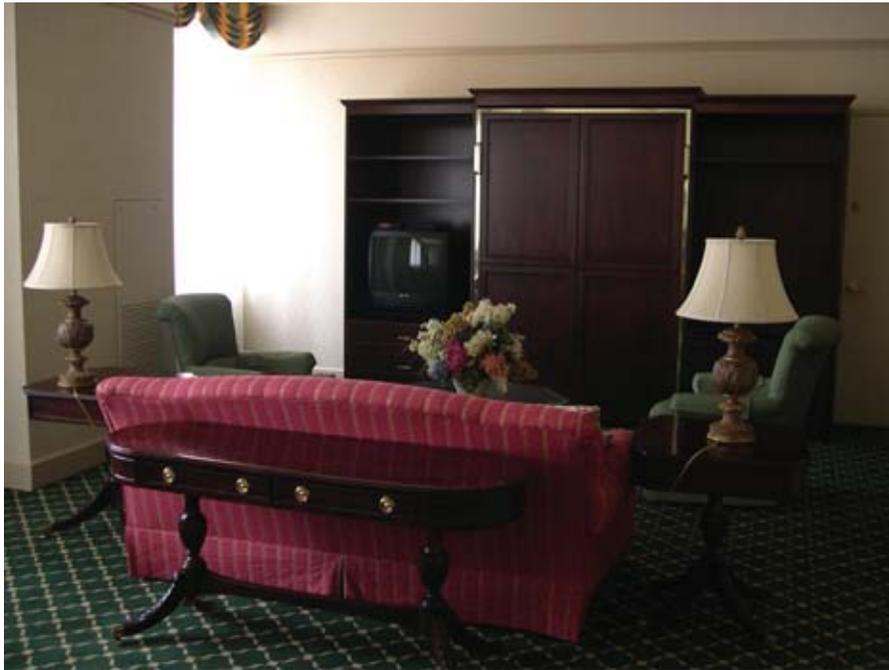
Figure 53: City Hall Annex, 2nd floor suite with picture molding at 8 feet to compensate for floor to ceiling height, April 2005.

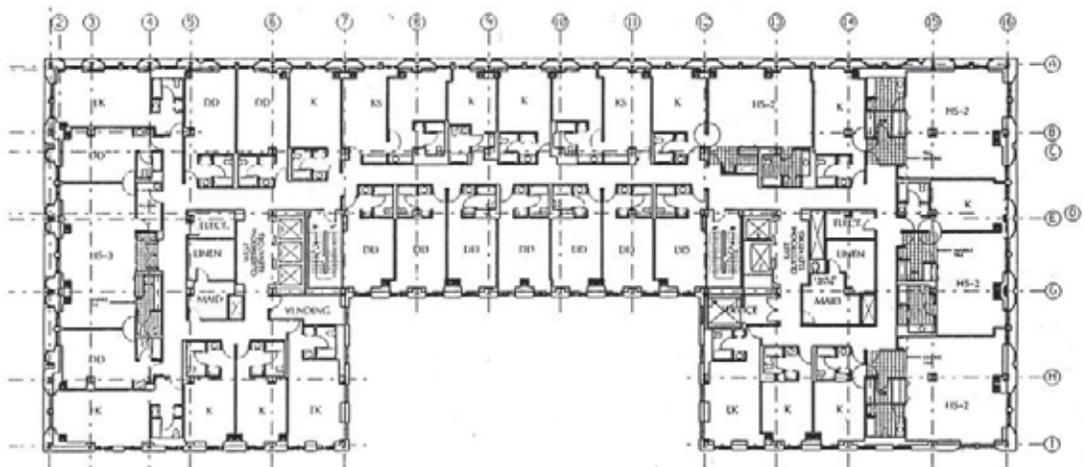
Figure 54: City Hall Annex, plan of 2nd floor guest room layout, Burt Hill Kosar Rittlemann Associate Architects, September 9, 1997.

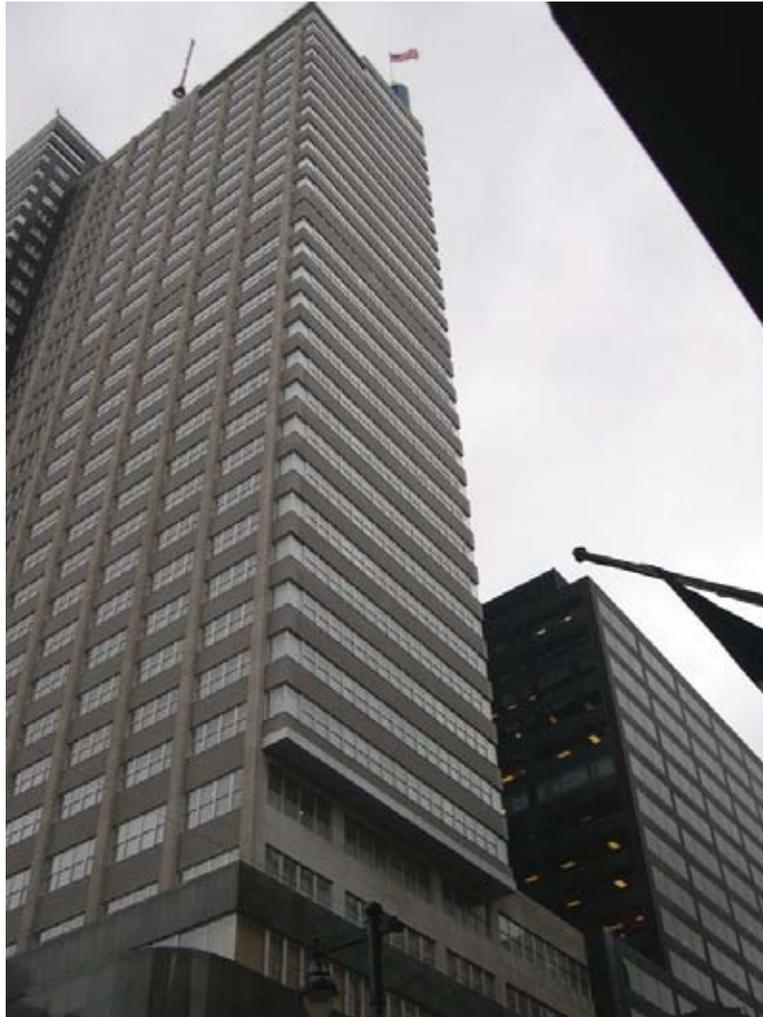
Figure 59: Philadelphia Savings Fund Society Building, view of tower illustrating the double-hung, one over one windows, December 2003.

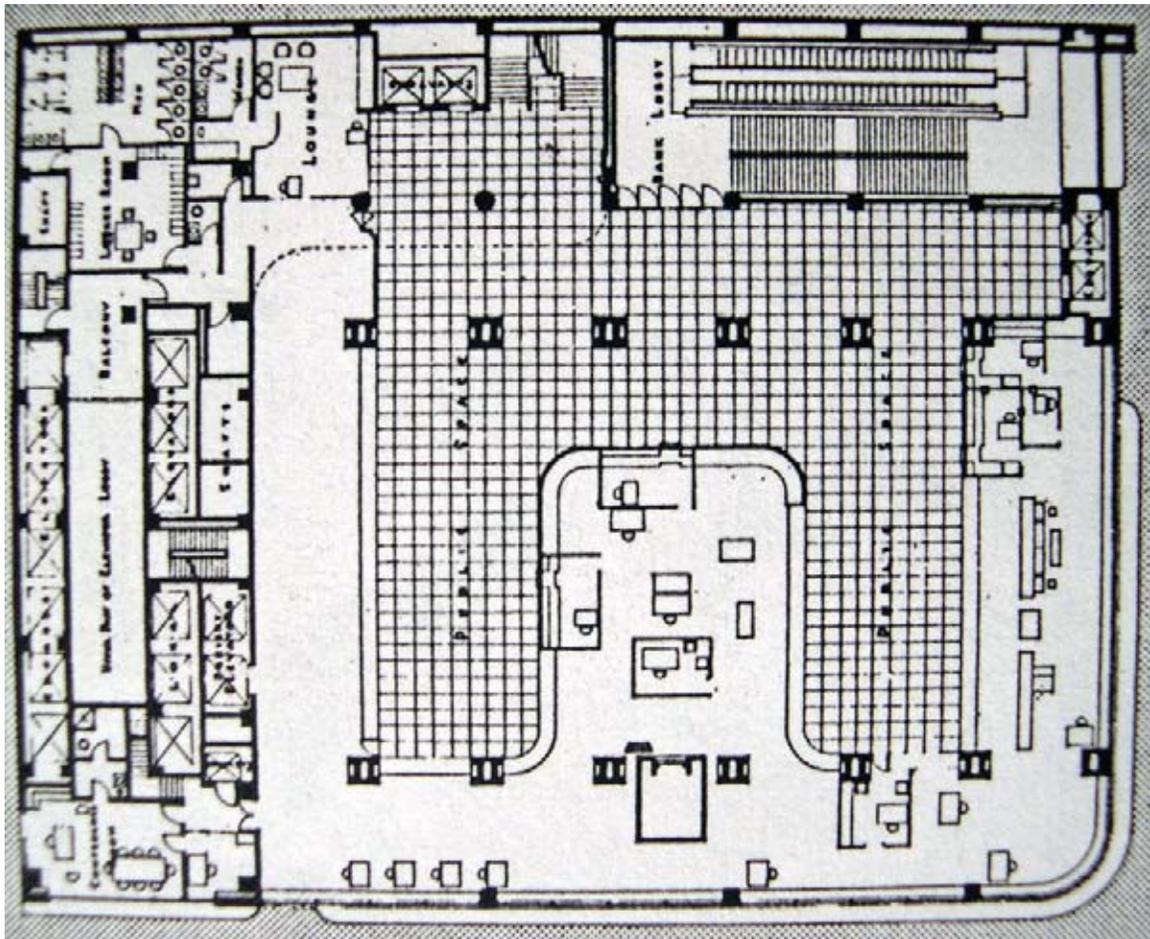
Figure 61: Philadelphia Savings Fund Society Building, original 1932 plan of second floor illustrating banking hall and escalator lobby in northwestern corner.

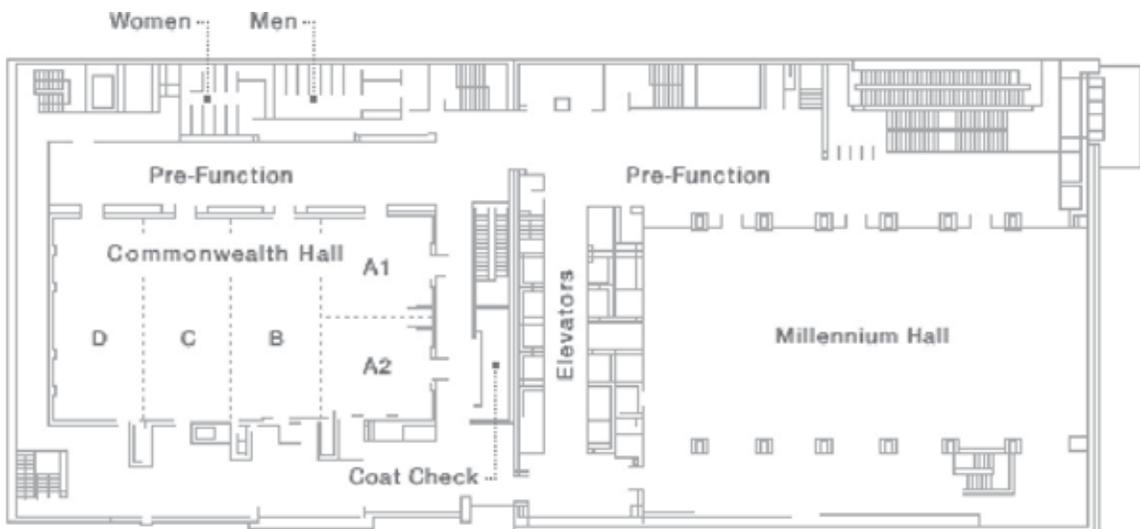
Figure 62: Philadelphia Savings Fund Society Building, plan of second floor and addition to the south, after rehabilitation, 2000.
