ADAPTIVE REUSE: RECENT HOTEL CONVERSIONS
IN DOWNTOWN PHILADELPHIA

A THESIS

Historic Preservation

2005

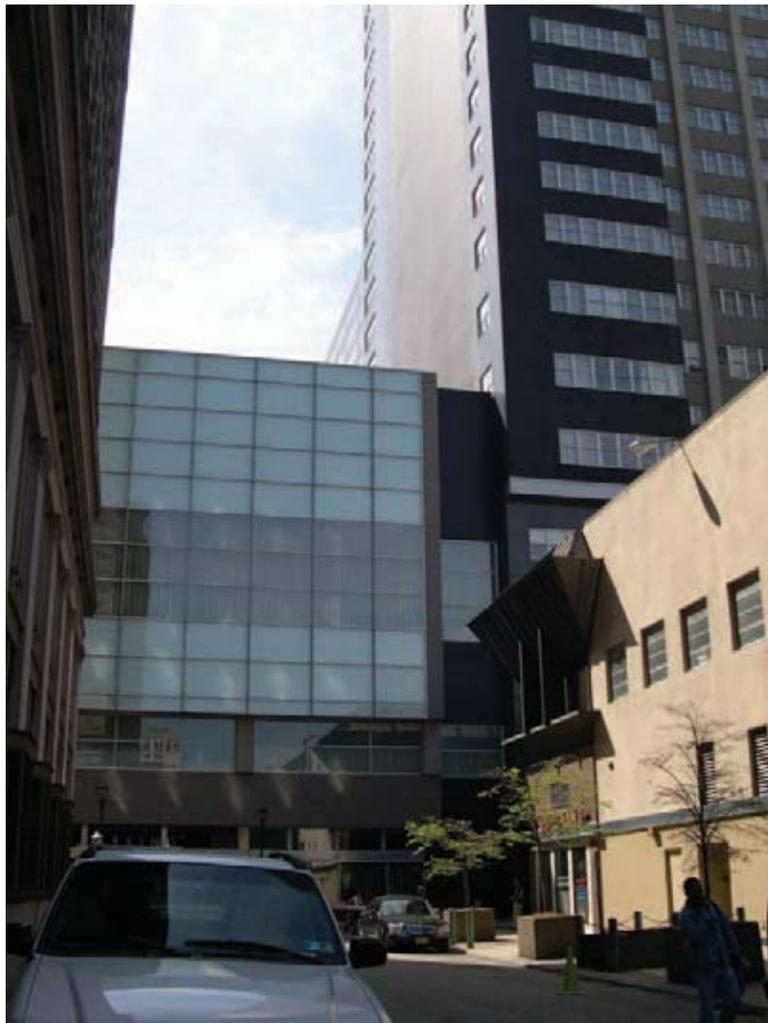
Figure 63: Philadelphia Savings Fund Society Building, the addition and linking section located to the south. The addition made the project feasible, April 2005.

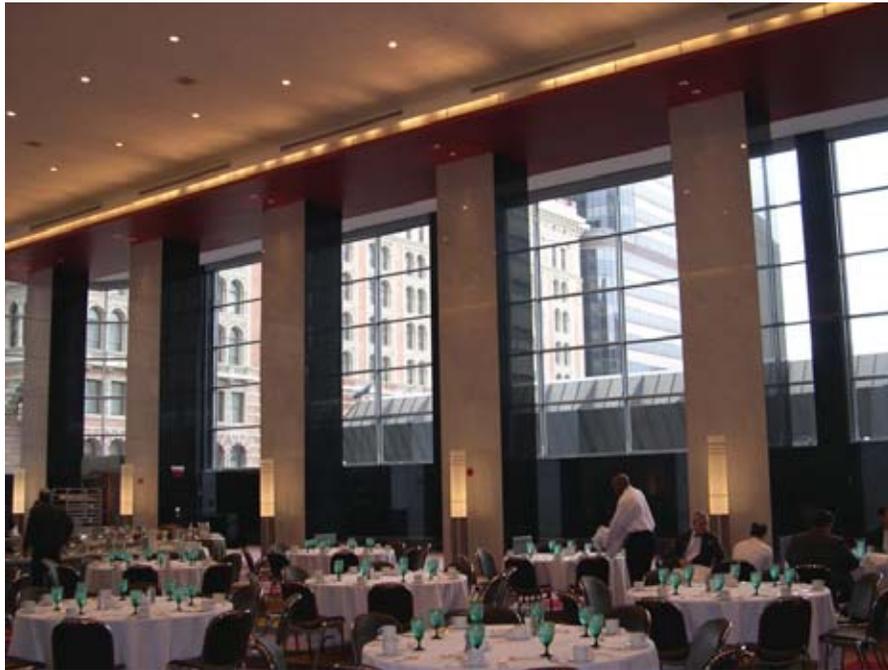
Figure 69: Philadelphia Savings Fund Society Building, banking hall, after restoration showing monumental windows looking out towards 12th and Market Streets, author, December 2003.

Now called the Millennium Hall ballroom, the banking hall, is a large, breathtaking space, juxtaposing hard and soft finishes in color and form (*Figs. 68 & 69*). The wall surfaces and columns were restored and several changes made to the room. The teller window counter, a “character-defining” feature, was removed. The SHPO recommended that a shadow line be retained in the flooring;³¹⁶ however, this was not carried out.³¹⁷ The most significant changes were the addition of a fire exit, now hidden by the door of the vault originally in the hall, and the separation of the hall from the mezzanines with a metal and glass screen wall not dissimilar from the existing wall separating the escalator lobby from the banking hall.

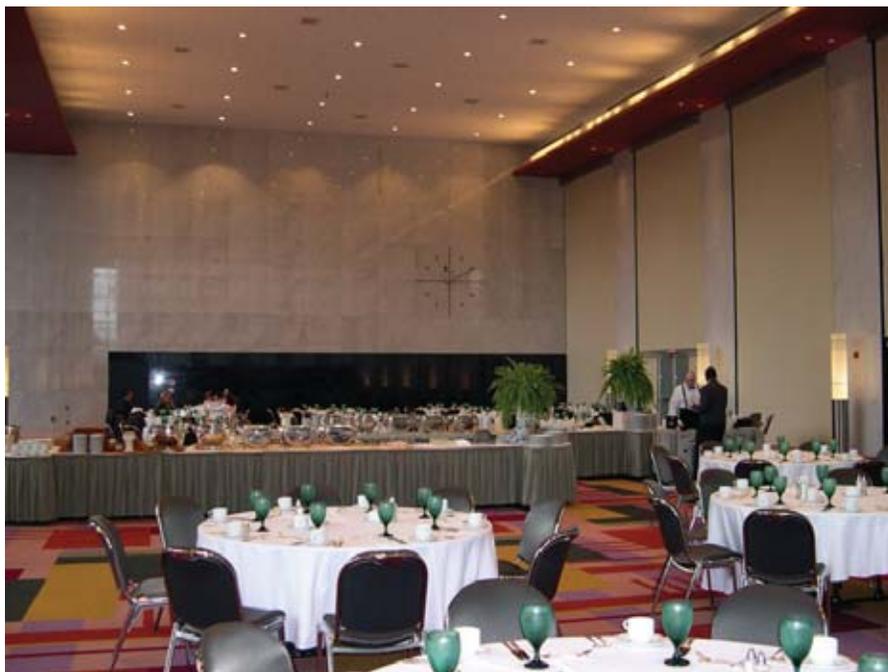
Figure 70: Philadelphia Savings Fund Society Building, banking hall, after restoration and illustrating new glass wall covered by a curtain, December 2003.

The new glass wall was required by safety code and some debate occurred centering on where on the columns to affix the wall (*Fig. 70*).³¹⁸ Pre-function areas could be accommodated in this new space. These changes were required to successfully make the transition to a full service hotel. Critics have argued that the space would have made a far more effective registration lobby and restaurant.³¹⁹ This argument has merit, yet the necessity for revenue provided by a ballroom was also crucial. As hotels do not profit greatly from their guest rooms, profits must be sought elsewhere.

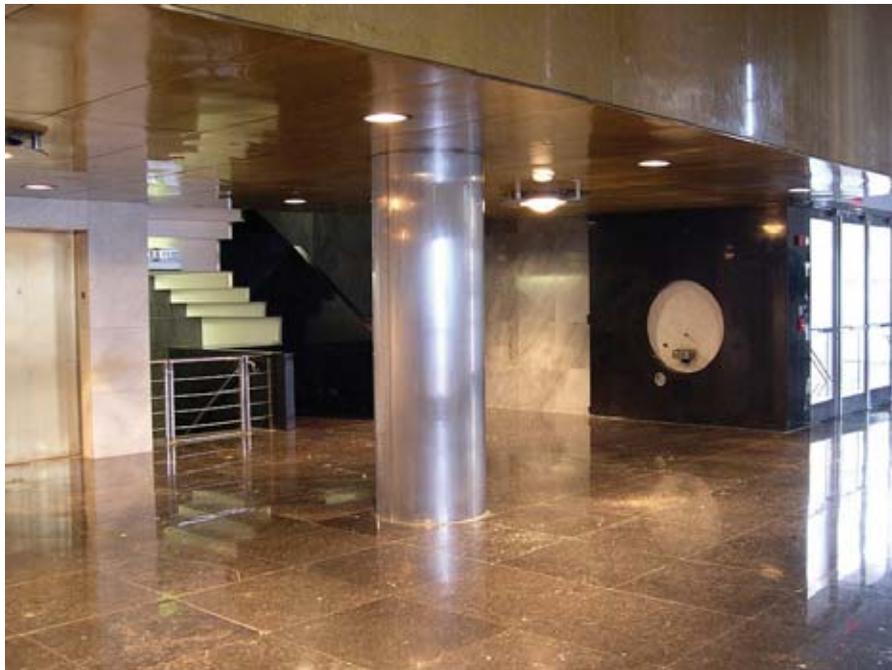
Figure 71: Philadelphia Savings Fund Society Building, second floor, view underneath mezzanine showing black and white connecting stair and drinking fountain, after restoration, April 2005.

experience had it been retained. The safe deposit boxes blocked a fire exit.³²⁰ Parts of the vault were removed and the area became the engineer's office.³²¹ A bank of safe deposit boxes placed on the second floor near the public telephones recalls the area's intended function. The beautiful black and white stair connecting the mezzanines was restored, with the modern wall enclosing the stair removed. Other "character-defining" features, such as the drinking fountain of Monel metal enclosed within a circle of white marble surrounded by black marble, have also been retained (*Fig. 71*).³²² The mezzanines are now used as pre-function space and make a more spatially intimate setting for a meal.

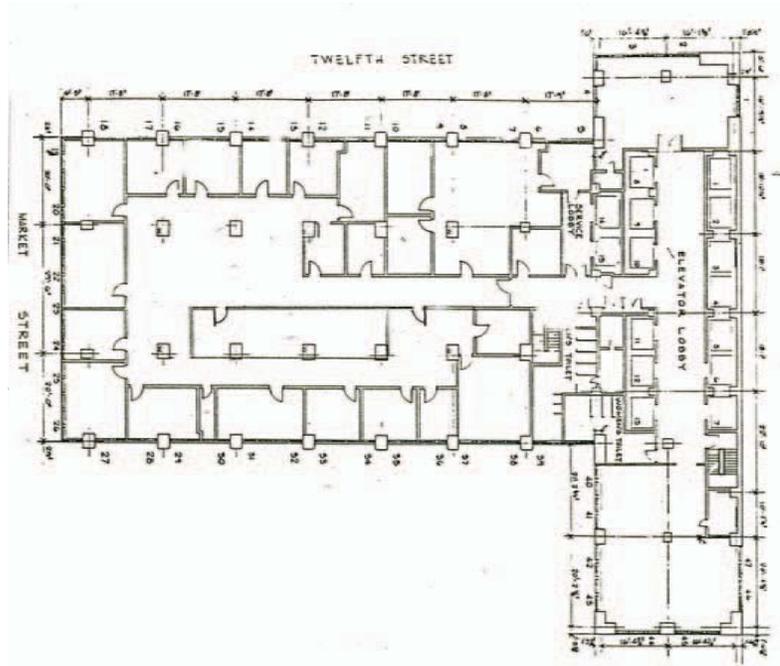
Figure 73: Philadelphia Savings Fund Society Building, 6th floor plan, illustrative of typical office floors, existing conditions, 1997.

The T-shaped plan incorporates elevator lobbies running east-west and central corridors running north-south. On floors 6-19, the elevator cabs are located on the north wall of the lobbies and on floors 20-32 they are located on the south wall.³²³ The PSFS Building was built as a "core and shell building," intended to be decorated by its tenants.³²⁴ Consequently, the configuration of the rental floor area within the tenant spaces had been repeatedly modified over the years (*Figs. 72 & 73*). While the rental areas were very plain, the elevator lobbies on each floor featured a similar degree of finish and quality as those on the first floor: Belgian black marble wainscoting and particle terrazzo floors, flush steel elevator doors, Cartier clocks, original elevator lanterns. The lobbies and their finishes were retained and restored. The east wall of the elevator lobby was brought inwards to accommodate adequate rooms behind the wall.

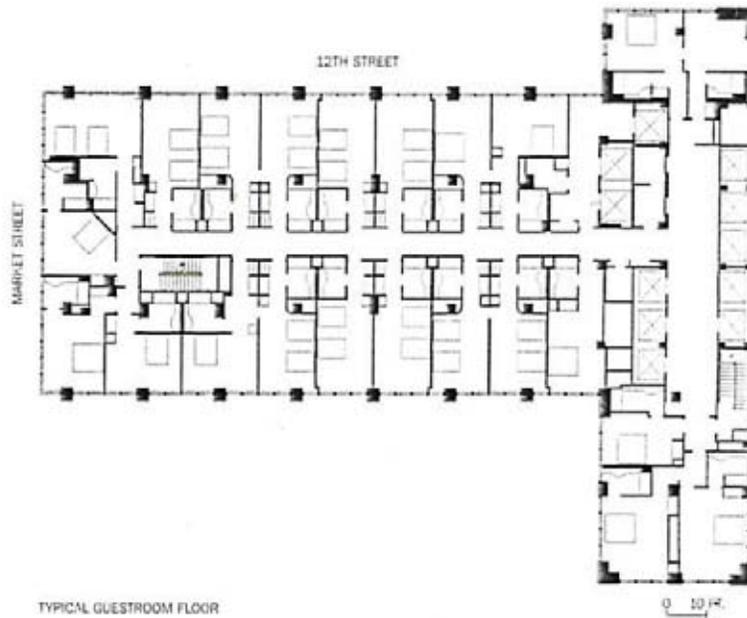
Figure 74: Philadelphia Savings Fund Society Building, plan of typical guest room floor, 2000.

The central corridors are 7 feet wide, and at the time of the rehabilitation, most of them had been shortened to just beyond the door to the stair.³²⁵ The rehabilitation intended to incorporate about 23 guest rooms per floor off a corridor narrowed to 5 feet at the bathroom walls, with the original width retained at the room entrances (*Fig. 74*). The existing metal doors with glazing and fresh air vents at their base could not be retained, as they did not meet fire code.³²⁶ In its review of the Part 2, the SHPO indicated that the corridors should not be reduced in width to 5 feet at the bathrooms. The proposed treatment was listed as a Condition for Approval, as the typical office floor plans were a “character-defining” feature and to alter them would violate Standard 2.³²⁷ However, the Part 3 indicates that this treatment in the end was judged acceptable.³²⁸

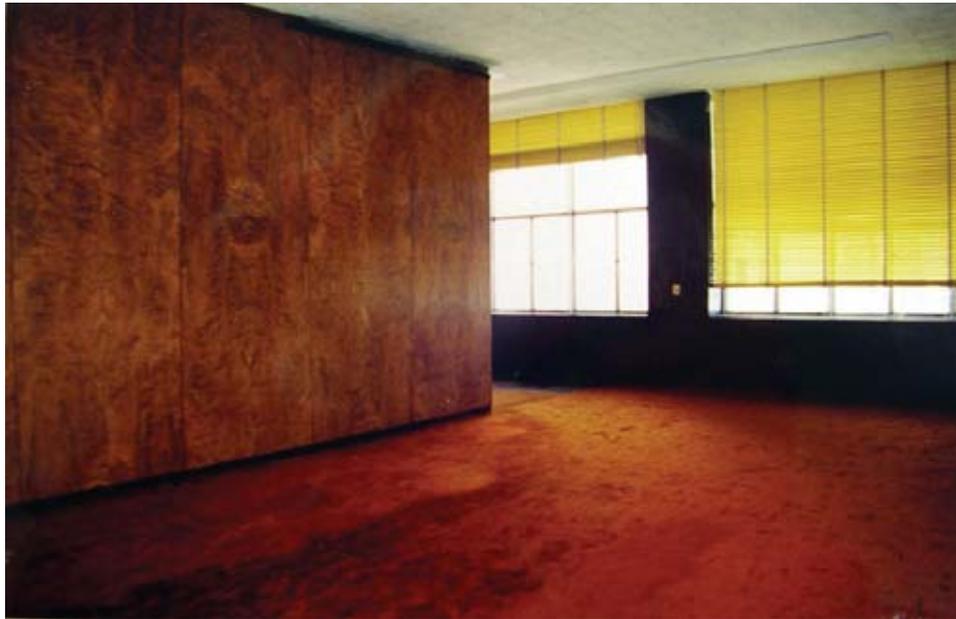
Figure 76: Philadelphia Savings Fund Society Building, 33rd floor, view looking southwest of original wooden Venetian blinds in vestibule outside boardroom, before rehabilitation, April 1997

lobby, stainless steel and folding bronze doors in a small vestibule, rich wood paneling, including hudoke wood veneer in the Committee Room, Macassar ebony walls and original wooden Venetian blinds in the hallway, and Macassar ebony and rosewood paneling in the boardroom (*Figs. 75 & 76*).³³⁰ The wood had become bleached out but was restored.³³¹ The solarium is primarily glassed in except for the Roman travertine marble west wall (*Fig. 77*). The flooring consists of blue tile.³³² The Main Dining Room is also finished in rosewood and Macassar ebony paneled walls.

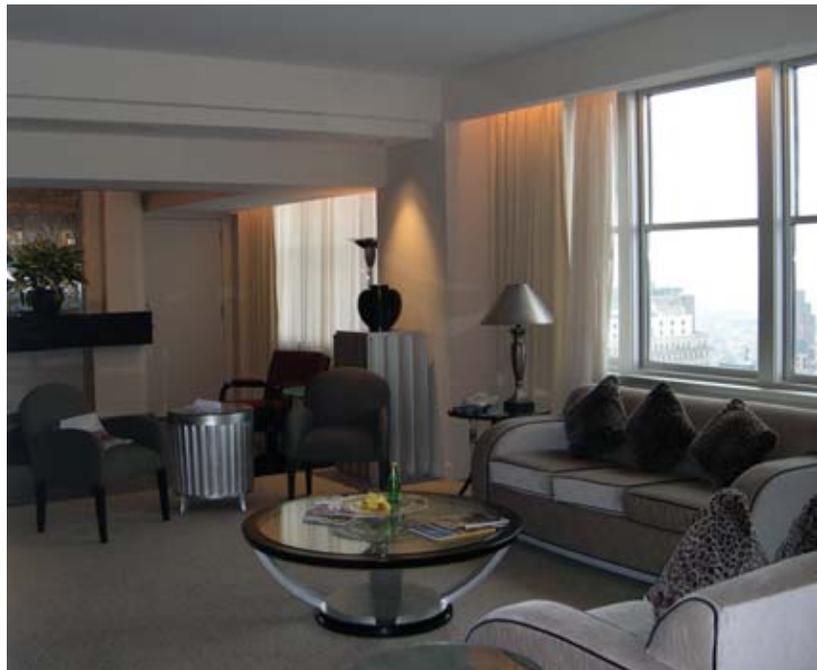
Figure 79: Philadelphia Savings Fund Society Building, an example of Daroff Design's Art Deco guest rooms, December 2003

paint colors, identified by the paint analysis.³⁴⁰ A compromise was made and more freedom was allowed in the rooms and the corridors to the rooms (*Fig. 79*).³⁴¹ However, a peach color was mixed in with the primary colors in the banking hall and throws off the design.³⁴²

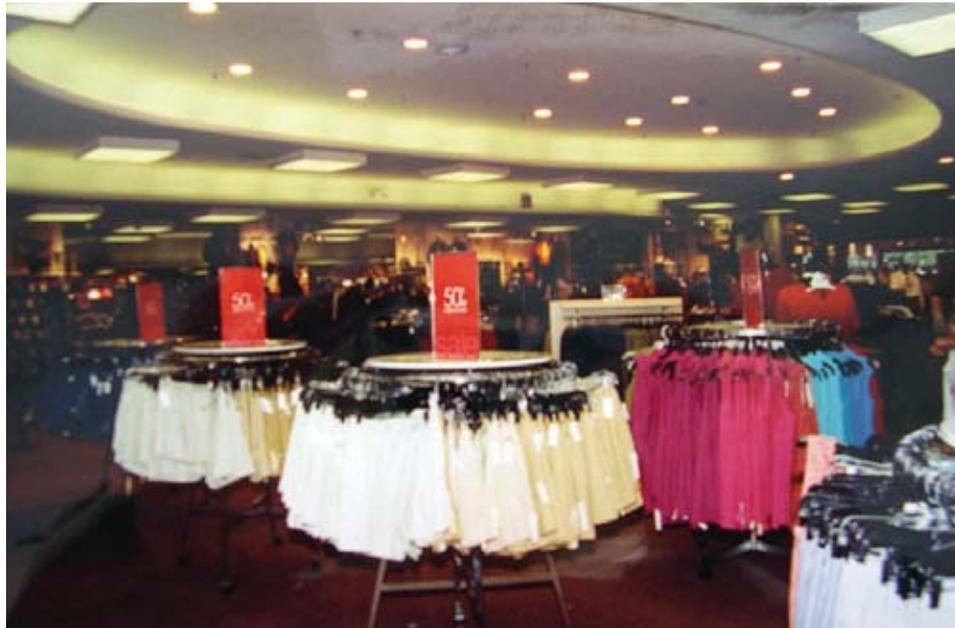
Figure 80: Philadelphia Savings Fund Society Building, first floor retail space with Lerner's dress shop, before rehabilitation, September 1997.

The first floor was rented out to Lerner’s dress shop at the time the rehabilitation began, and contained none of the lavish finishes associated with other parts of the building (*Fig. 80*).³⁴⁵ While the banking hall would have made an impressive lobby, a more financially viable use was needed. The first floor was to become the new main circulation corridor leading between the Market Street entrance, the reception area, and the 12th Street lobby. A

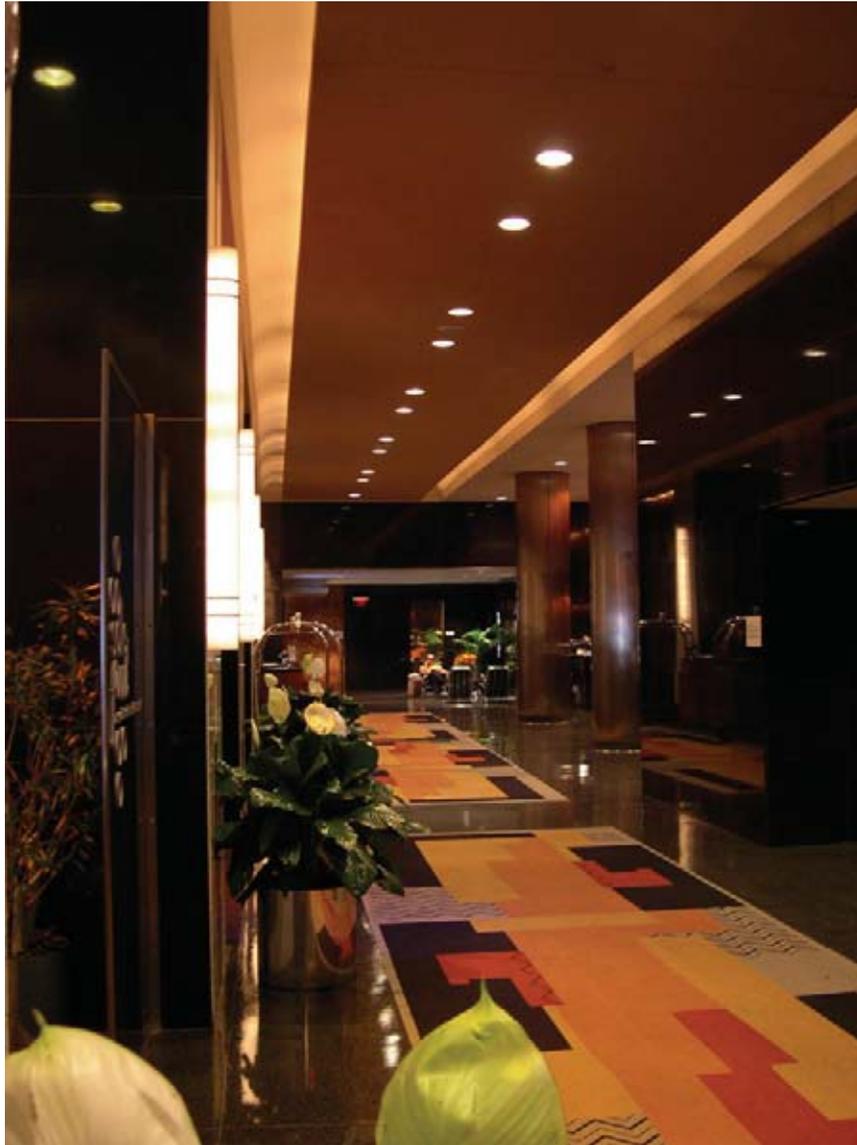
Figure 81: Philadelphia Savings Fund Society Building, former first floor retail space, now the lobby, December 2003.

new construction, the lobby boasts features and finishes intended to be “compatible with the design of the building,” in accordance with Standard 9 (*Fig. 81*). Details from other parts of the building, including an original vault door from the third floor mezzanine, the bronze ceiling from the safe deposit box area, and the tellers’ counters from the former banking hall decorate the lobby. The stainless steel clad columns are copies of those on the mezzanines.³⁴⁶ The lobby is finished off with original materials, such as Belgian black, Bardiglio gray, and reddish Numidian Sanguine marbles and striking woods.³⁴⁷ The warm and cool colors and varied textures contrast nicely. Typography similar to that originally used in the building is used to direct guests and identifies the Philadelphia Savings Fund Society as having been founded in 1816.
