# Title:Preserving Trees During Construction: A Look at the<br/>Bender Oak and How it May Be Sheltered From Impending<br/>ConstructionAuthor:Ari Miller, -Arboriculture InternDate:August 2003

# Abstract:

New accessibility laws for people with disabilities have required the Arboretum to install a new path from the parking lot to the Widener Visitors Center. The installation of this path as planned could potentially threaten the health of the Bender oak by disturbing its root system. A more specific study is needed to determine ways to implement this path with low impact to Bender oak.

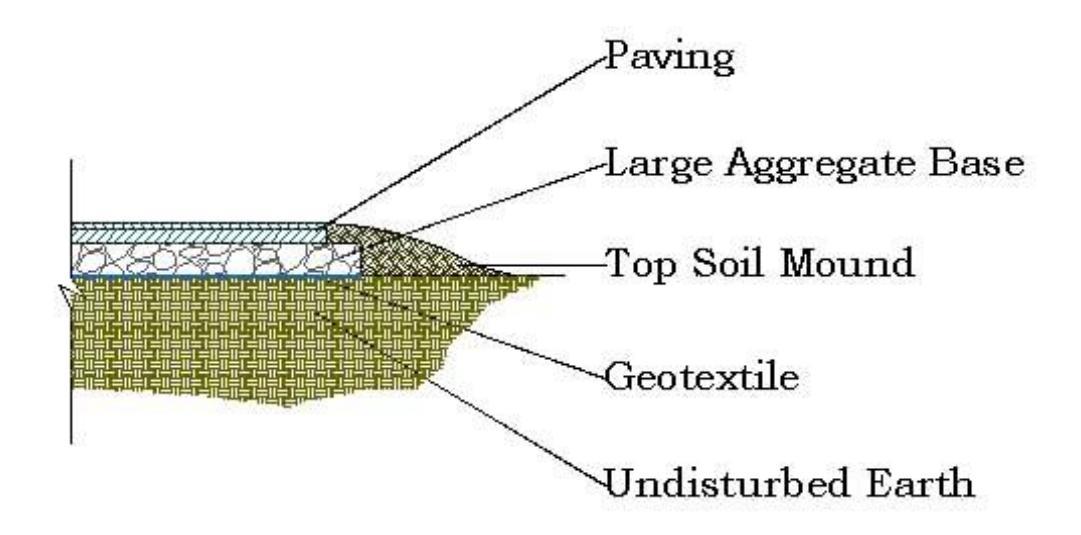
# **ALTERNATIVE PAVING DETAIL**

Alternative construction practices can sometimes allow us to tip toe over sensitive protection zones. In this particular case we are dealing with alternative methods of achieving an accessible walkway for people with disabilities. Traditional construction practices for installing any sort of paved walk requires cutting into the existing grade to lay an aggregated base, intentional compaction of the existing soil beneath the base, another round of compaction with a steamroller to set the aggregate and then finally laying the asphalt. This method is obviously not acceptable within the protection zone. An easy alternative to the standard practice is a method in which the path is simply laid on top of the existing grade. Laying the path on top relieves the need to cut in to the existing grade in order to make the path flush with the ground. Other modifications to the standard practice. Geotextile placed beneath an aggregate base consisting of larger stones helps to dissipate almost all of the weight. A steamroller is still needed to lay the asphalt, but the geotextile and large aggregate distribute the weight so effectively that there is virtually no compaction of the soil below.

The second alternative design scheme incorporates the alternative paving method in which the path is laid on top of existing grade. In order to implement this alternative method of paving all the areas where the alternative method is used grade change can only be facilitated with fill. Filling soil on top of roots can be harmful, but the impact of the fill is greatly lessened when the fill material is large aggregate. Using the tree-friendly paving allows the path to follow almost the same path as was proposed in the beginning. The major differences between this scheme and the original scheme are in the areas beneath the dripline of the tree where the path begins. The new path here is laid directly on top of the existing path. There is no need to disturb the soil to try to remove and reroute the existing path when the new path can simply be laid directly on top.

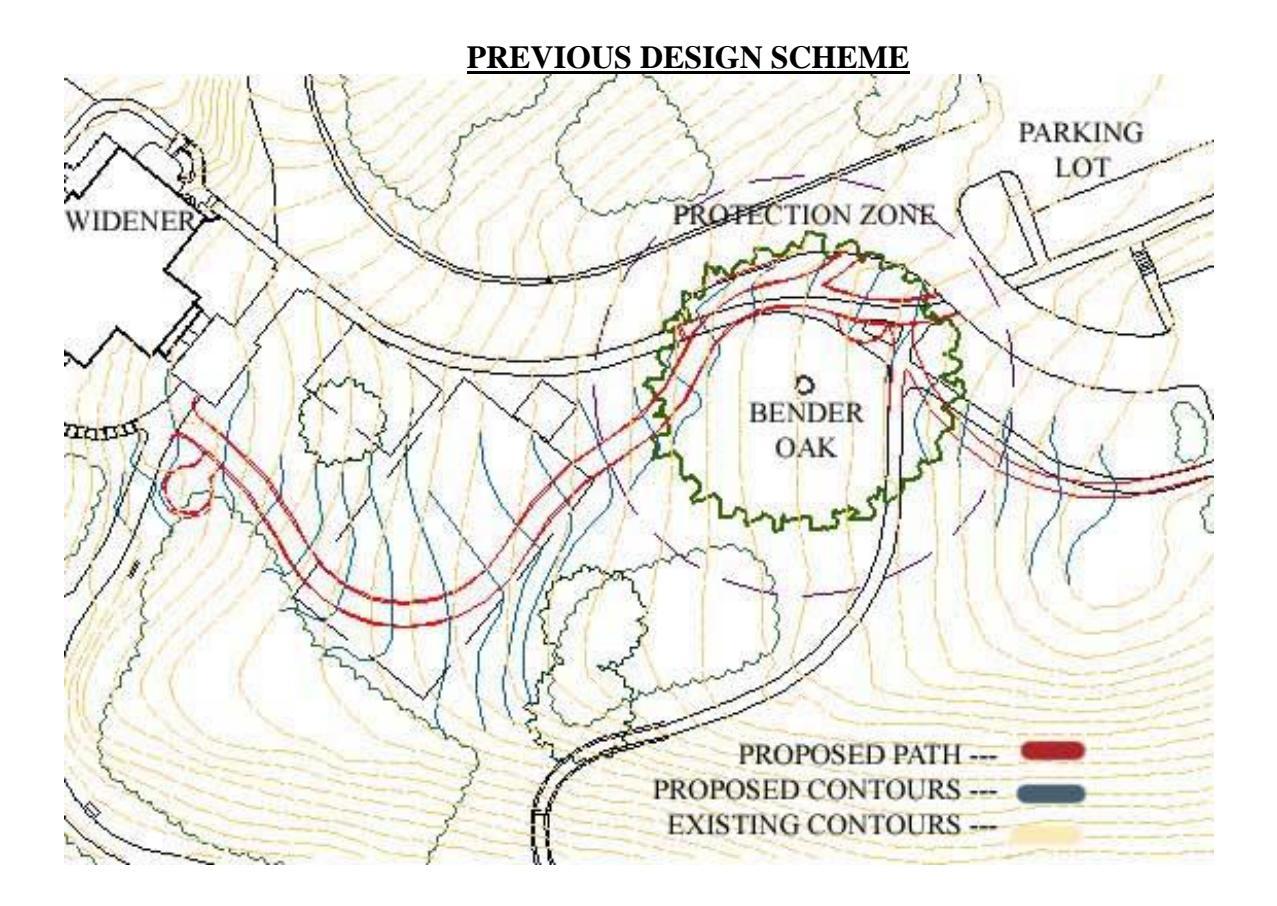
The first design scheme to consider was the plan that had already been proposed by a landscape architecture firm. Evaluating the previously suggested scheme against the criteria for the path and the criteria for tree preservation served as a reference for what to do and/or what not to do in devising new alternatives.

The previous scheme deals with the criteria of the path beautifully. The path slopes down from the parking lot to the Widener building at the prescribed 5% slope, it catches people off the driveway inviting them to follow the new path and it incorporates a welcoming node at the start of the path and provides a space near the visitor center where visitors can gather to go on guided tours of the Arboretum. The criteria that this scheme does not satisfy are those which pertain to preserving the health of the Bender oak. The most obvious transgression is that the path is laid across the protection zone with no provisions for alternative paving methods. The proposed grading near the start of the path calls for significant cutting of grade within the protection zone, which could possibly damage or sever potential structural roots. Also some seemingly unnecessary construction work is proposed within the dripline of the tree to remove parts of the path and the needs of the tree.

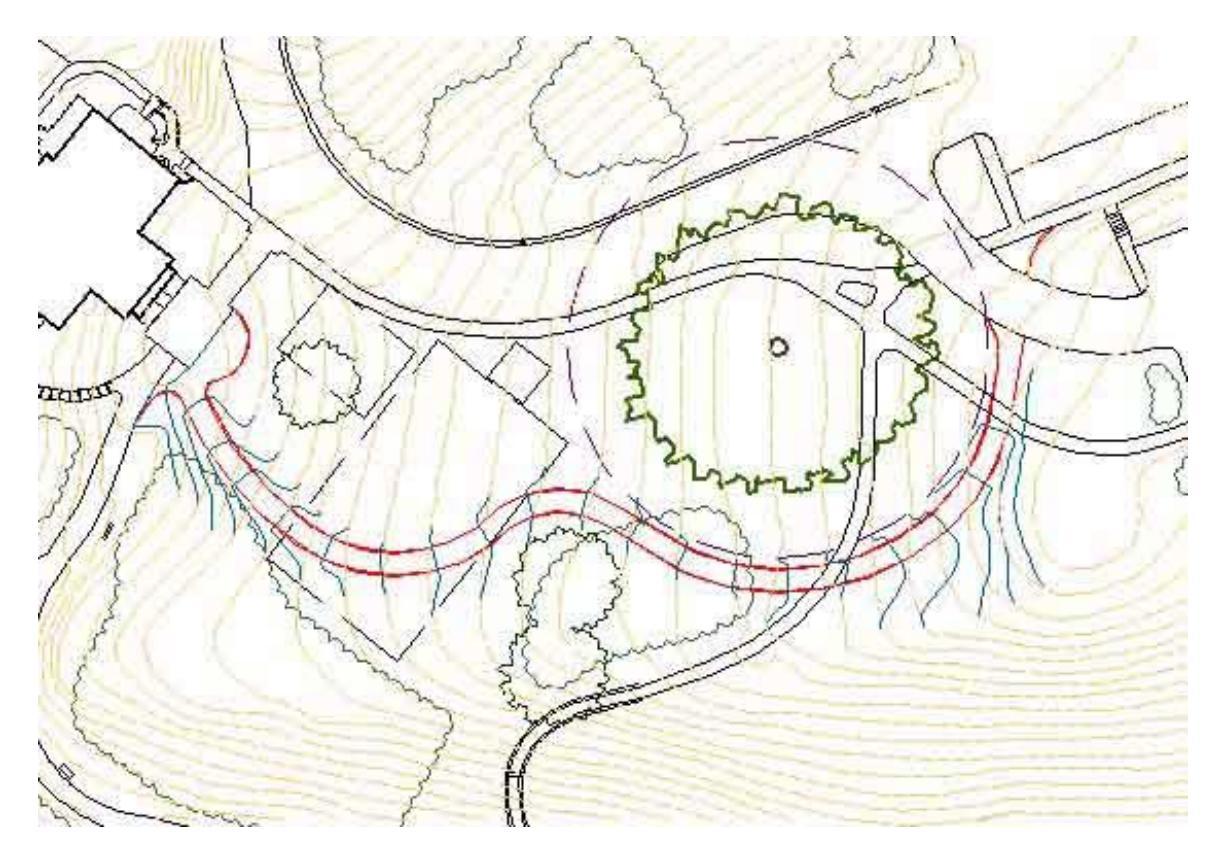
#### **ALTERNATIVE SCHEME 1**

The first alternative scheme takes the safest route circumnavigating the entire protection zone. If this scheme were to take affect then a large fence could be erected around the protection zone preventing any activity to take place where roots could be damaged. This would be an ideal situation from a tree preservation standpoint, however this scheme is barely practical in regards to the criteria of the path. The path does not entice people off the road nor does it provide a welcome node. It takes such a round about route to the Visitors Center that few people would even know where it was going and even fewer people would ever walk on it. This scheme is on the opposite end of the spectrum from the previous. This illustrates that over-precautionary measures with regard to preserving tree health can sometimes be impractical. A compromise is needed.

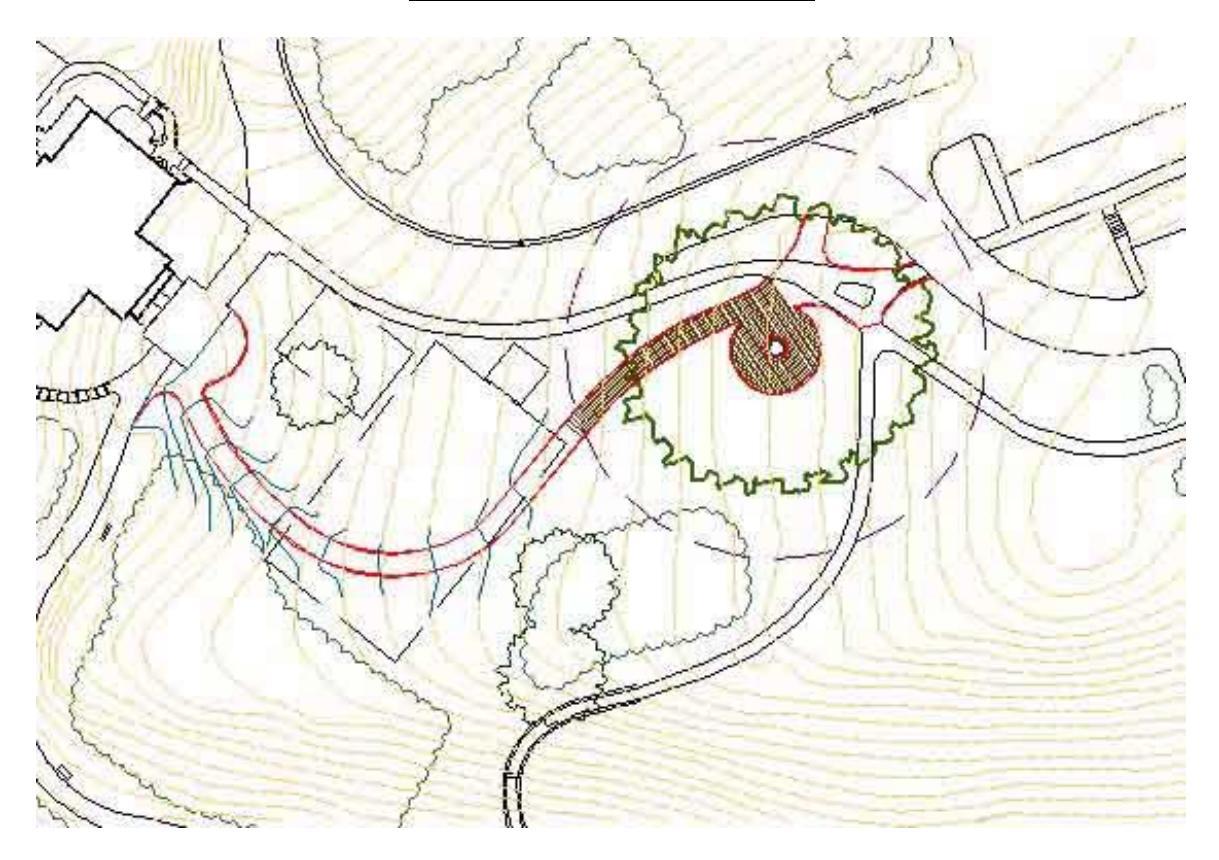
#### **ALTERNATIVE SCHEME 3**

The final alternative scheme solves the problem of balancing the needs of the path and the needs of the tree by adding a feature that highlights the tree and provides visitors with an opportunity to safely interact with it without endangering the health of the tree. This scheme uses a boardwalk elevated only a few inches off the ground to carry visitors over the delicate root system. This boardwalk approaches the tree and actually circles around the trunk allowing visitors to touch the tree and view it from different perspectives. By introducing an exciting, unique feature more people will be enticed to come off the road and on to the path. Highlighting the tree and visibly illustrating a tree preservation technique can also give the Arboretum an opportunity to educate visitors about tree preservation through interpretive signs. This proposal does not just address the needs of this particular tree; it adds a feature that could potentially save other trees by educating the public about tree conservation.
