Function and Use of a Nineteenth-Century Barn
"Walnut Hill" Estate
Pawling Road, Lower Providence Township
Montgomery County, Pennsylvania

Brooke Elin Vincent

A THESIS
in
The Graduate Program in Historic Preservation

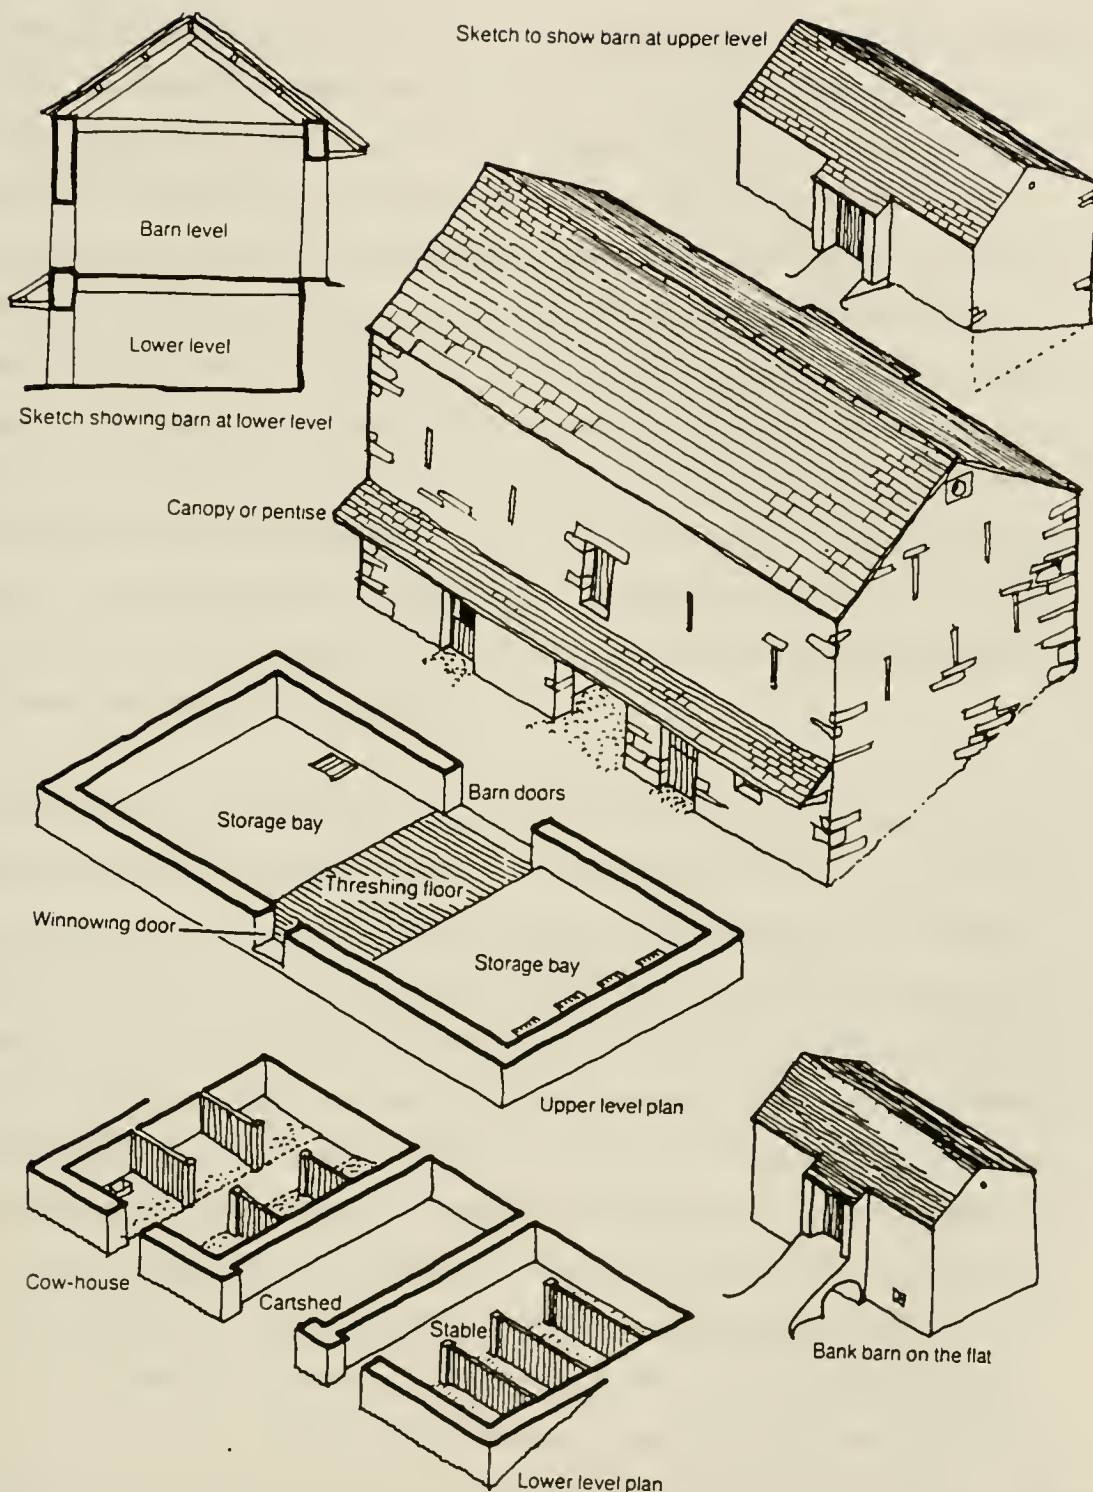
Figure 5: Isometric drawing of English bank barn showing floor plans, cross section and elevations. Illustration from R.W. Brunskill, Traditional Farm Buildings of Britain, London: Victor Gollancz Ltd., 1987, 114.

Counties due to its hilly terrain, with the main concentration in Cumbria, Pennine Cumbria, and the West Cumberland Plain (Plates 3-5).¹⁹ The principal farm buildings found in this region were the barn, cow-house, stable and granary, while the “bank barn” was a more specialized farm structure, mainly a development of the eighteenth and nineteenth centuries.²⁰ The English bank barn developed along parallel lines to the German-Swiss counterparts, and basically served the same purpose of consolidating mixed uses under one structure. Essentially, its design combined the traditional threshing barn with the cow-house and stable barns and was praised for “its compactness, its economy, and, very often, its rugged beauty.”²¹ The English bank barn was almost always situated along the contours of a natural or artificial slope.²² Its arrangement was similar to the German and Swiss types-- a ramp provided access to the upper threshing level and the lower level opened into the farmyard. The efficiency of its design saved on labor-intensive activities, in that the “unprocessed crops were hauled easily into the upper level and straw, or later hay, could be dropped through hatches into the cow-house and stable”.²³ The arrangement of the upper level was composed of a central threshing floor and large barn doors opening outwards at the head of the ramped rear entry. The doors were usually protected by a canopy and sometimes incorporated projecting wings, or “outsheds”, to each side of the ramp. A “winnowing” door was located at the opposite end of this opening, placed high up on the wall.²⁴ Upper windows generally consisted of ventilation slit openings. The lower level combined several different functions together. Access to a cart shed, generally located directly below the threshing floor, was flanked by a cow-house and stable. In place of the typically Swiss “forebay”, the English bank barn employed a small cantilevered canopy, or pent roof, over the stable doors (Fig. 5).²⁵

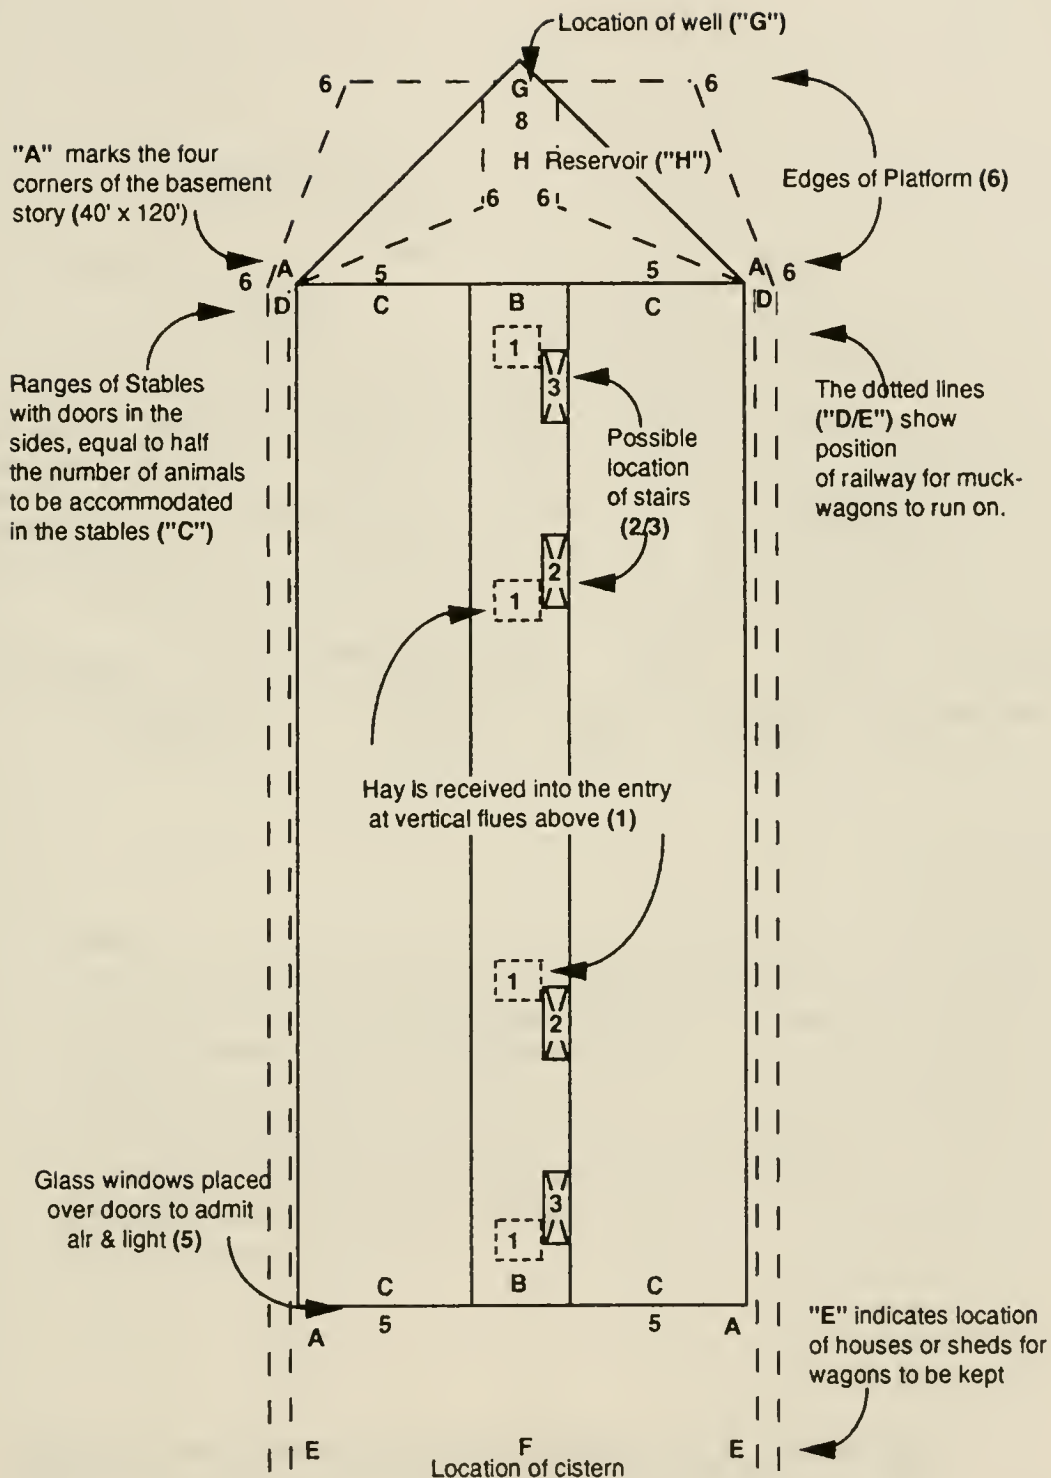
Figure 7: Basement floor plan showing efficient layout of stable area. From "Remarks upon Agricultural Buildings. No. 3. Barn and Stabling," *The Farmer's Cabinet*, Volume II, August 1837-July 1838, Philadelphia, PA: John Libby Publishing, 1838, 181.

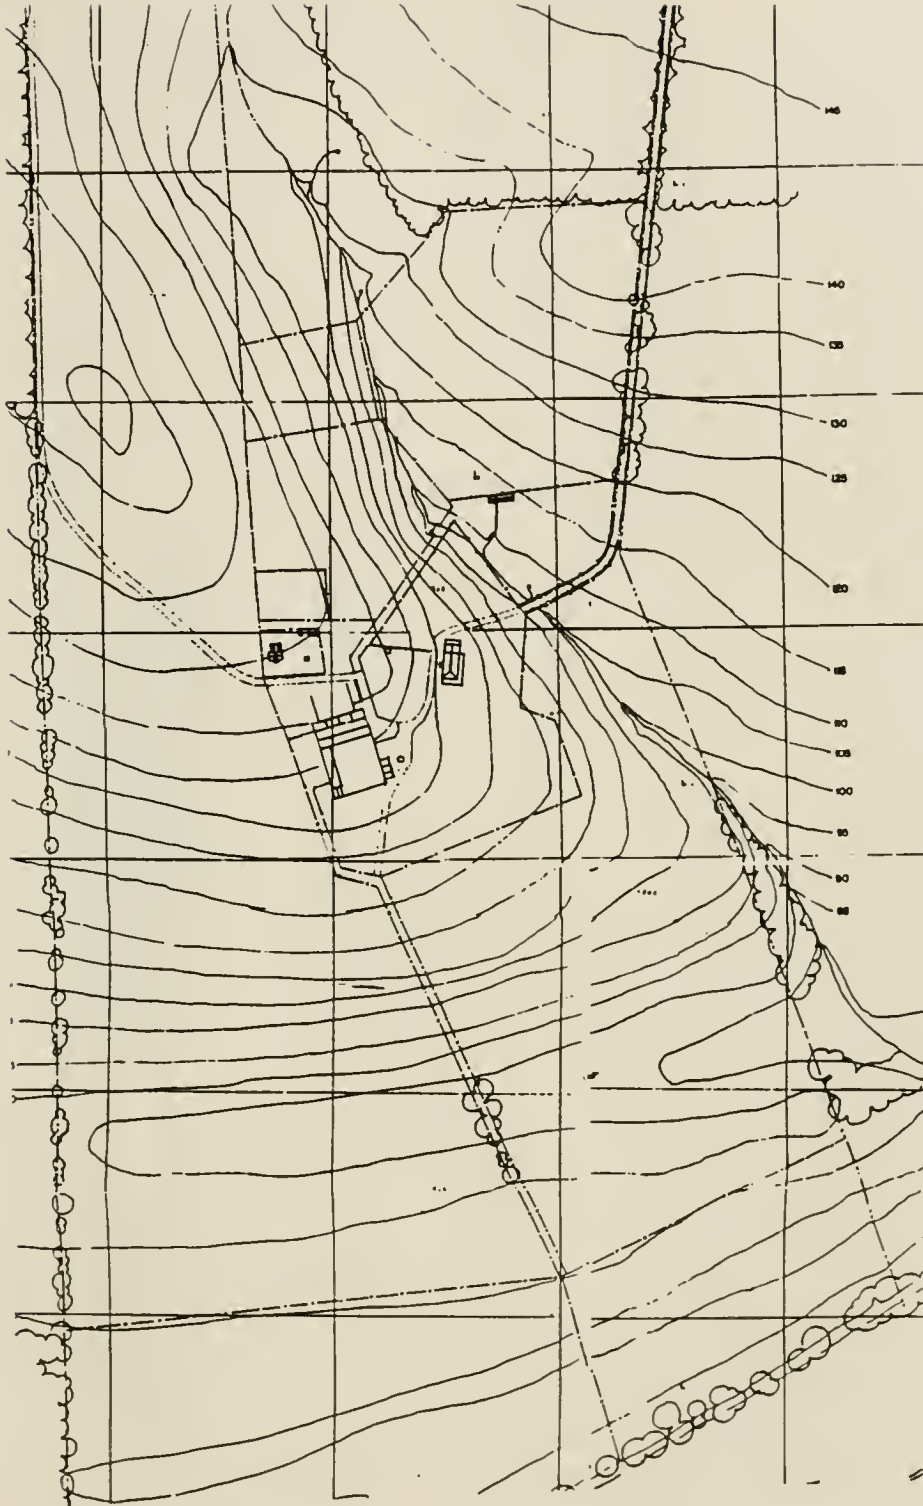
Figure 9: Site plan prepared by Tim Long, 1990, based on surveys conducted by J.L. Janeway, Reg. Engineer, in 1929. Valley Forge National Historical Park, Valley Forge, PA.

The barn is situated just southwest of the main house, with fields surrounding it on the north, south and west sides (Figs. 9 & 10; Plate 6). As a result of its close proximity to the main house, special attention was paid to the execution of the east gable end facing the house, which was executed in a symmetrical, restrained manner.⁴ The Schuylkill River, located about one-half mile south of the barn, flows along a northwest course, connecting with the Perkiomen Creek to the north. Fields along the Schuylkill were primarily used as meadows for grazing sheep and cattle (Plates 7 & 8).⁵ At an early stage in the region's history, a canal system was established along this river course, when the Schuylkill Canal began operating in 1824. A series of dams and locks was designed to allow an efficient means of river transportation from Philadelphia to the Port Carbon region in Schuylkill County, and passenger boats were powered by horses along the bank.⁶ An advertisement for the sale of "Bakewell Farm" property after Samuel Wetherill's death, highlights its river location: "The value of this property is much enhanced by its proximity to the Schuylkill Navigation, affording an easy mode of conveying to market its wood, & c., and obtaining supplies of lime and manure."⁷

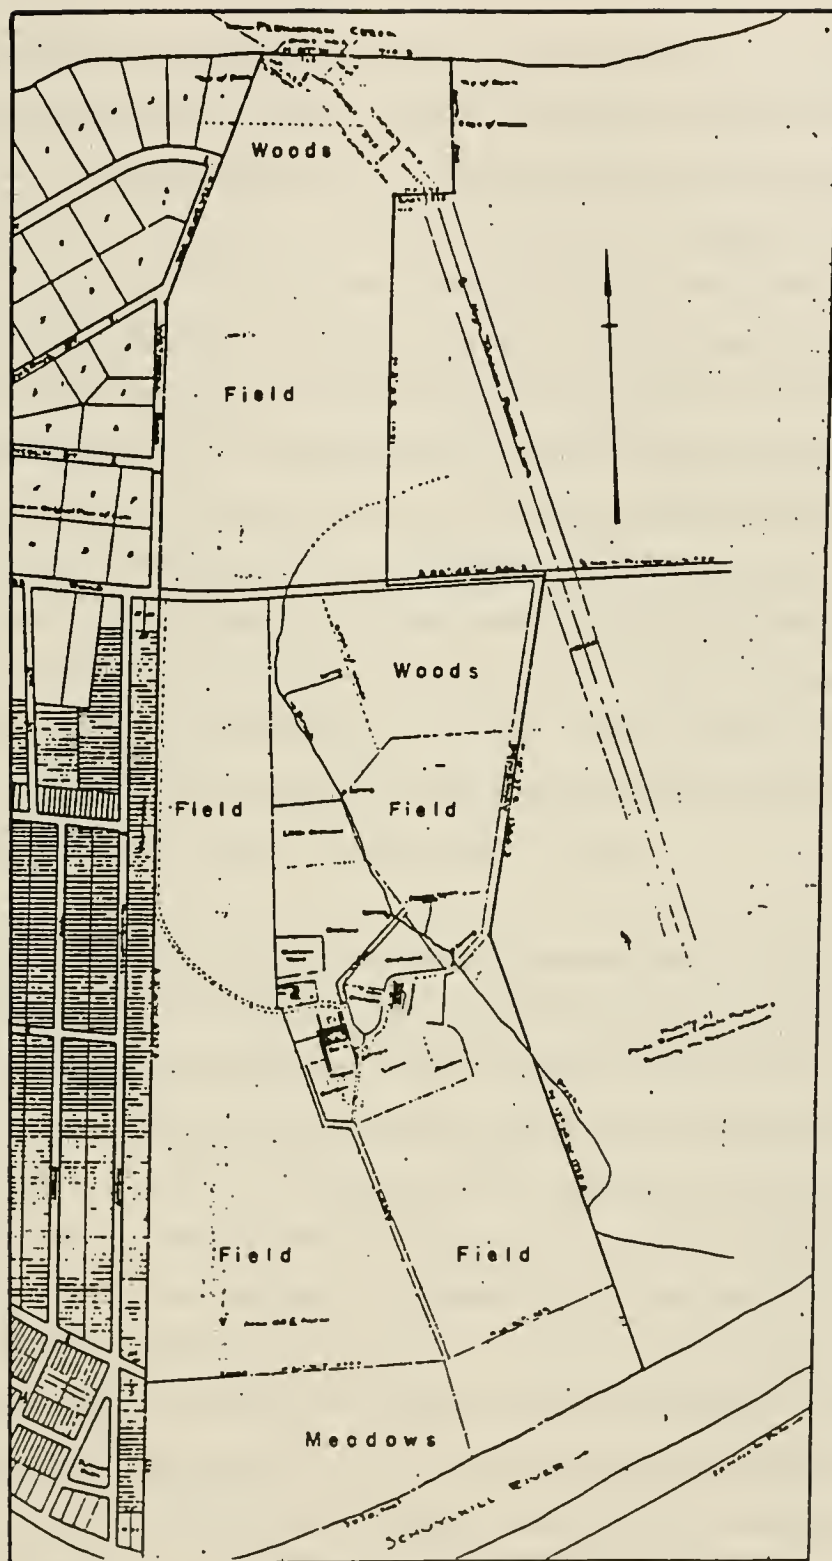
Figure 10: Site Plan showing layout of fields at Walnut Hill. James E. Kurtz, "Archaeological Survey and Assessment: North of the Schuylkill River," (Draft), U.S. Department of Interior, National Park Service, 1988.

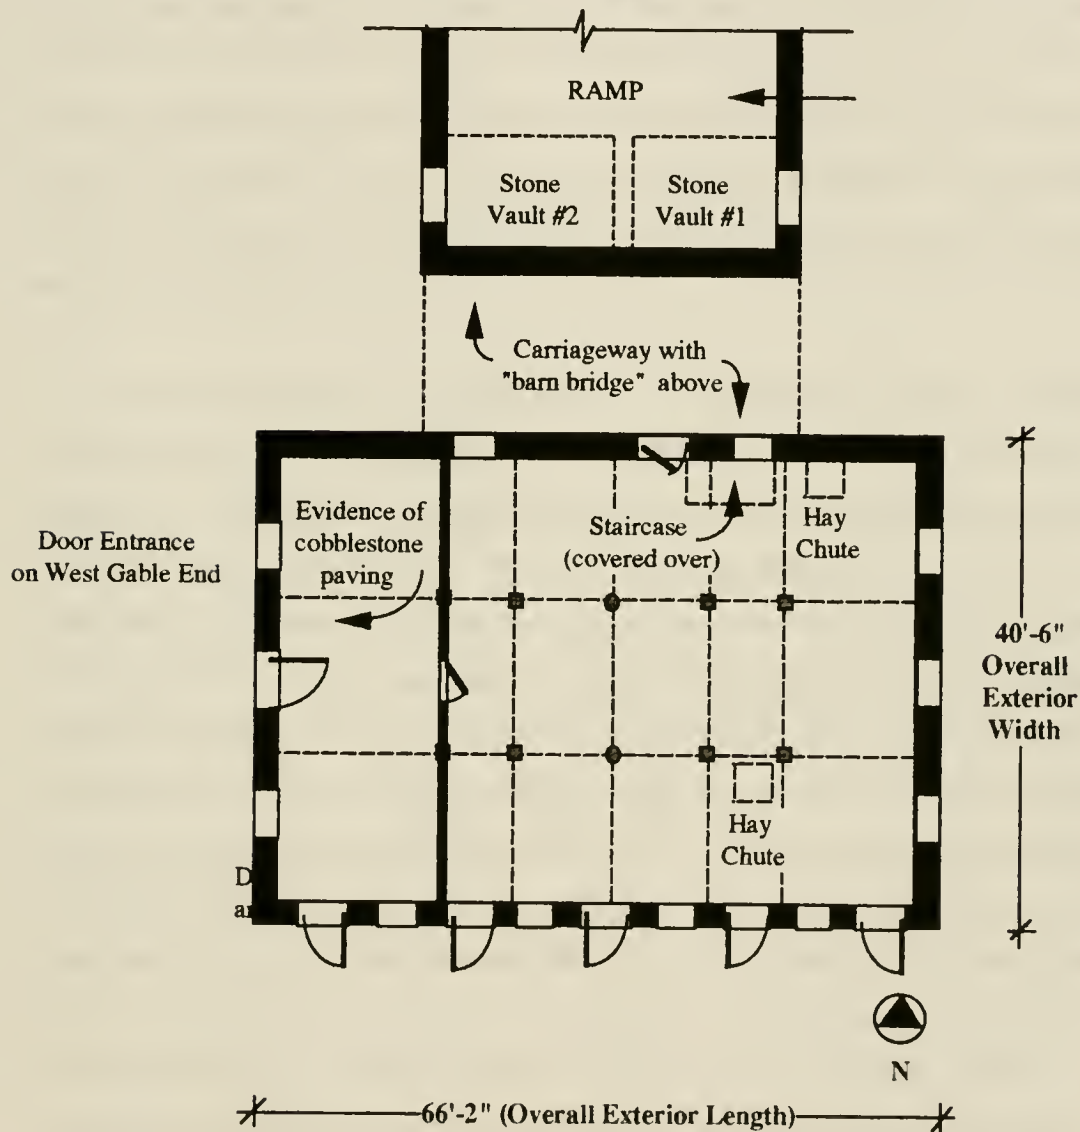
Ramp measured 33' wide by 65' long

Figure 11: 1826 Ground Floor Plan of Walnut Hill barn (not to scale)

The interior arrangement of the 1826 barn consisted of stables at the lower basement level, grain storage at the middle level, and the threshing platform and hay mows at the third level. The stables were sheltered on the north side by the bank and, most likely, opened to an enclosed farmyard along the south elevation. This open corral served as a place to exercise and water the animals, and collect their dung. As cited in the previous chapter on Pennsylvania barns, John Nicholson, an early writer on the subject of agricultural practices, recommended the construction of a high fence to enclose a section of the barnyard. The ground should slope slightly, with the lowest area in the middle to collect the manure, which could then be spread on the fields as fertilizer. Nicholson also mentioned that a well should be nearby to supply water for the cattle.¹⁵

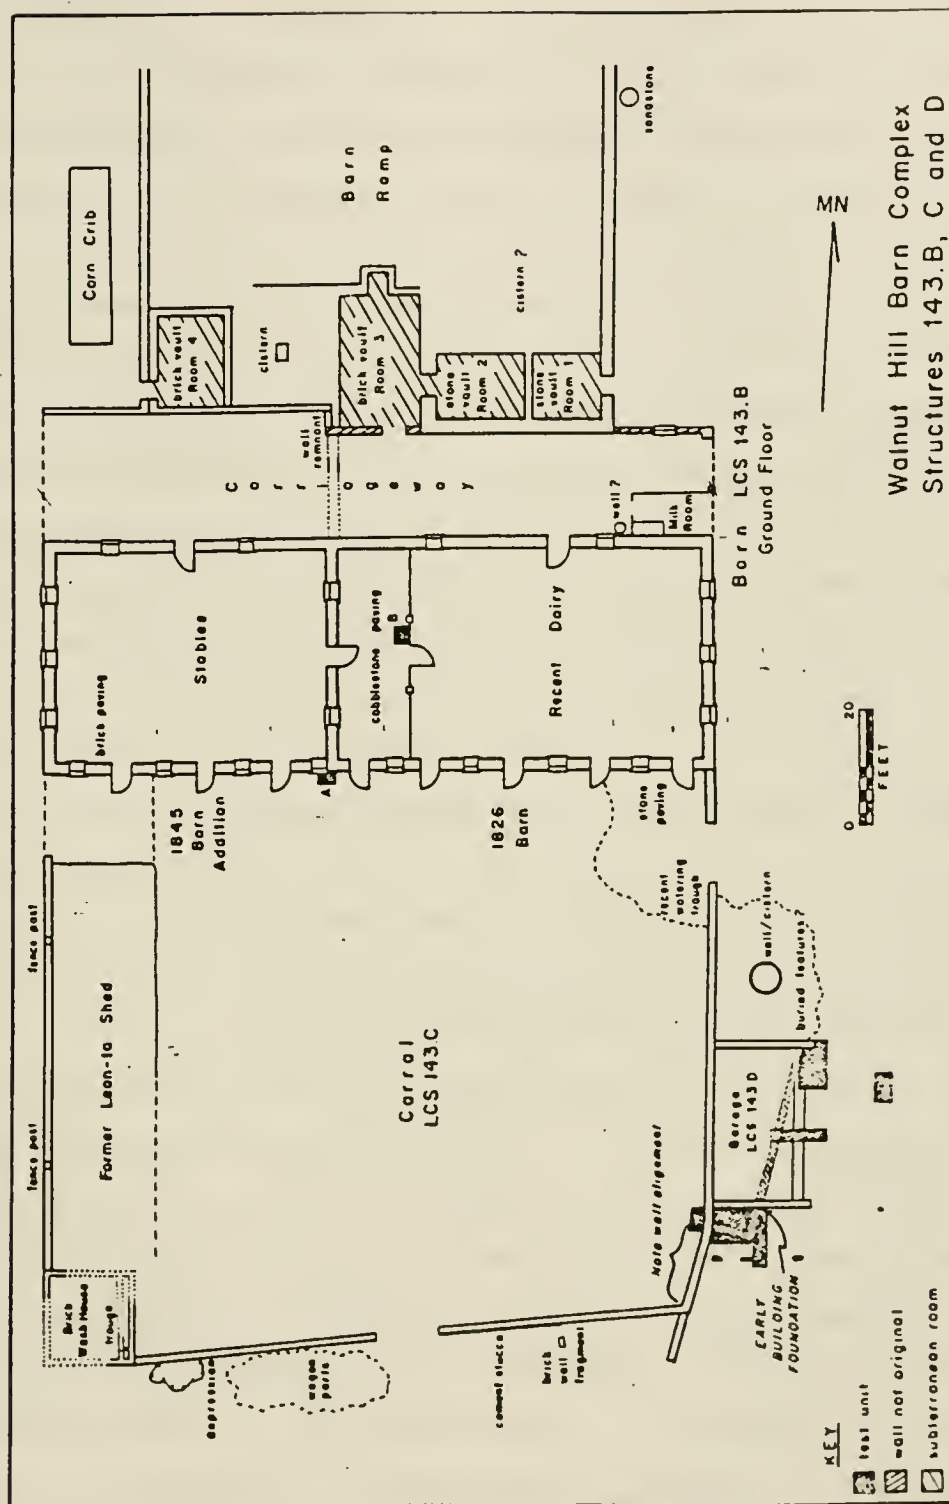
Figure 12: Plan of Walnut Hill complex showing archaeologists's test units. James E. Kurtz, "Archaeological Survey and Assessment: North of the Schuylkill River," (Draft), U.S. Department of Interior, National Park Service, 1988.

An enclosed farmyard area, consisting of a low stone wall on three sides, extended from the south elevation and created an open area for the animals to feed (Fig. 12). An opening was centered on the south stone wall, and other openings were provided along the side walls (east and west) near the barn. The west wall has several pocket openings for joists, located approximately 2 to 3 feet above ground level (Plate 28). Nine pockets are evident in the stonework and appear to be found every 3 to 4 feet apart. The northwest section has remains of a concrete foundation, about 4 feet by 10 feet. In the southwest corner, a brick foundation wall is visible as well as remains from a concrete trough. Concrete slabs are located in the ground across most of the length of this wall, except where the concrete foundation and brick foundation wall is located. It is difficult to determine what was original and what portions were later additions. There is also a trace of a previous gable roofline evidenced in the stonework at the west end of the barn wall, which extends to the top of the middle level window. This is the remaining visual evidence of the gable building that once stood along this west wall. A photograph taken in the 1940s by Charles Dornbusch shows a two-story wood building, or "straw shed", that existed along this wall (Plates 23 & 25). The east stone wall has a small section that extends approximately

Plate 39: Evidence of cobblestone paving in west end of 1826 stables, uncovered during archaeologist's investigations. Refer to Figure 12 for location of test unit.

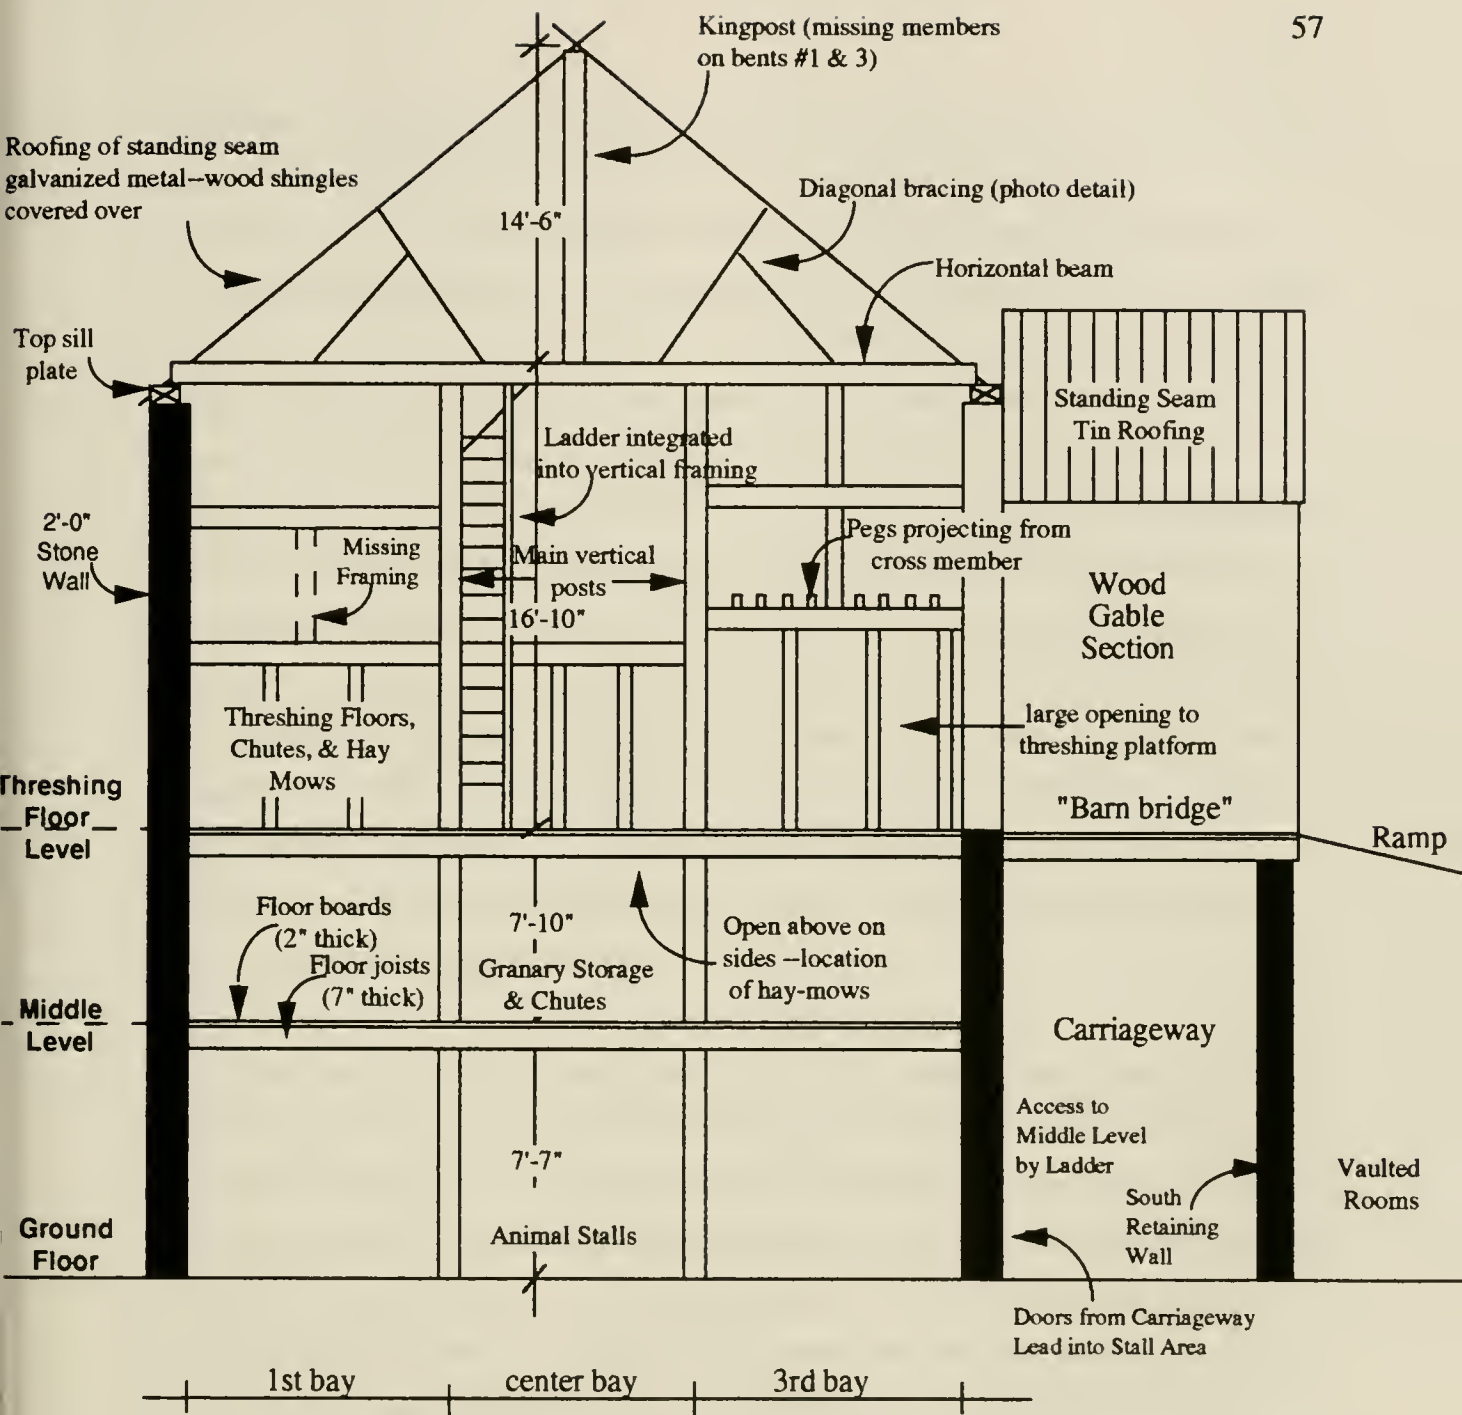
Figure: 13 1826 Section of Walnut Hill barn showing cross section of typical bent (not to scale)

The barn was constructed using mortise-and-tenon construction techniques. At the beginning of the nineteenth century, this framing system was applied universally to construct both houses and barn buildings. Framing was modified shortly after the Civil War by the introduction of the “balloon frame”, which employed a lighter framing system of vertical studs and siding. Walnut Hill barn consists of a three-bay “H-bent”, or framing system, with each bent placed approximately 14 feet apart across the length of the structure.²⁸ A diagram of the typical bent in this section of the barn illustrates the composition of the structural members, location of hay chutes and integrated ladders used to access hay (Fig. 13). The typical framing system consists of two main vertical posts connected by a large cross beam that extends the width of the structure at the roof height .

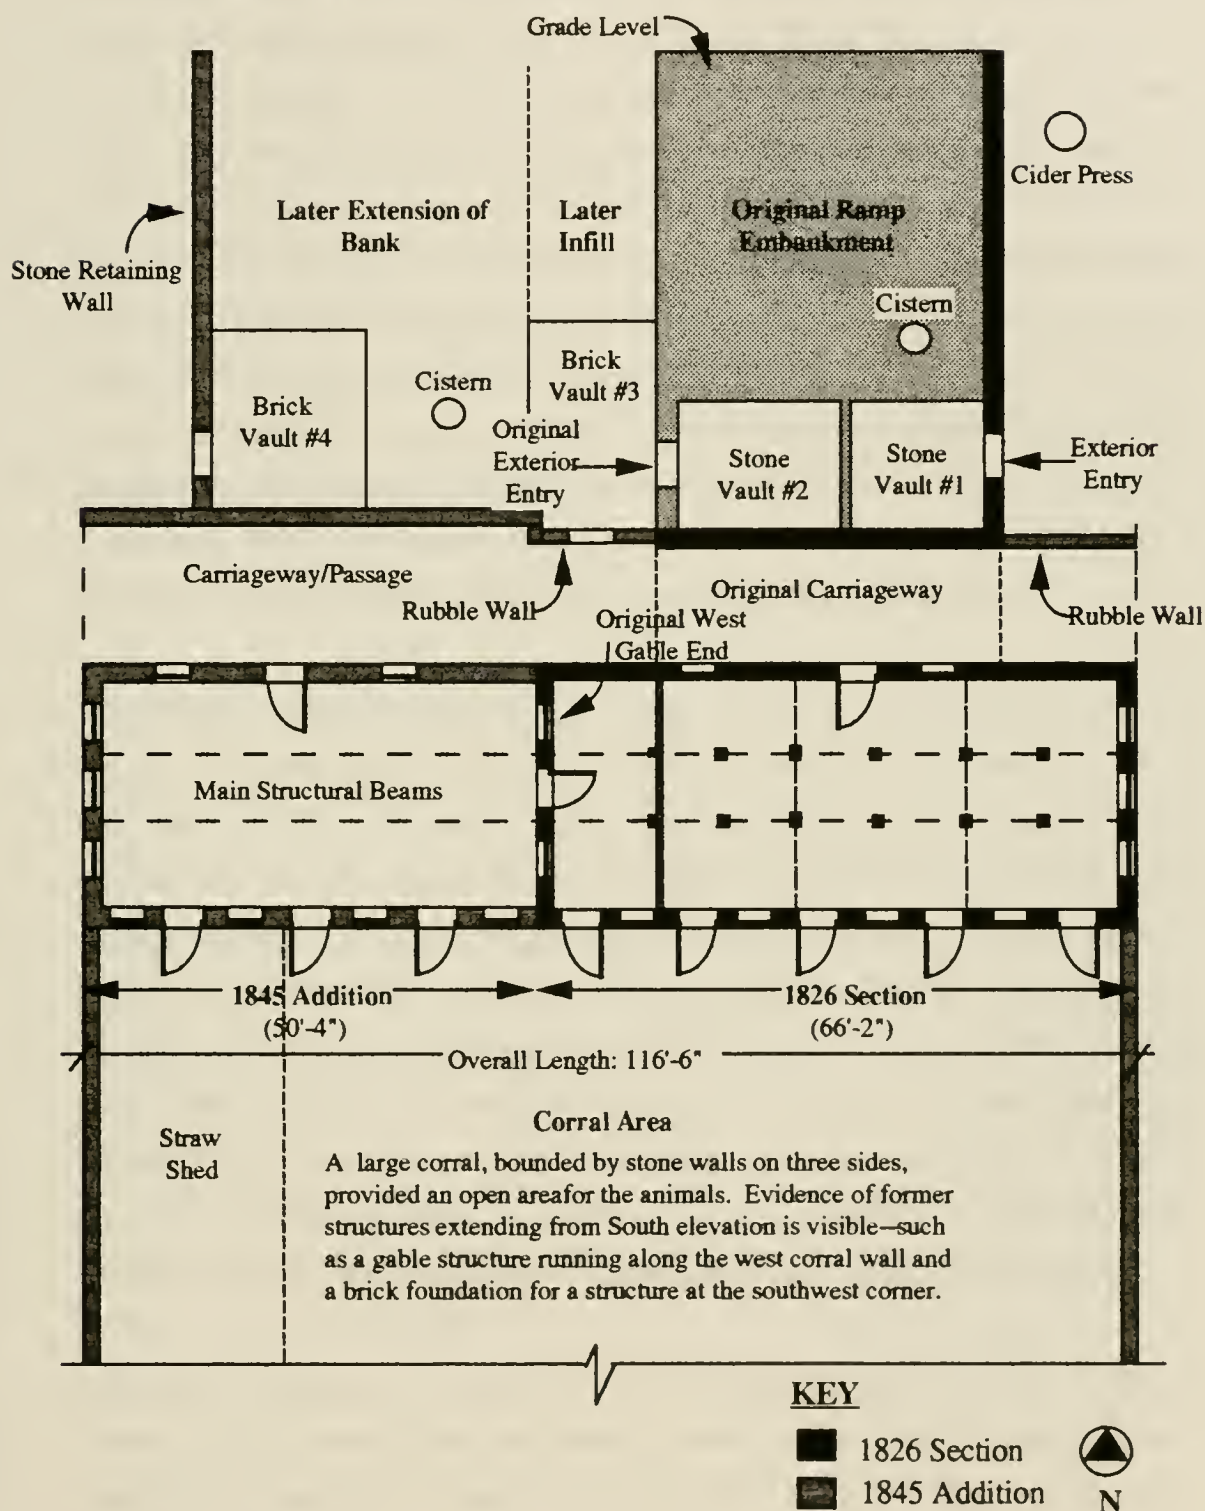
Rampway leads up to third, or threshing floor, level. Four tranverse and longitudinal arched vaults are located underneath earth embankment along south side of bank.

Figure 14: Overall Ground Floor Plan of Walnut Hill barn (not to scale)

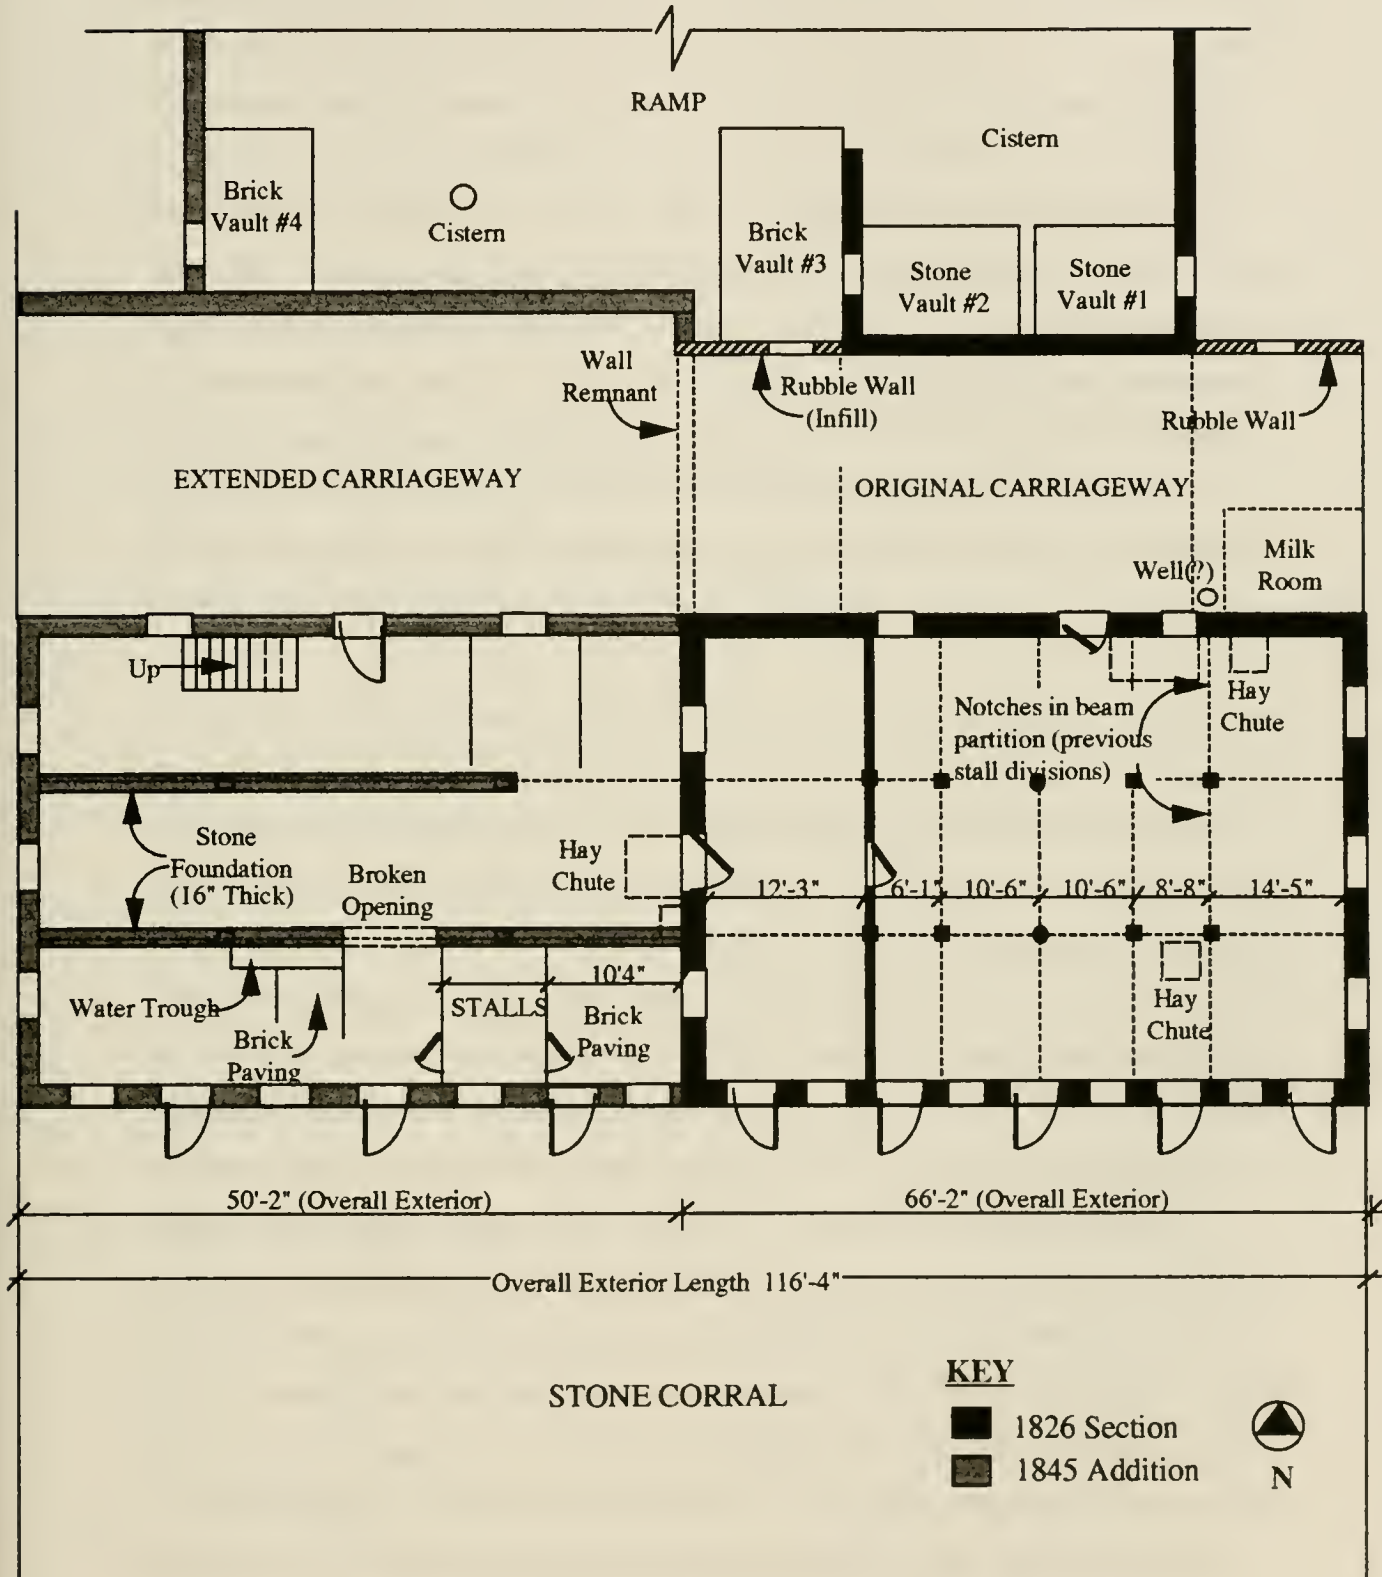
Ramp extended to the west when barn enlarged circa 1845.
Two brick vaulted rooms (Vaults #3 and #4) added under new
section, with one connected to an earlier stone vault (Vault #2)

Figure 15: Ground Floor Plan of Walnut Hill barn (not to scale)

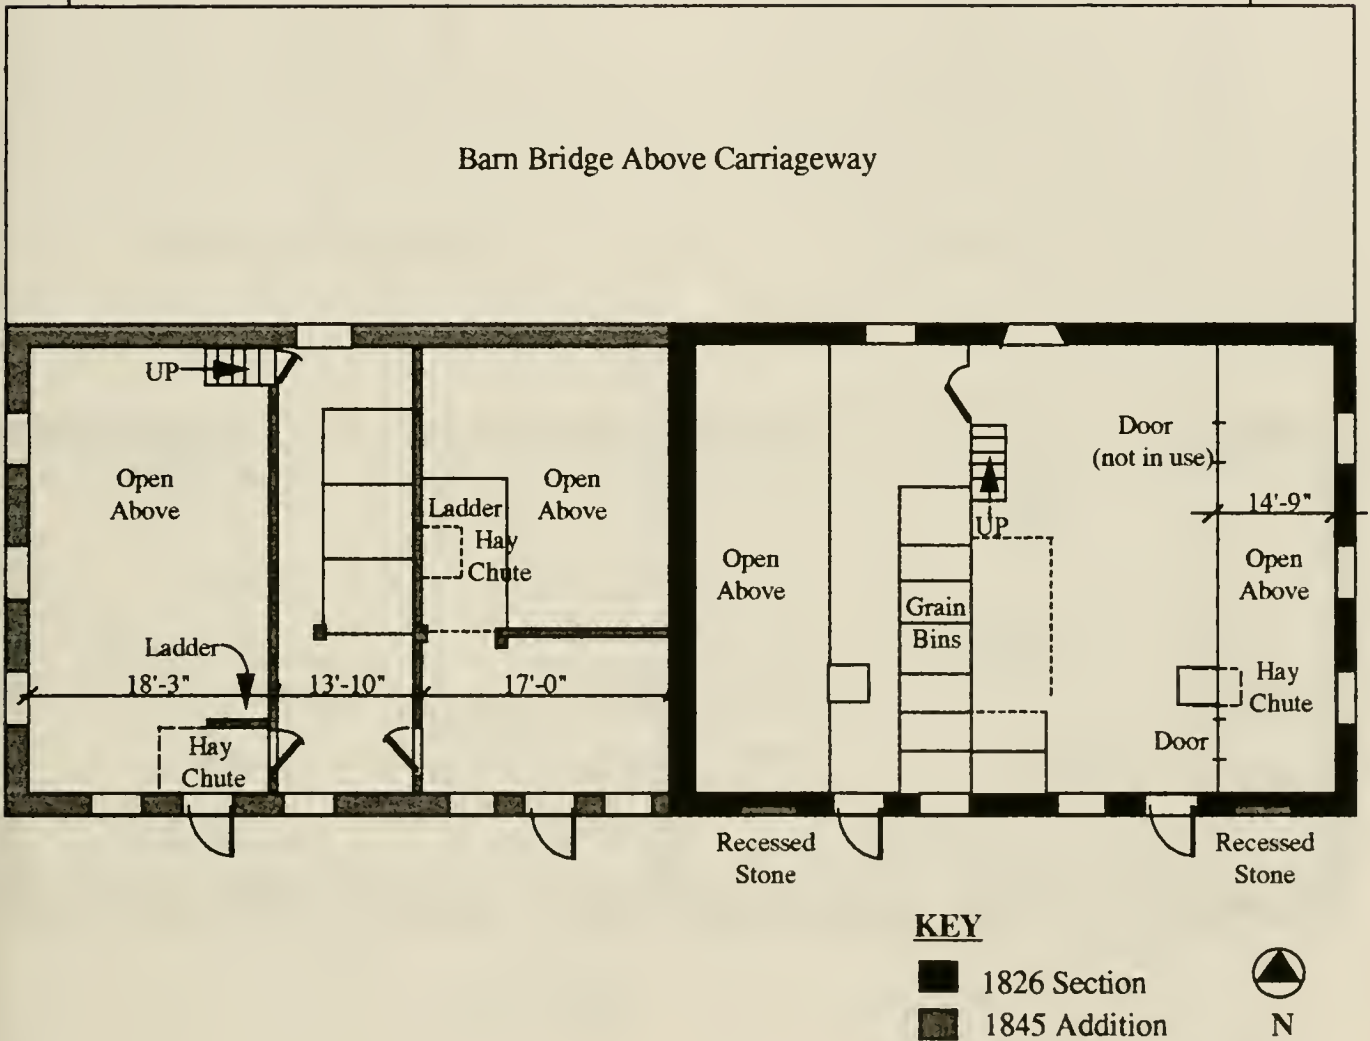
Figure 16: Middle Level, or Granary, of Walnut Hill barn (not to scale)

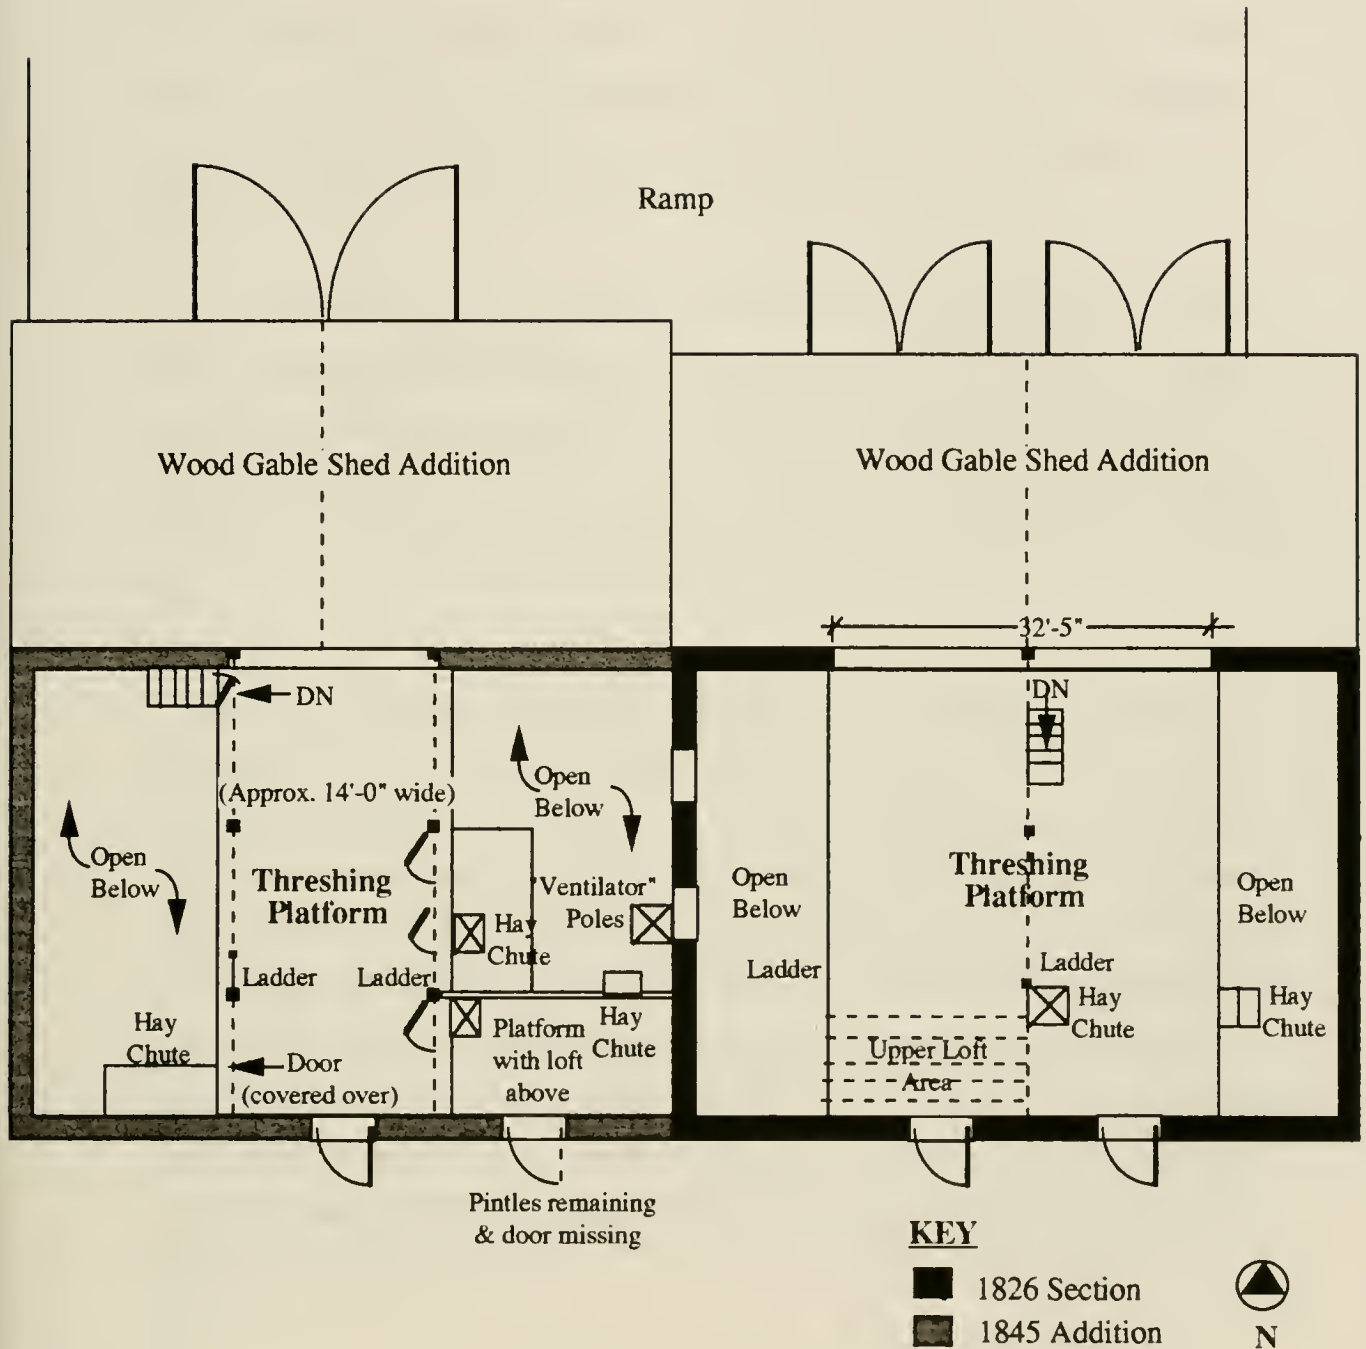
Figure 17: Third Level, or Threshing Floor, of Walnut Hill barn (not to scale)

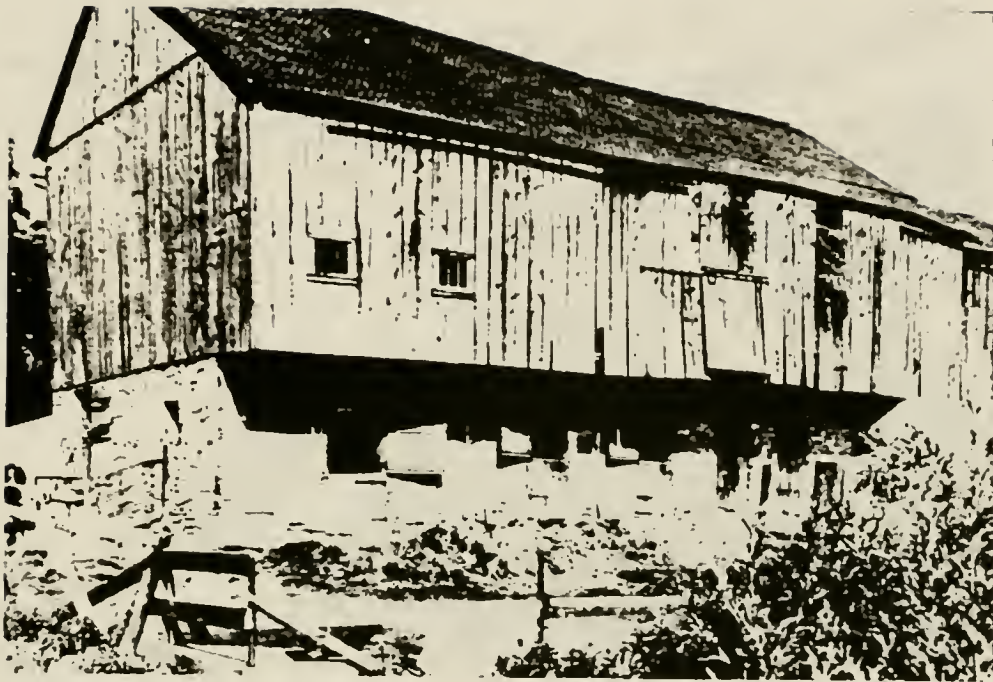
Plate 1: Example of a "Sweitzer" bank barn near Fogelsville in Lehigh County, PA. Shows the wood "forebay", or overhang, at upper level and the stone construction below where the stables are located. Charles Dornbusch, *Pennsylvania German Barns*, Volume 21xxi (Allentown, PA: Pennsylvania German Folklore Society, 1958), 81.

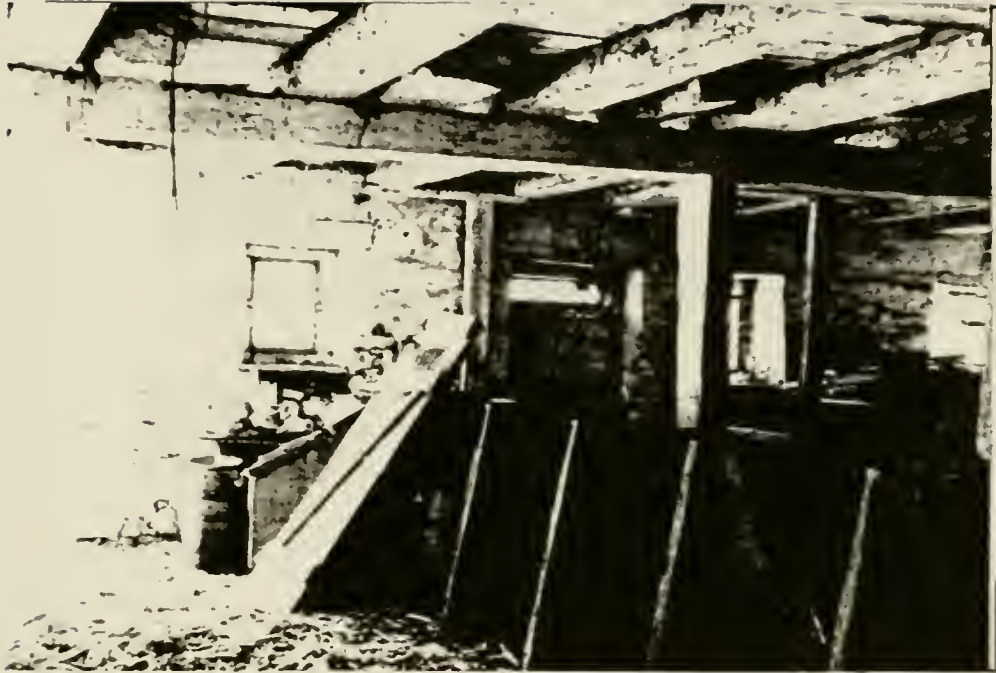
Plate 2: Interior of a barn in Lancaster County, PA (1804) showing typical stall arrangement at basement level. Framing of the structure consists of squared timbers running lengthwise and dressed vertical columns. Coat of lime whitewash keeps livestock area sanitary. Sloping bins on right are mangers for the cattle; aisle for feeding service located beyond first tier. Charles Dornbusch, 137.

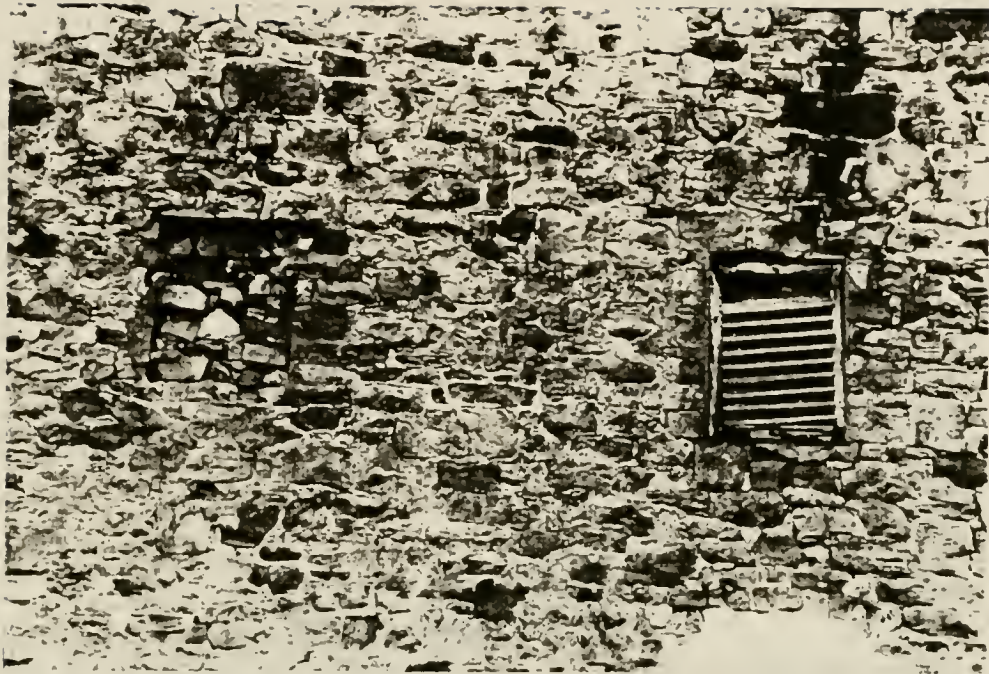
Plate 14: Detail of east gable end stone recessed panels and louvered frame to disguise false opening
