Function and Use of a Nineteenth-Century Barn
"Walnut Hill" Estate
Pawling Road, Lower Providence Township
Montgomery County, Pennsylvania

Brooke Elin Vincent

A THESIS
in
The Graduate Program in Historic Preservation

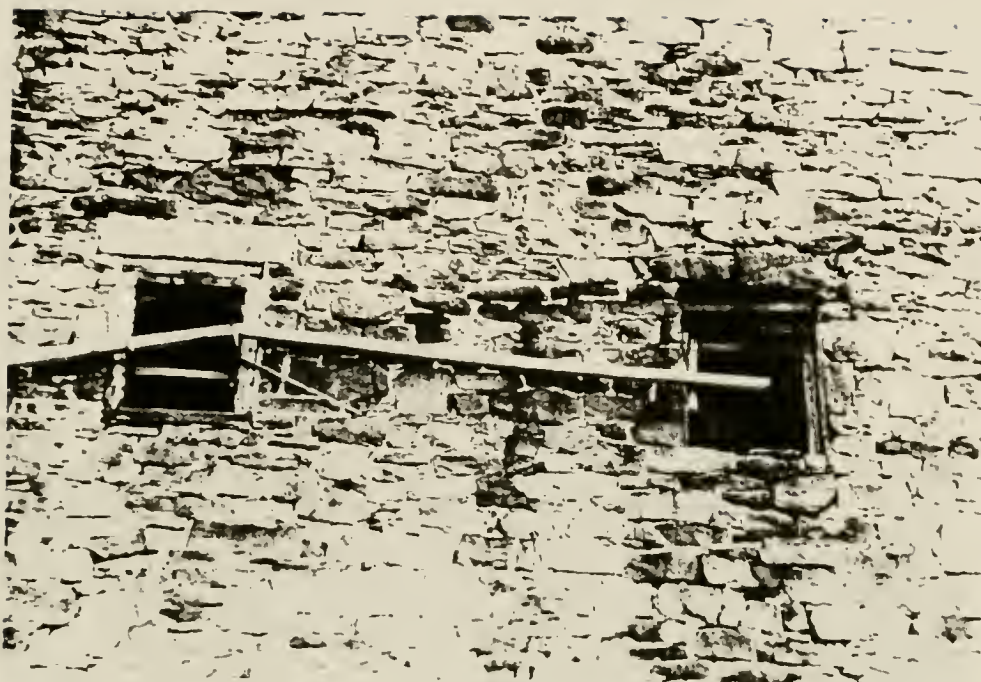
Plate 19: Detail of west gable end windows showing bluestone lintel (left) and sandstone rubble support (right)

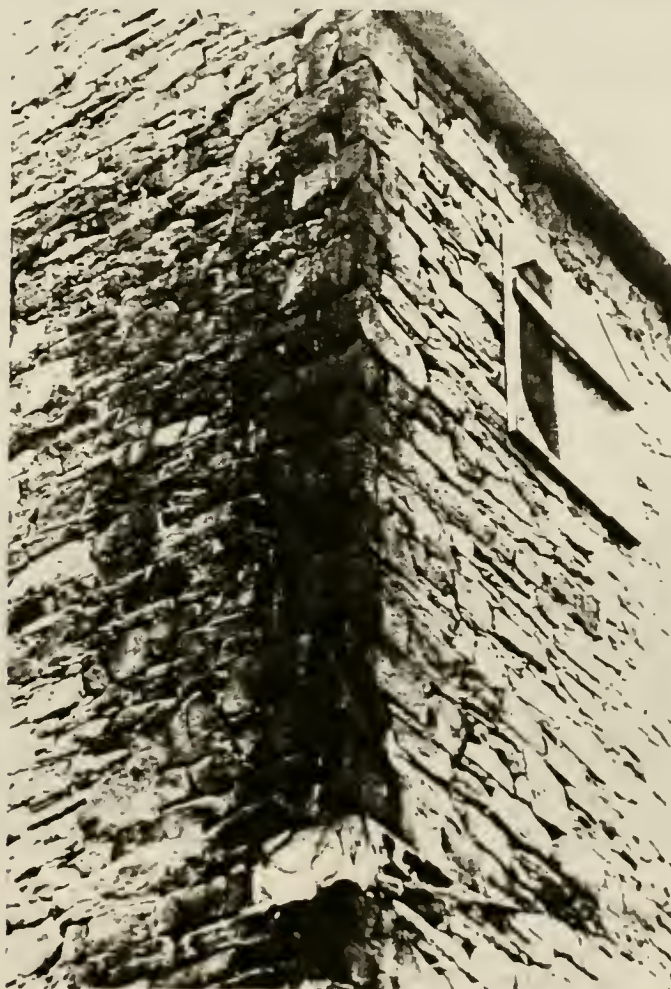
Plate 20: Detail of corner quoins along southwest edge of barn

upper gable portion. Stone quoins define the edges (Plate 20). Bluestone lintels are found on the first and second floor windows, as well as the center window on the third floor. The ridge pointing is still partially visible on this facade, although suffering an advanced state of deterioration.

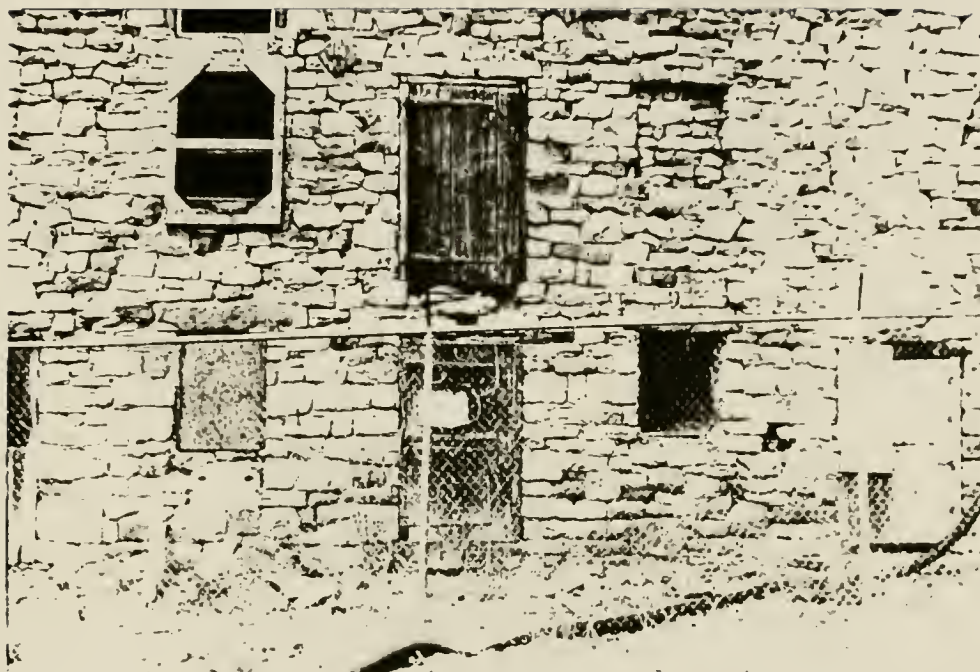
Plate 24: Close-up of 1826 section of south elevation, showing typical arrangement of openings at ground floor and middle level

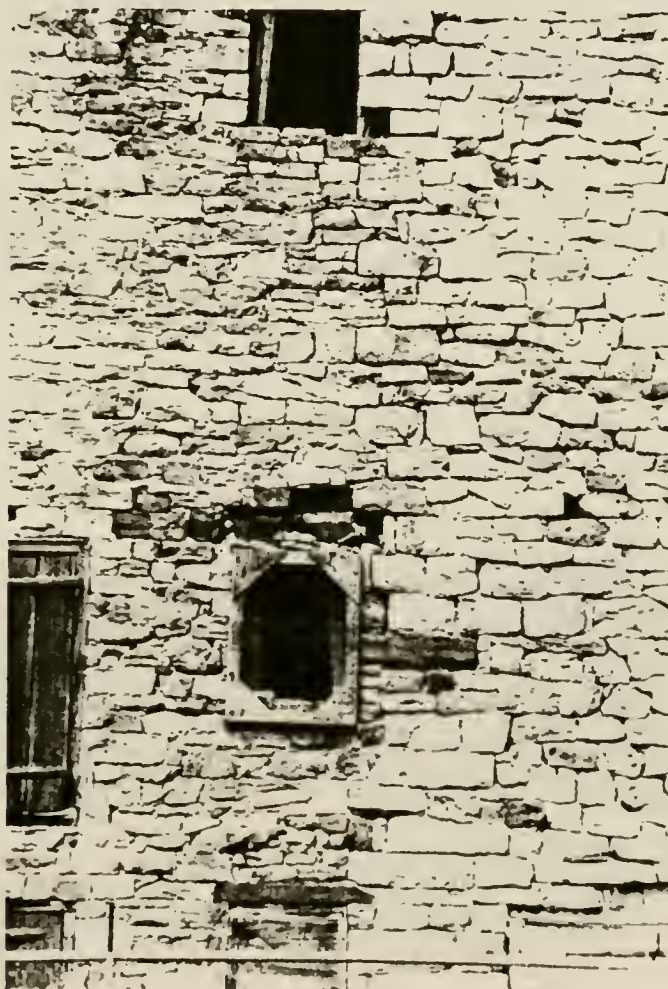
Plate 26: Detail of stone "dovetailing" on south elevation

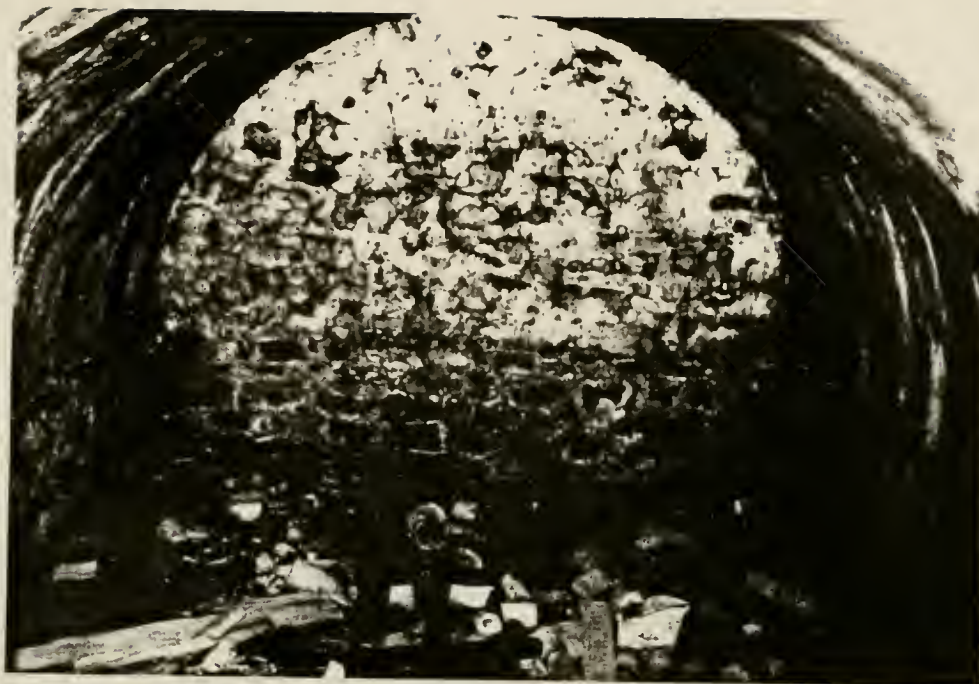
Plate 31: Stone vault #1 in 1826 ramp section, showing depth of room and whitewashed surfaces. This vault was accessed by an exterior door opening along southeast side of ramp retaining wall

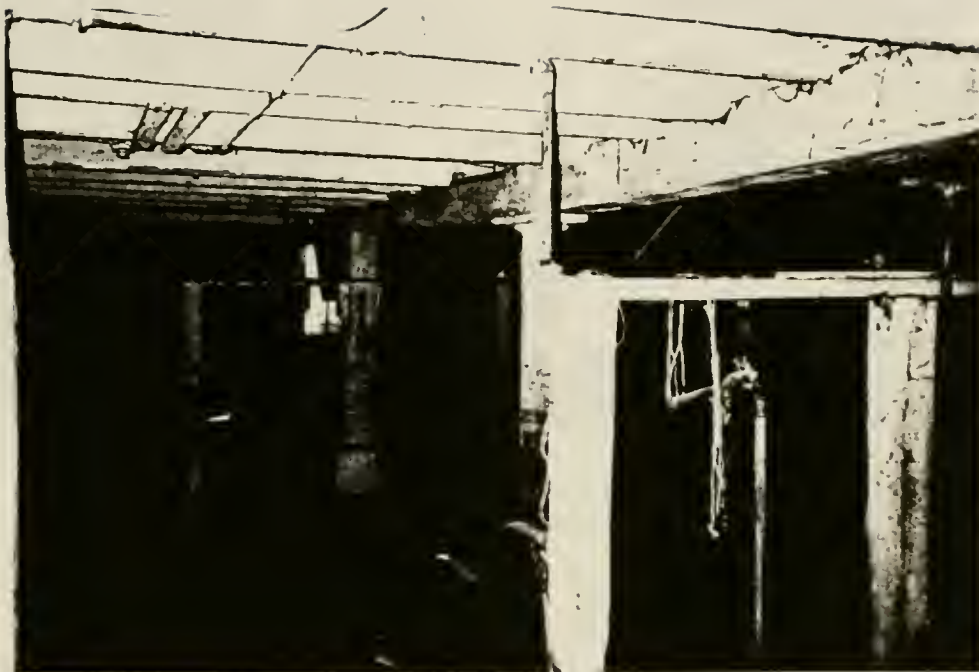
Plate 33: View of 1826 stall area looking east. Section has been modernized to serve as a dairy operation, however, original structural system remains intact.

The 1826 stall area was later modernized to house cattle, with a concrete floor laid down, leaving scant evidence of the original layout of the stall areas. The original whitewashed stone walls and interior structural members are still intact which provide clues to the type of open stall that may have existed in this section before the metal stanchions and new floor was added (Plate 33). Empty mortises are found along several cross beam in the barn,

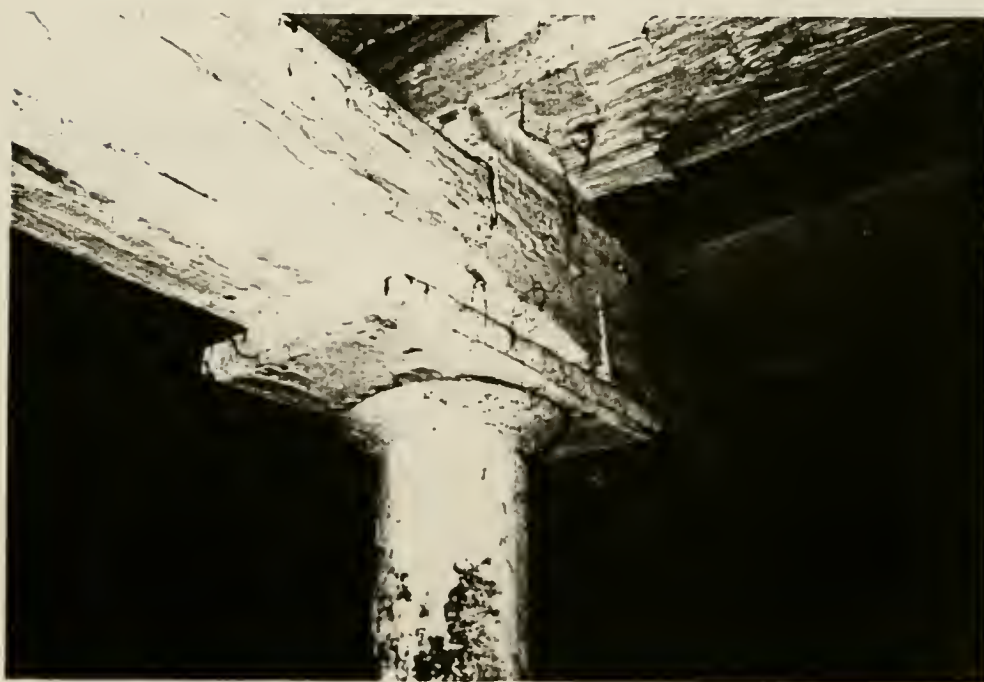
Plate 35: Detail of cast iron column and chamfered beam in 1826 stall section

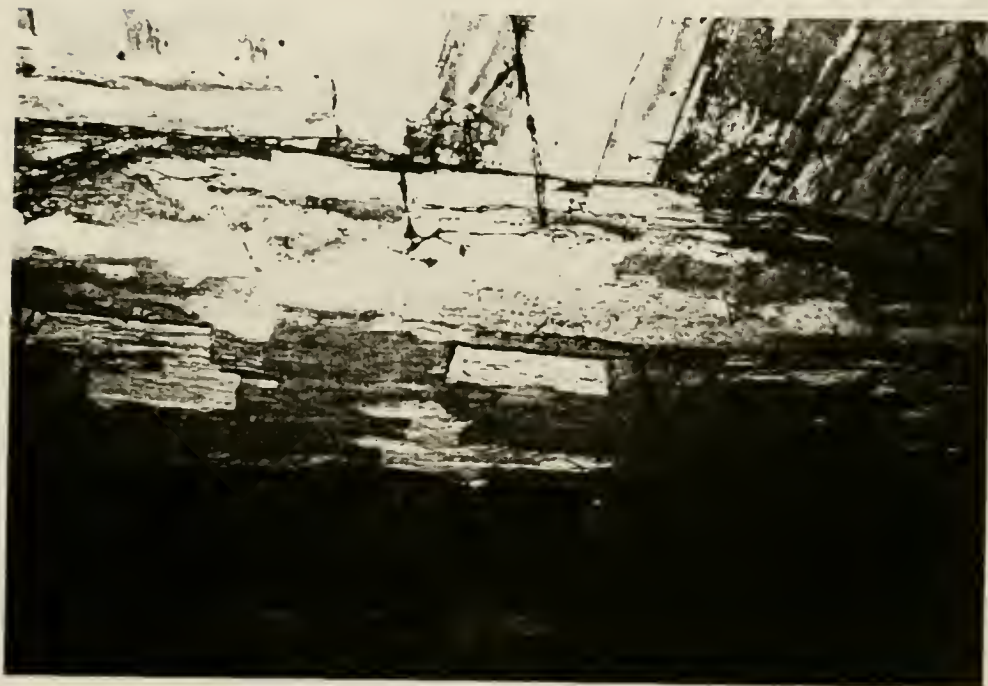
Plate 37: Detail of notches found in cross beam of 1826 stable ceiling framing. Holes may indicate location of earlier stall dividers (Refer to Appendix E for location of notches)

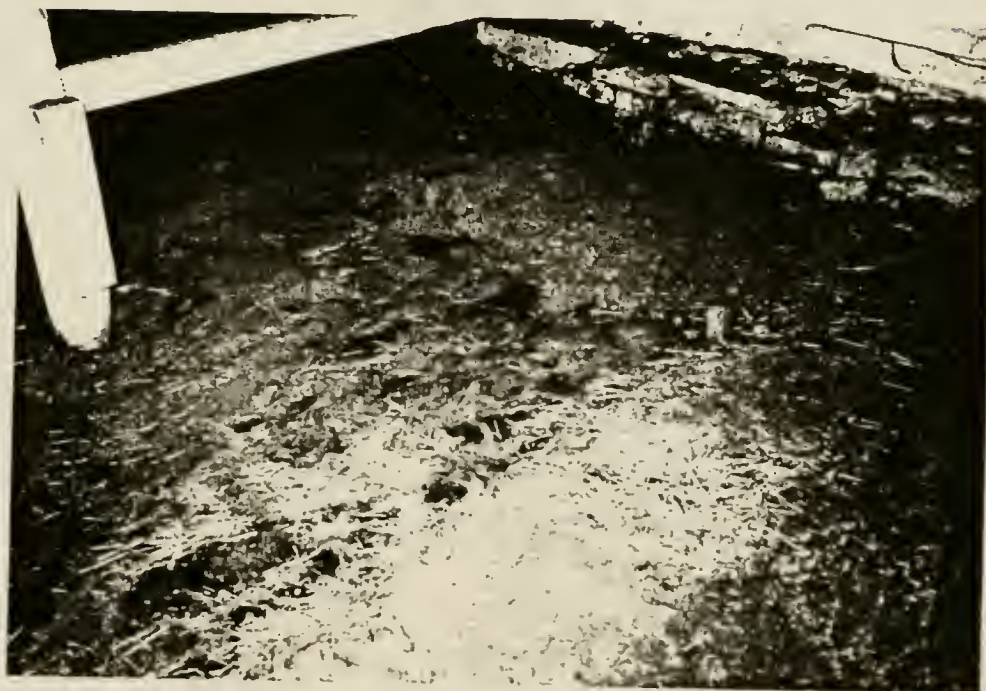
Plate 39: Evidence of cobblestone paving in west end of 1826 stables, uncovered during archaeologist's investigations. Refer to Figure 12 for location of test unit.

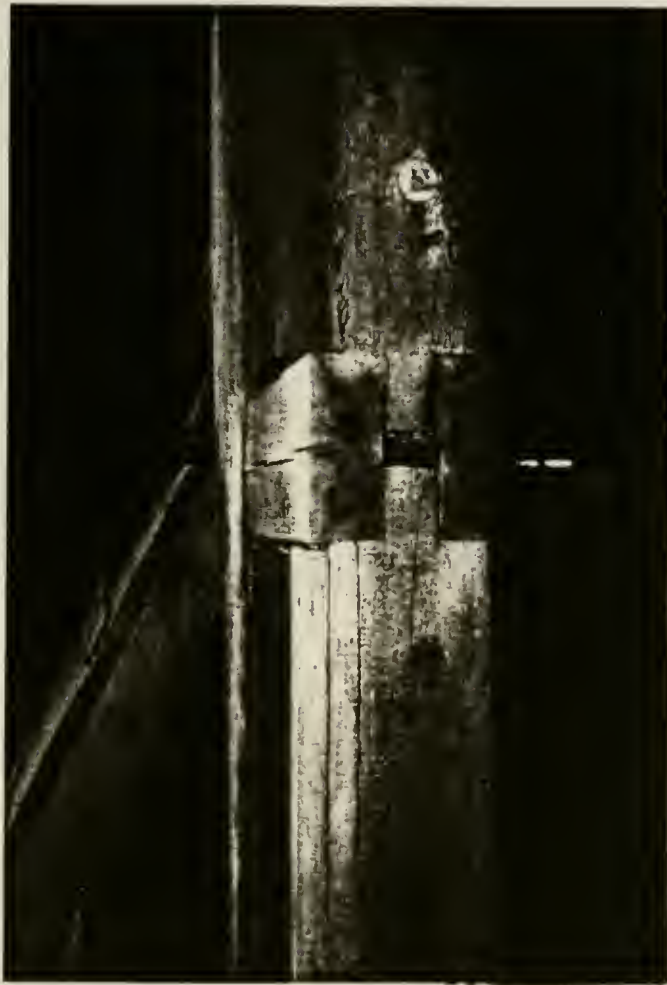
Plate 49: Detail of 1826 threshing floor framing, showing evidence of cut cross member

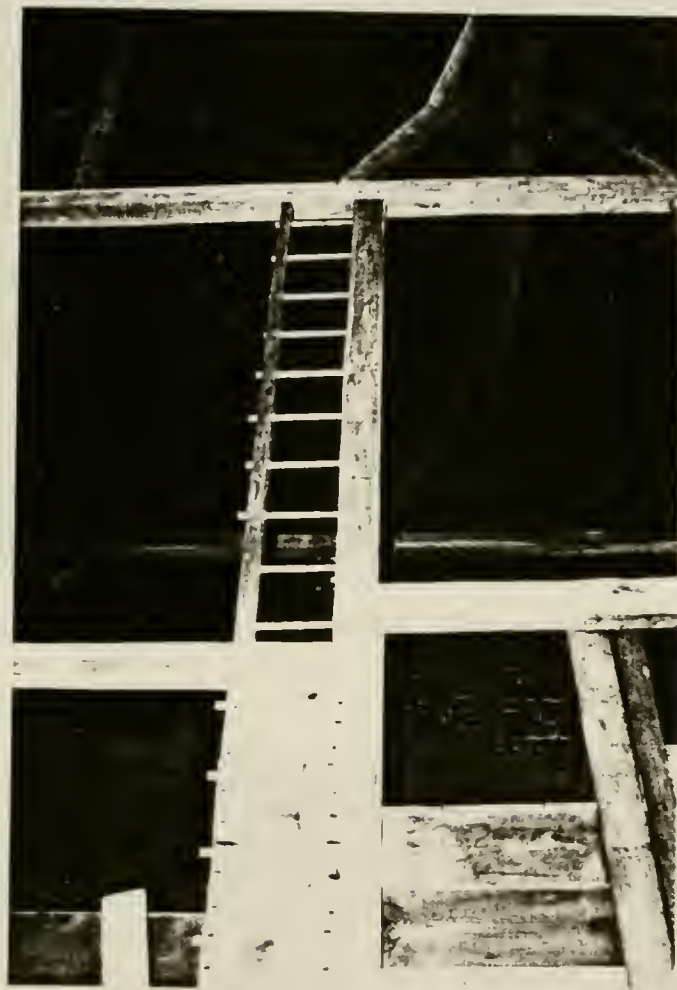
Plate 52: View west of 1826 structural framing, which employs a 3-bay H-bent design and system of diagonal braces at roof level. Note original west gable end in background.

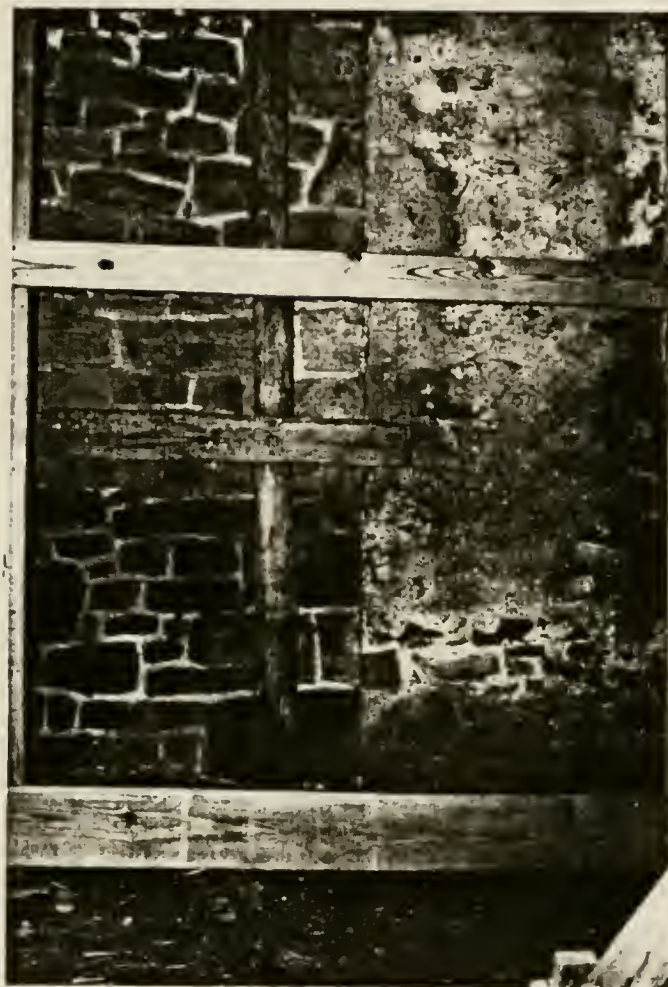
Plate 55: North elevation in carriageway section, showing exposed vertical seam between 1826 and 1845 sections. No attempt was made to disguise the joint on this elevation as opposed to south elevation.

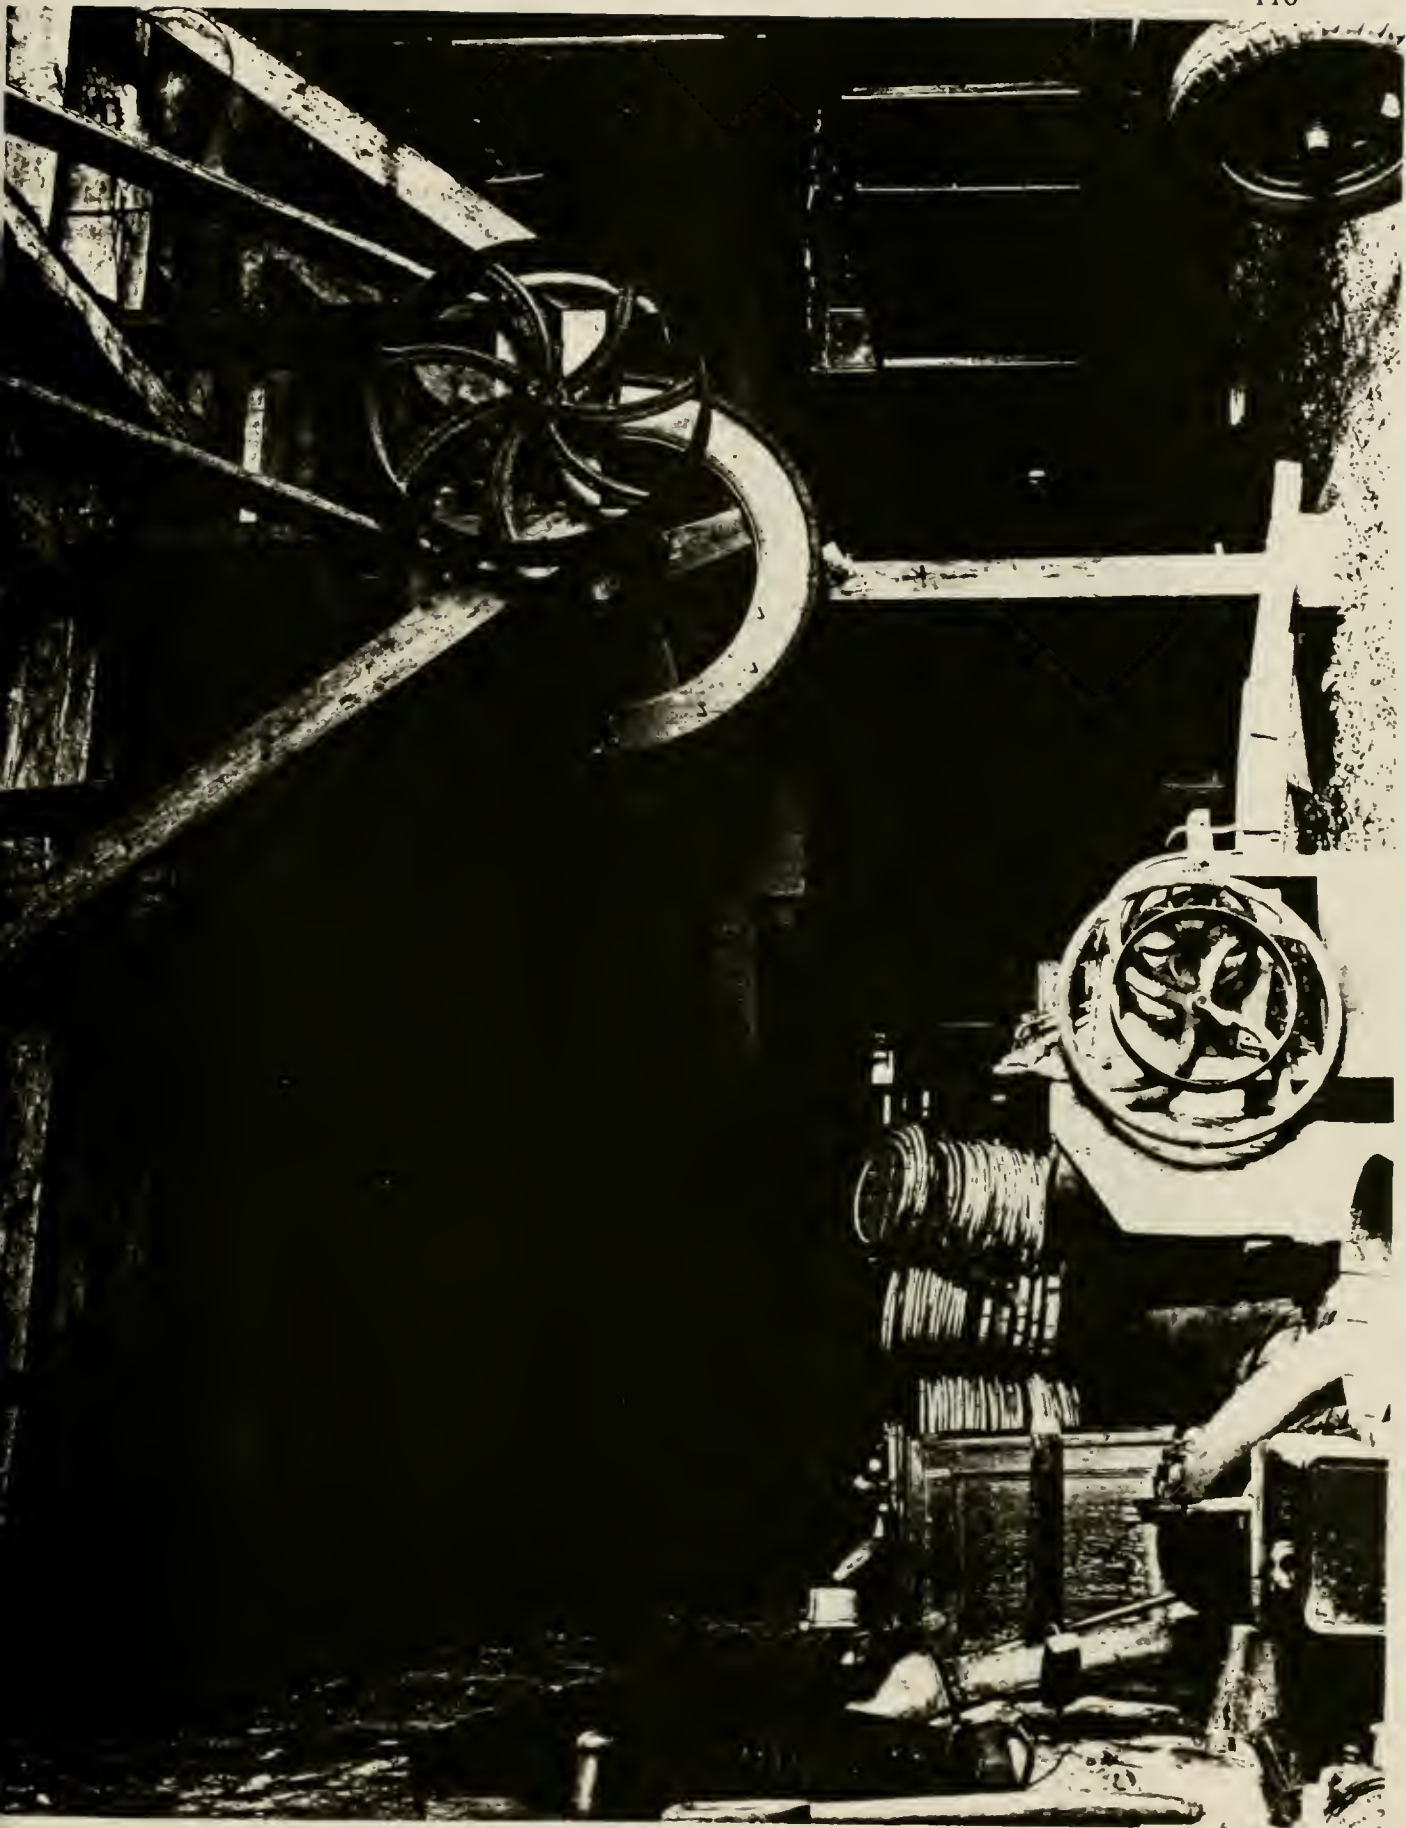
Plate 57: 1845 carriageway looking east, showing machinery setup, taken in 1940s. H.A.B.S. #PA-5350-4 (Washington, D.C.: Library of Congress)

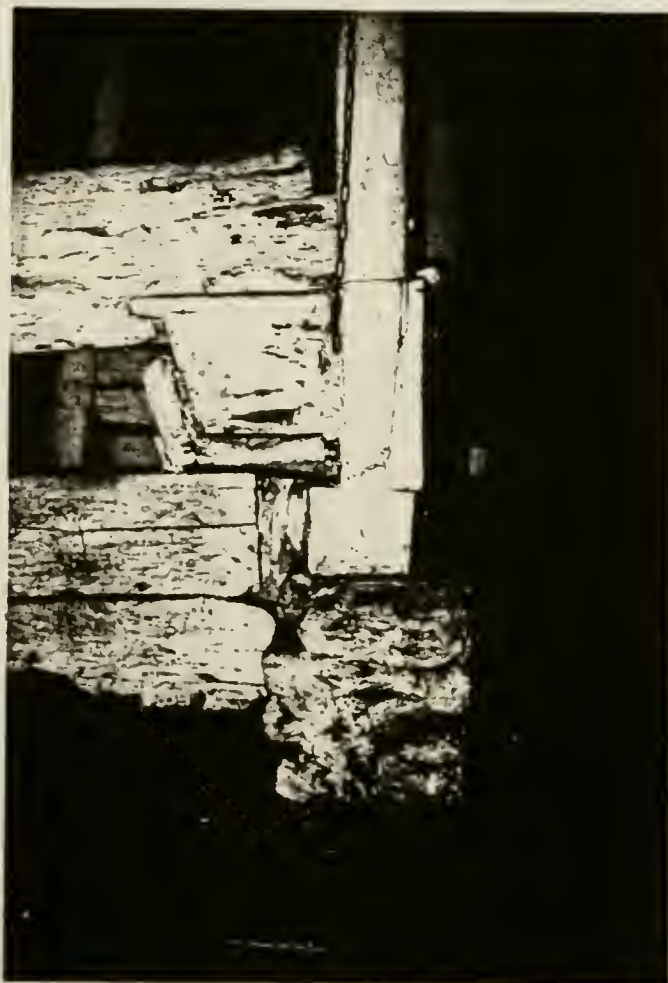
Plate 62: South stall area in 1845 section, showing broken stone foundation wall at midsection

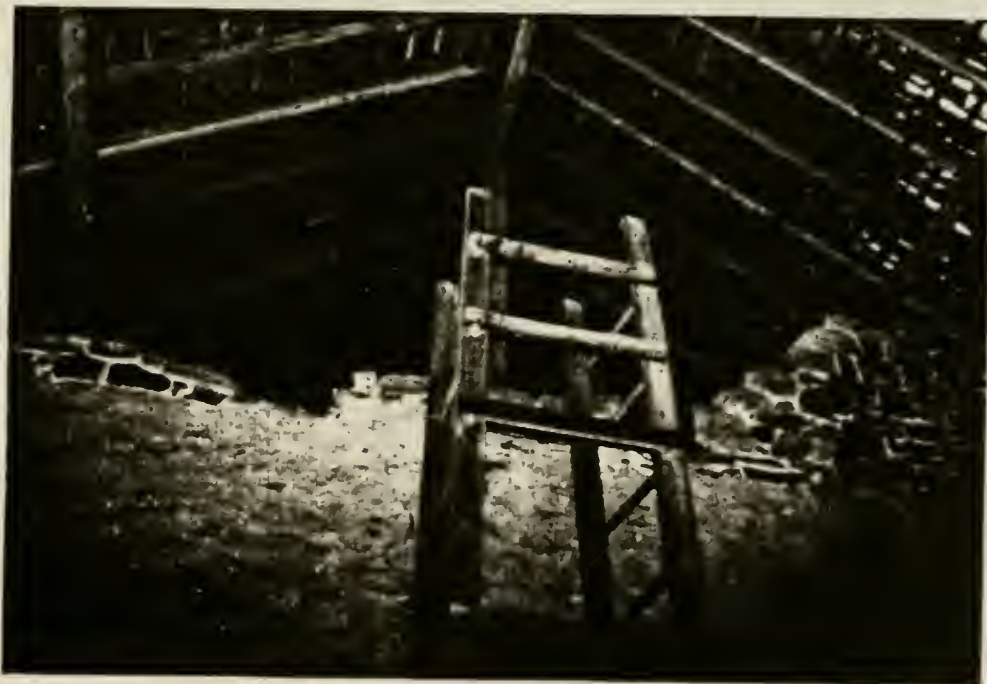
Plate 72: Close-up of ventilator poles. Note broken section of original west gable end

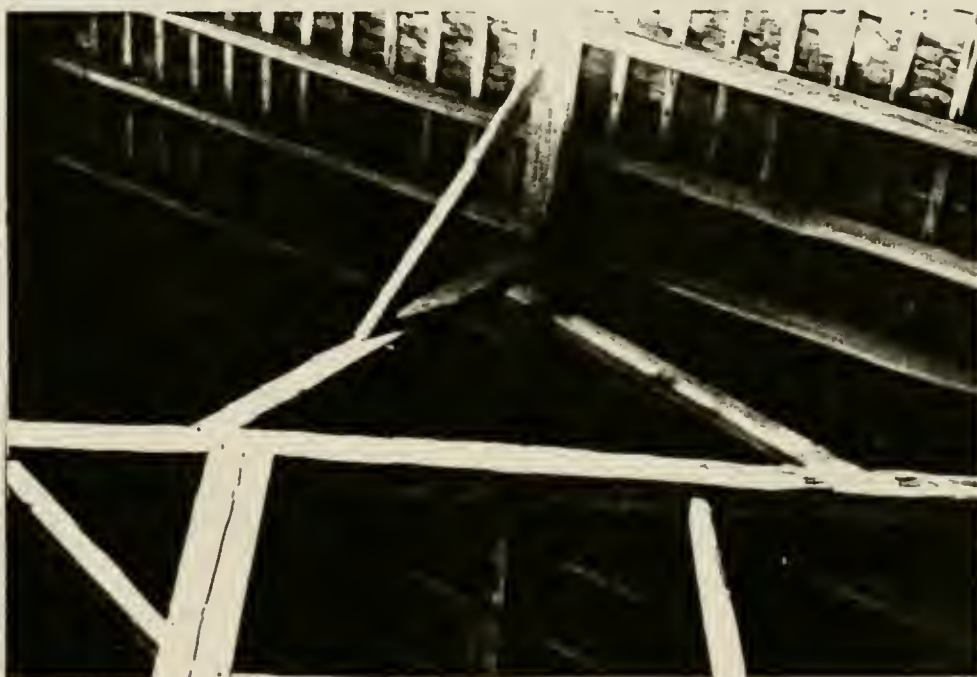
Plate 78: Detail of diagonal braces at roof level of 1845 barn
