ARCHITECTURE AS A PORTRAIT OF CIRCUMSTANCE:  
THE RESTORATION CAREER OF GEORGE EDWIN BRUMBAUGH

Cynthia Anne Rose

A THESIS

The Graduate Program in Historic Preservation

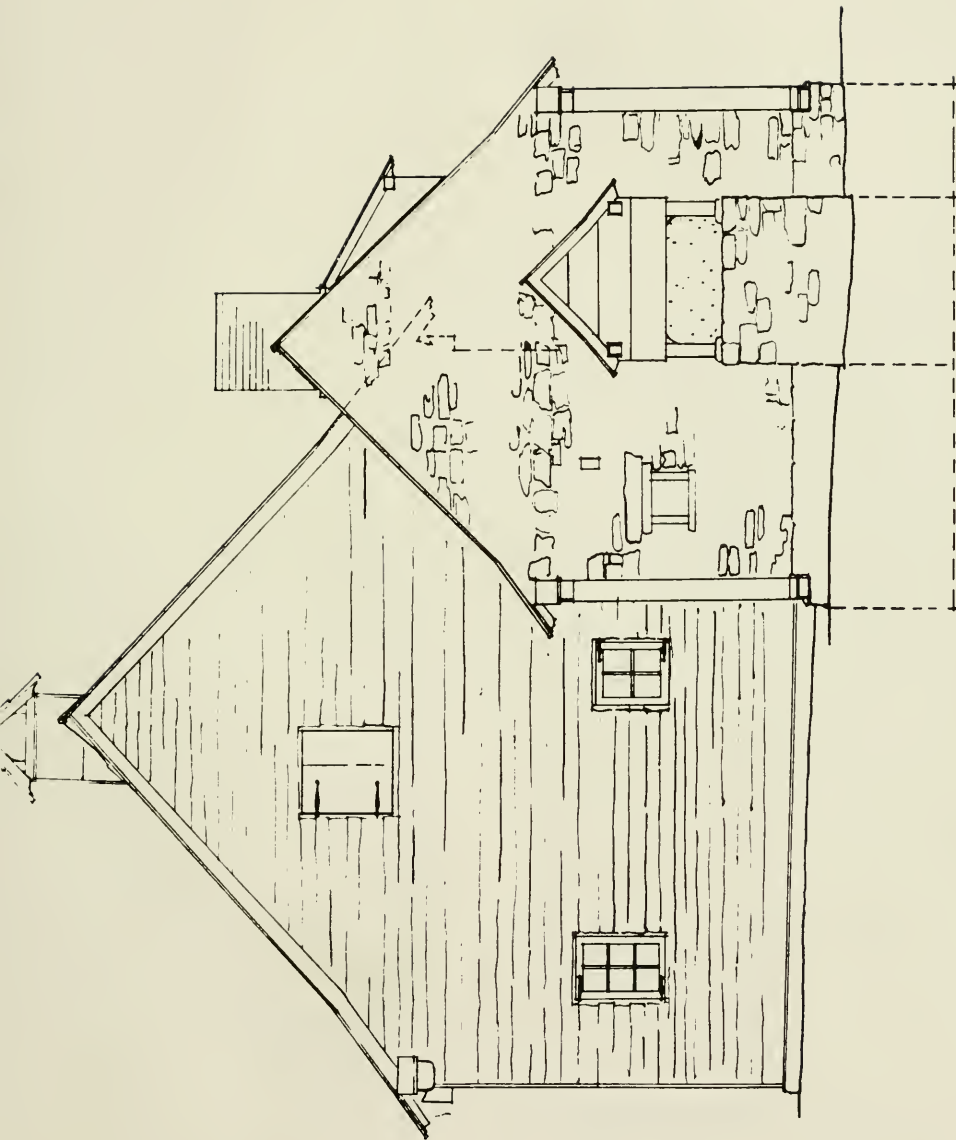
*SOUTH ELEVATION*

Ephrata - Beissel Cabin and Original Bake-House  
South Elevation

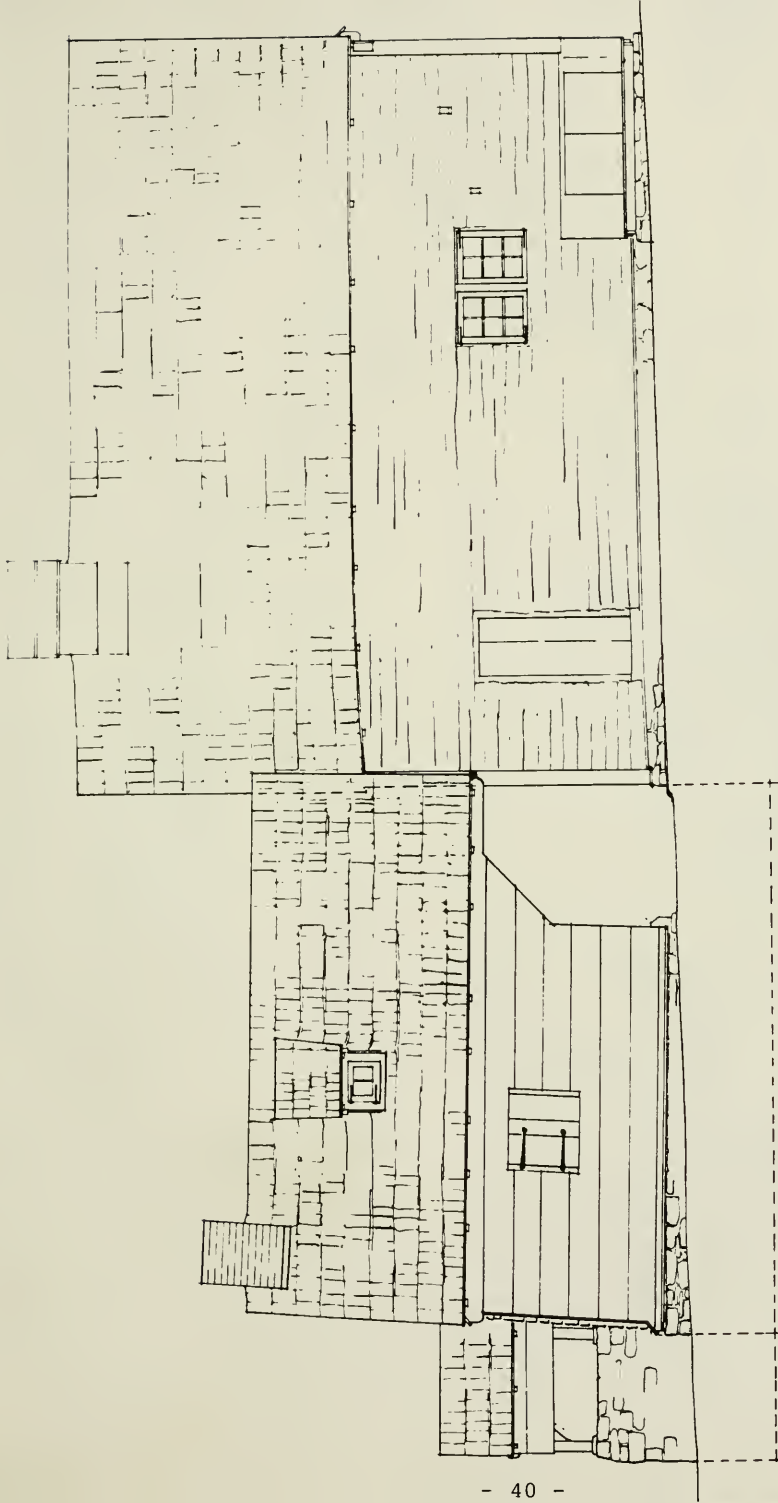
*EAST ELEVATION*

Ephrata - Beissel Cabin and Original Bake-House  
East Elevation

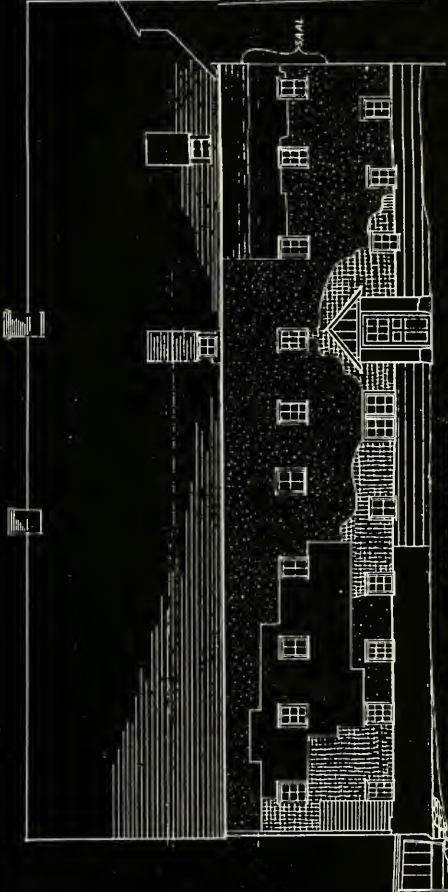
SOUTH ELEVATION

2 in. fl. and  
Finish 20 ft. Ceiling

2 1/2 in. fl. and  
Finish 18 ft.

NOTE: Walls covered with various  
specimens of paper, wood,  
marble, stone, etc., as  
shown on page 20.

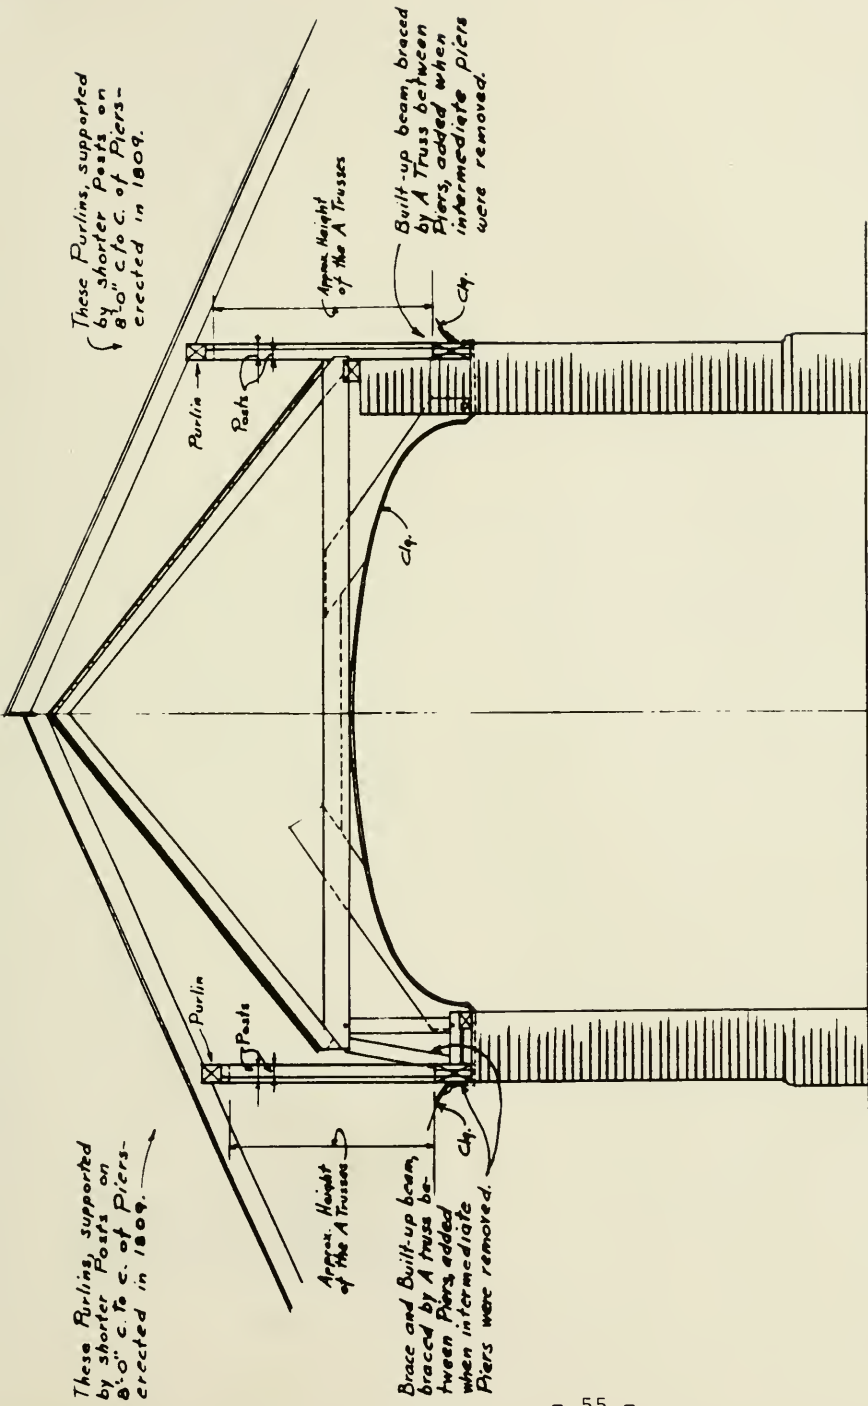
These Purlins, supported by shorter Posts on 8'-0" c. to c. of Piers - erected in 1809.

Brumbaugh was particularly concerned with the configuration and restoration of the shamble piers. His drawings illustrated the types of construction and proposed repairs of the piers. Also included

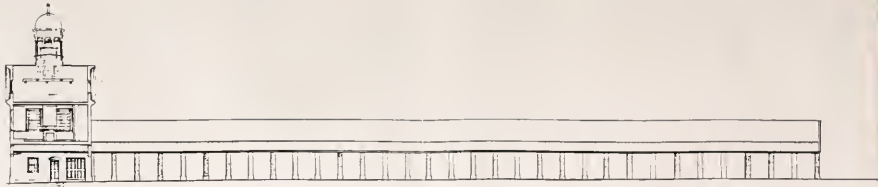
LONGITUDINAL SECTION Looking EAST

Second Street Market  
Preliminary Drawing  
omplete First Floor Plan  
and Longitudinal Section

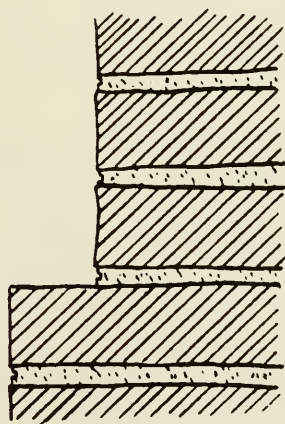
END  
PIER A  
ORIGINAL SHAMBLES  
Erected 1745

SURVIVING MARKET PIERS  
Scale:  $\frac{3}{8}'' = 1'-0''$

RECENT  
RECONSTRUCTIONS

1804  
EXTENSIONS

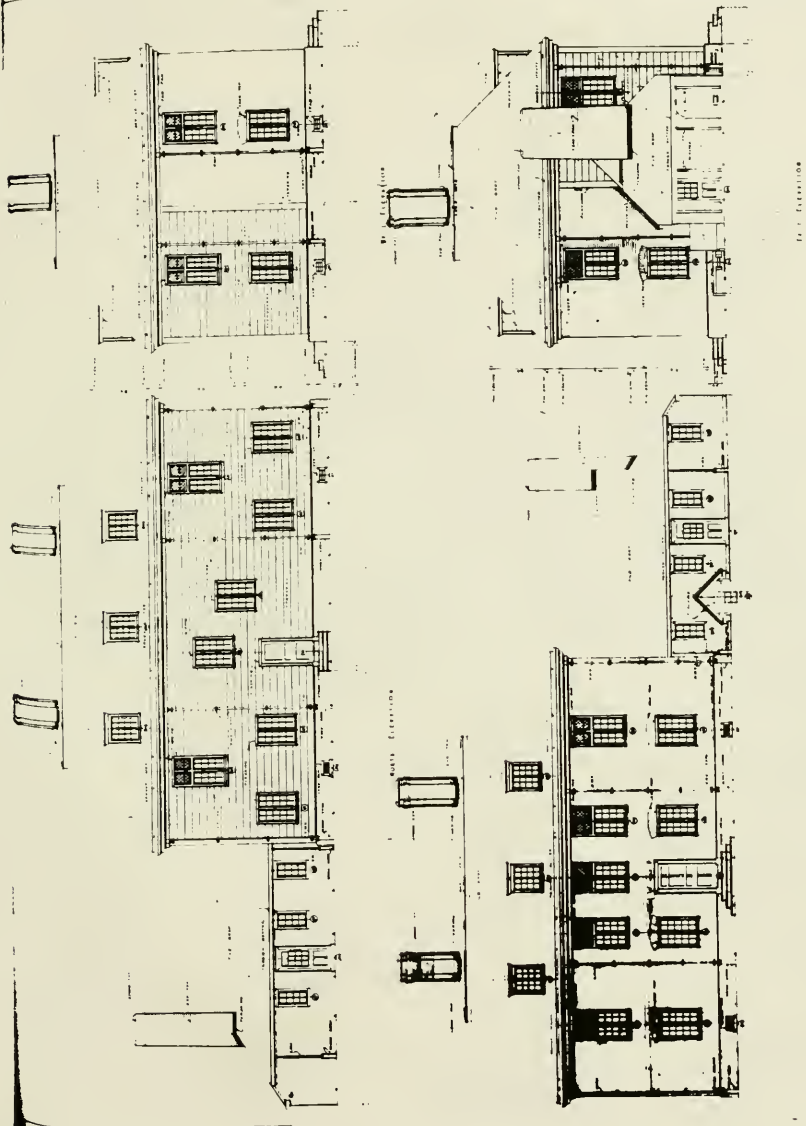
REAR ELEVATION

MAIN ELEVATION

Architectural drawings of Pennsbury Manor, showing the rear and main elevations. The drawings include a section drawing on the right side.

Pennsbury Manor - Prepared by R. Brognard Okie

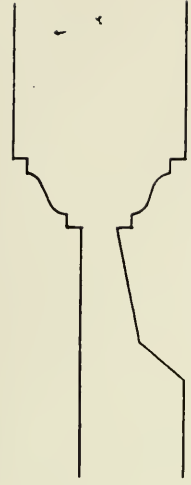
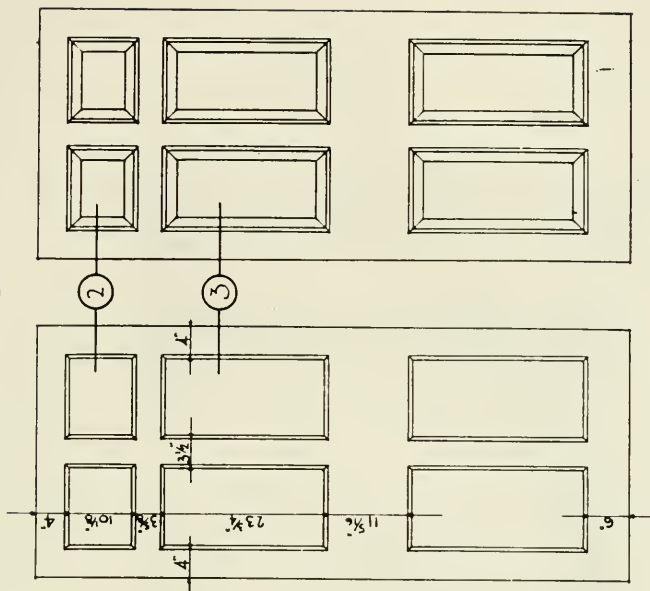
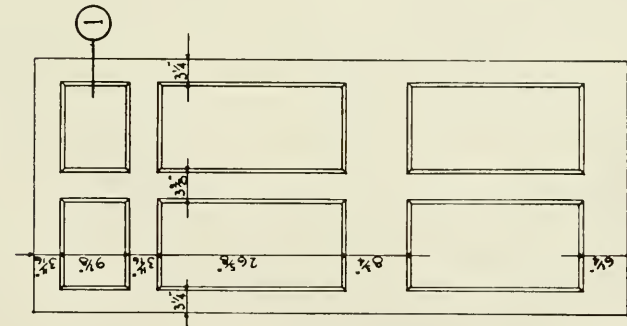
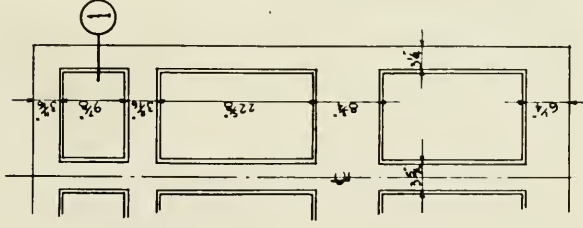
# INTERIOR DOORS

DOOR # 250  
TYPE D-1

TYPE D-1'      SCALE 3/4"=1'-0"      TYPES D-1 & D-2a

Old Economy Village - Interior Doors  
Prepared by Charles M. and Edward Stotz, Jr.

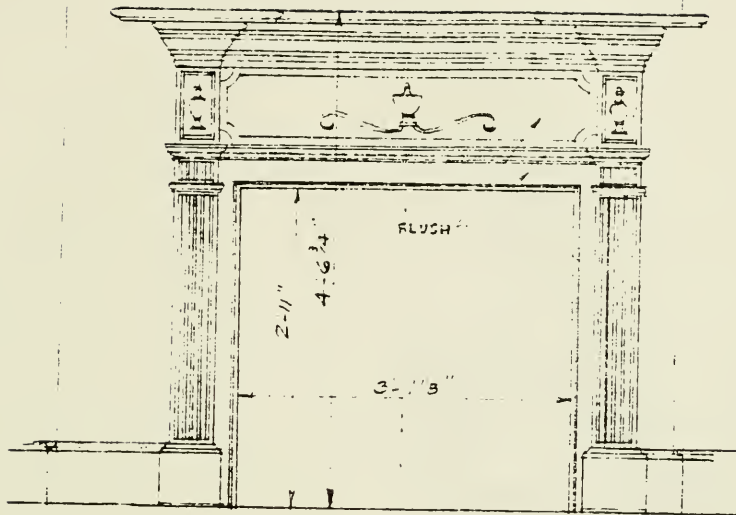
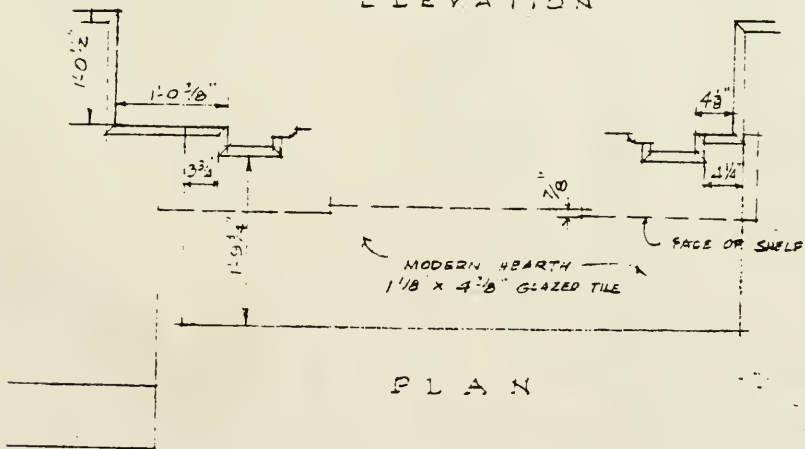
ELEVATION

PLAN

Old Economy Village - Mantel  
 Prepared by Charles M. and Edward Stotz, Jr.
