TITLE: Paper Mill Run Riparian Zone Management Plan and Partial Restoration

AUTHOR: Kevin Brown
The Walter W. Root Endowed Arboriculture Intern

DATE: March 2017

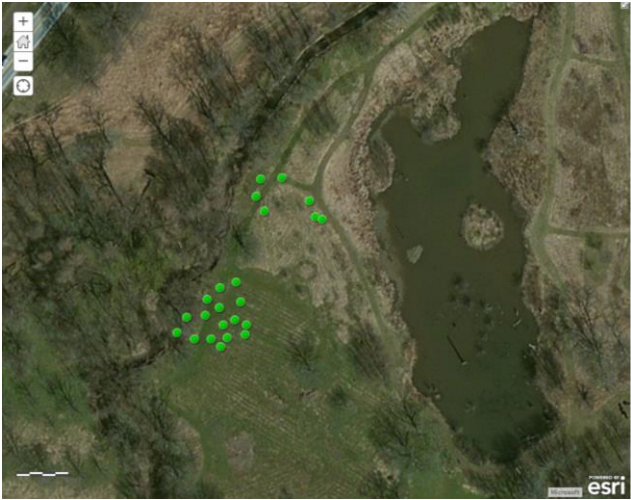
Figure 3: Active Project Planting Zone, showing new trees.

A smaller section at the beginning of this riparian zone was designated as the active project area where riparian restoration would begin (see Figure 3). The active work area was mapped out using the ArcGIS Collector™ online function, in which one can use aerial images and GPS coordinates to map an area in square feet (see Figure 4). This information was used to order an appropriate amount of native grass seed mix to be planted in the work area. This grass seed mix would be seeded in the fall of 2017 following an application of aquatic-safe herbicide to kill any existing herbaceous plants. This would rid the area of invasive herbaceous grasses and forbs and reduce competition for the native seed mix.

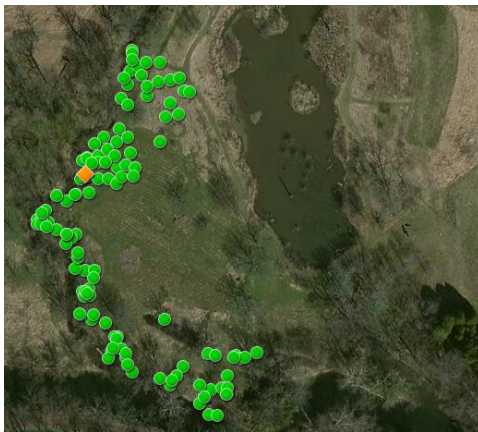
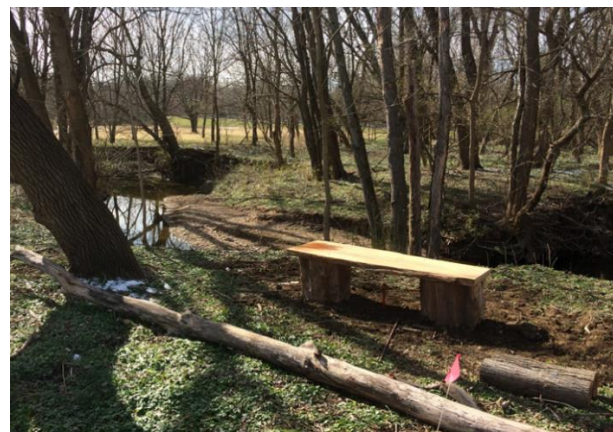
Figure 5: Bench location is indicated by orange diamond; Bench image.

To enhance the public appeal of the area, a bench was built at the end of the planting area, and its location is indicated on the ArcGIS Collector™ map (See Figure 5). This bench

was built using rot resistant *Robinia pseudoacacia* (Black Locust) wood from a tree that was cut down from the property of the Morris Arboretum about five years ago. The wood was milled using a chain saw mill, and was stored in the Bloomfield Farm barn. This board was mounted to two legs made of Black Locust logs standing upright. These logs were buried one foot at the base to aid in stabilization, and were made to look like tree stumps in the ground. In the middle of these legs, a four foot long rod was drilled into the ground. This rod had a disc on the bottom to anchor it in the ground, and an eye on the top end to be used to anchor the bench. To anchor the bench to the ground, tree support cable was passed through this eye and anchored to both of the legs of the bench using lag hooks, as demonstrated on pages 138 – 140 under the “Cabling Installation Techniques” section in chapter nine of the Arborists’ Certification Study Guide 2010 version (Lilly, S. J., 2010). This serves not only to anchor the bench in the case of a flood, but also to demonstrate tree support systems used by arborists.
